# University of Central Florida Colbourn Hall Building Analysis

February 2014

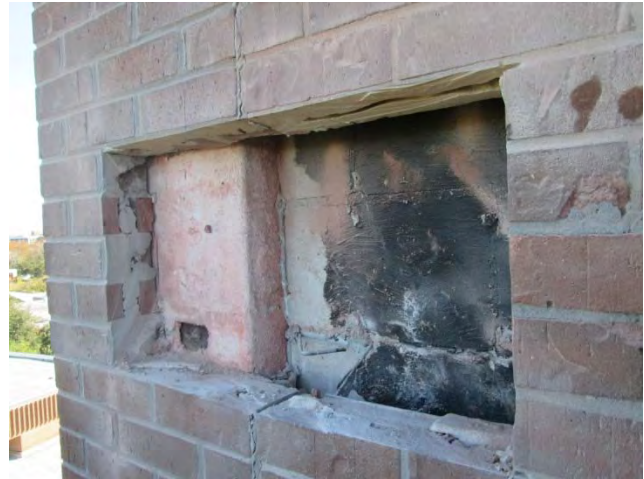
tower waterproofing – deteriorating and  
not consistently applied, no vapor barrier,  
no insulation

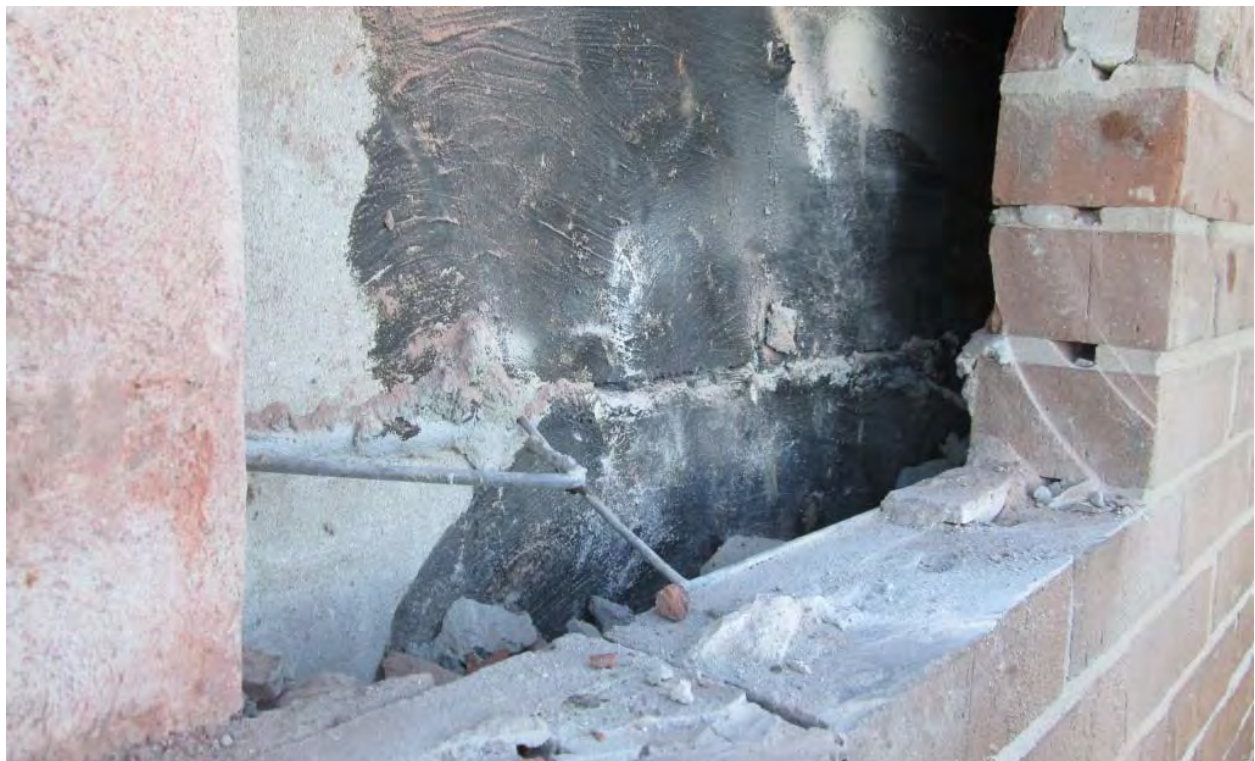
tower waterproofing – deteriorating and not consistently applied, brick ties not embedded in mortar

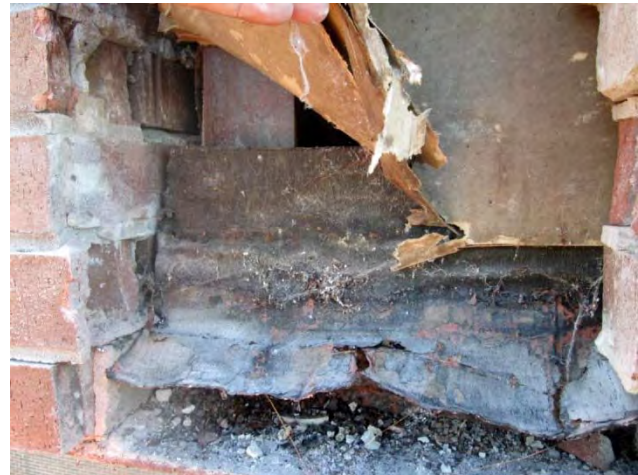
deteriorating substrate, flashing,  
no insulation, no vapor barrier

gypsum wallboard  
used as backup (not an  
appropriate material)  
with no asphaltic  
coating, deteriorating

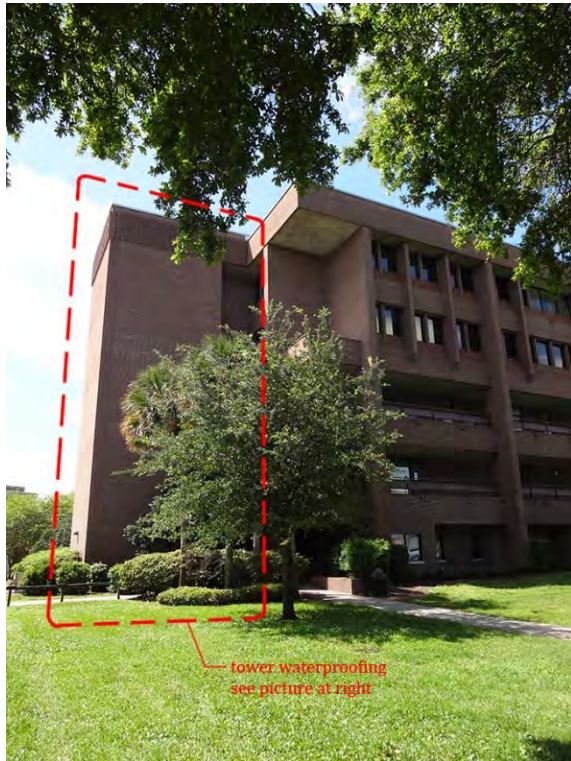
A1 – tower waterproofing – see A2, A3

- II. Exterior Skin Waterproofing, Towers (Stairs, Elevators, Restrooms, Mechanical) – see pictures A1, A2, and A3
  - a. The building façade enclosure consists of a cavity wall system. The cavity depth was noted to vary significantly at different areas of the facility from ½-inch to 9-inches at different façade areas. At the tower locations the CMU backup was not consistently treated with asphalt coating as specified in the design drawings (see details in the Executive Summary), and the locations with asphalt coating were deteriorating significantly. This could lead to water intrusion issues in the future, especially if cracking in the brick skin worsens over time. Additionally there is no vapor barrier or building insulation at these locations.

- b. PRIORITY 2 - This is not an item that can be easily corrected. As described in the Executive Summary, we have two options:
    - i. OPTION 1 - this option is to remove the brick and 4" non-reinforced CMU backup, and replace it with a properly installed backup system including cavity wall insulation, waterproof membrane, densglass backup, and cold formed framing structural metal studs tied to the existing building steel. This has the advantage of having a complete new exterior skin which has the desired vapor barrier, building insulation and waterproofing.

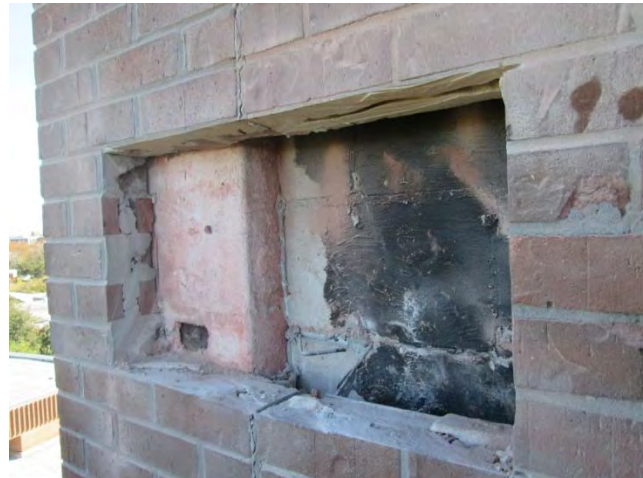
A2 – tower waterproofing lacking

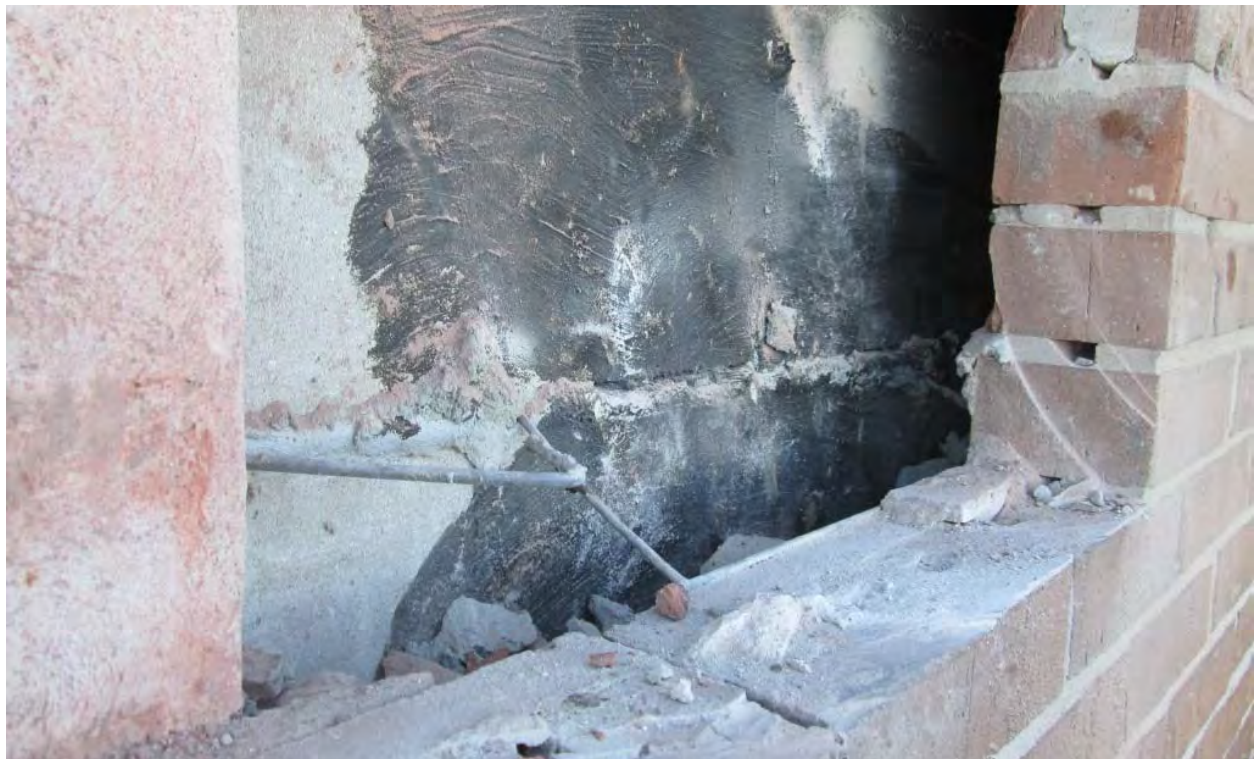
A3 – tower waterproofing lacking – cavity waterproofing coating, small air space, no insulation

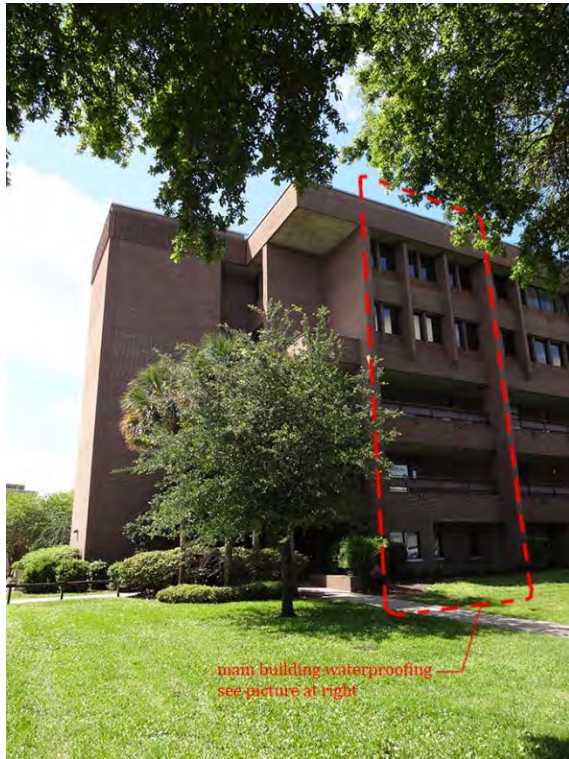
A4 – main building waterproofing – see A5, A6

- III. Exterior Skin Waterproofing, Main Building – see pictures A4, A5, and A6
  - a. The building façade enclosure consists of a cavity wall system. The cavity depth was noted to vary significantly at different areas but in general were very tight at the main building (approximately ½") which in many cases the air cavity was filled with mortar rendering the air cavity useless. Waterproofing of the structural steel façade backup consisted of gypsum sheathing shingled over an asphalt faced copper flashing (Photo S46). The gypsum sheathing was not asphalt treated as specified in the design drawings (see details in the Executive Summary). The specified asphalt facing was intended as a

- b. **PRIORITY 2** – This is not an item that can be easily improved – we recommend the complete removal of the exterior skin, including the brick and sheathing, and replacement of the brick at the columns at roof parapet over a properly installed backup system including cavity wall insulation, waterproof membrane, densglass backup, and cold formed framing structural metal studs tied to the existing building steel. The existing windows and brick between columns from level 2 to level 5 will be removed and replaced with a curtainwall system. The second and third floor existing exterior circulation will now become interior circulation which will need additional fan coil units in the ceiling to condition the space. See the Executive Summary for additional diagrams and images describing this scope of work.

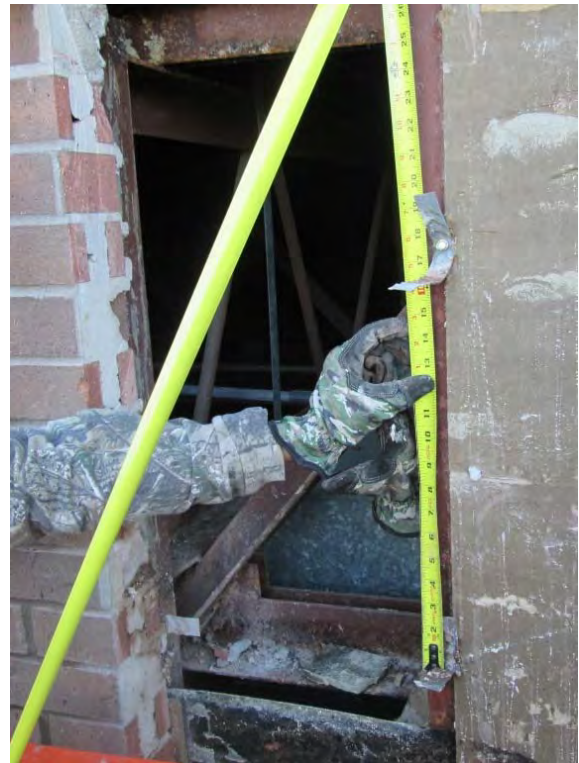
A5 – main building waterproofing lacking

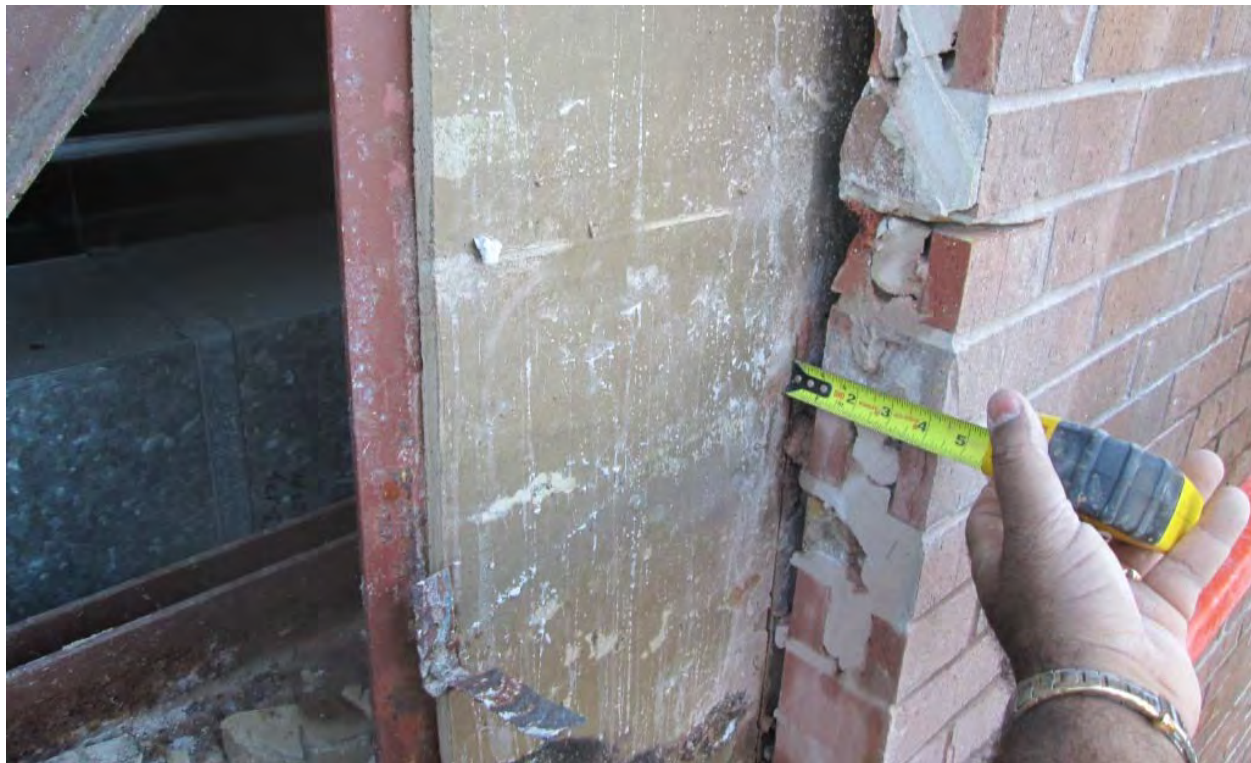
moisture barrier. The joints between adjacent gypsum boards were not taped against water infiltration; moisture deterioration and caking of this material was noted at multiple locations, particularly at the projected façade areas of the Level 2 and Level 3 exterior open corridors (Photo S47). The asphalt faced copper flashing was not installed over the full height of the wall cavity (Photo S48).

A6 – main building waterproofing lacking – gwb with no waterproof coating, small air space

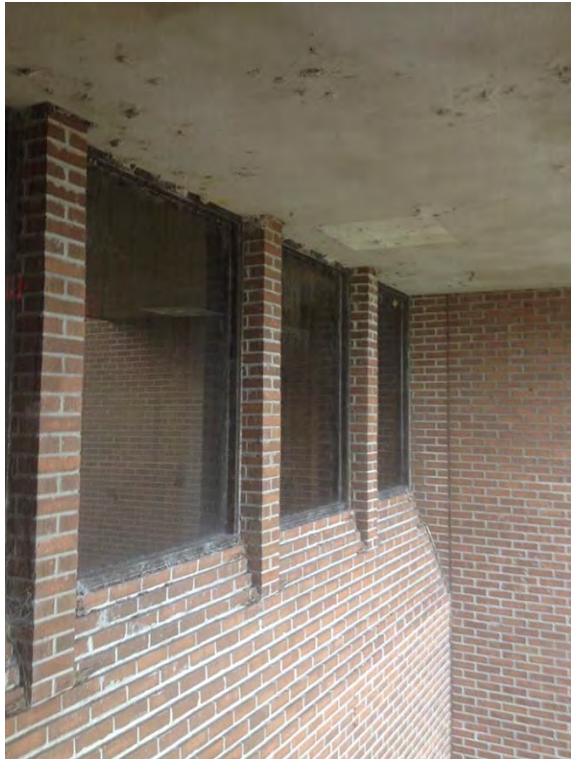
A7 – exterior soffit and brick maintenance

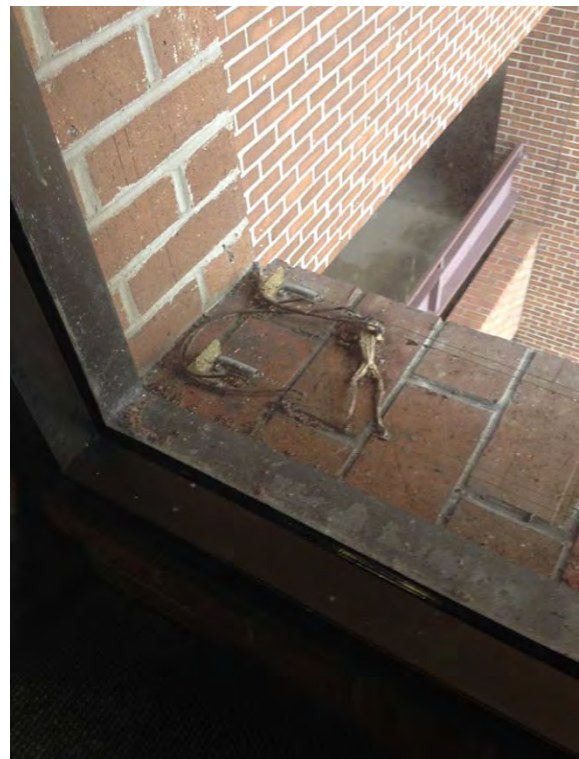
A8 – exterior maintenance, window cleaning

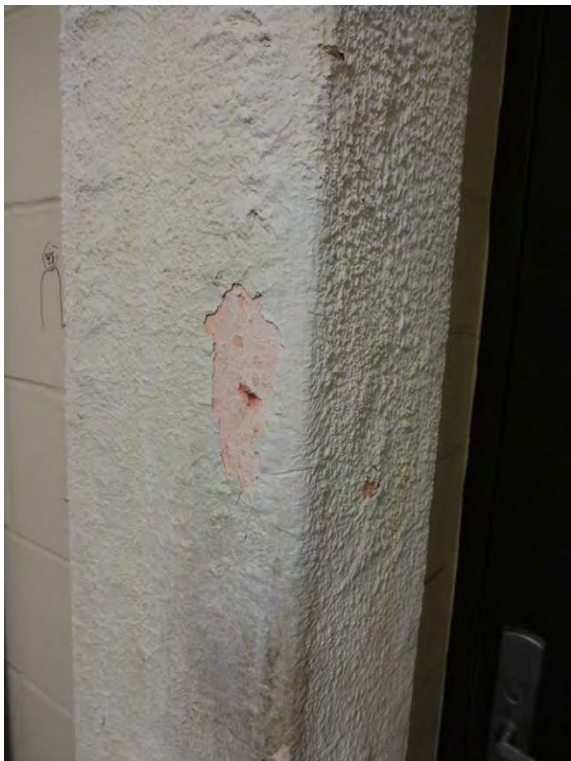
A9 – column maintenance and repair

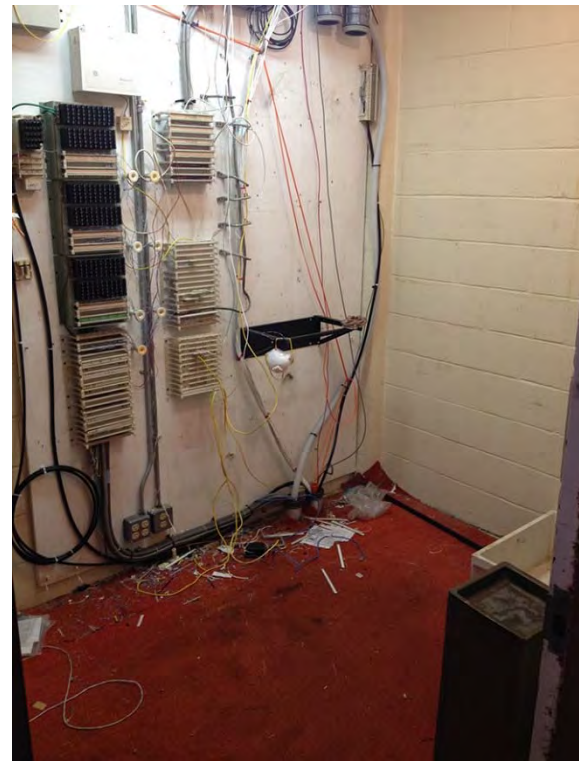
A10 – Janitor/Telecom cleaning

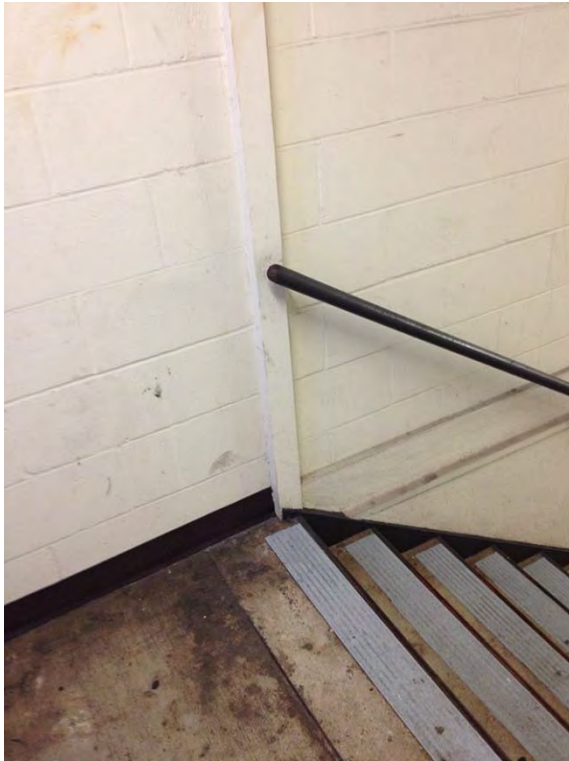
A11 – stair condition

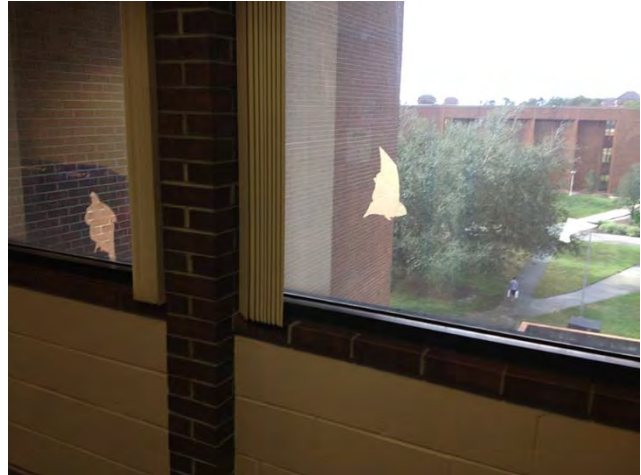
A12 – window film peeling, needs replacement

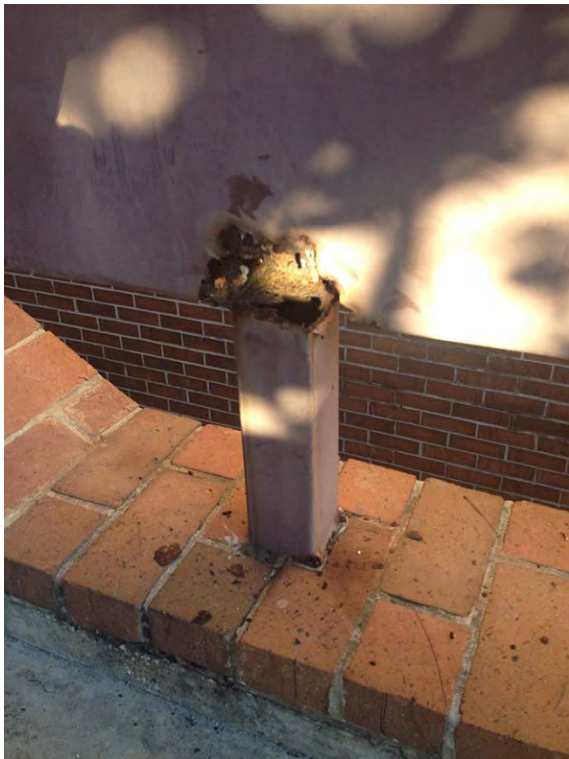
- a. **PRIORITY 2** – the exterior handrails are made of painted steel tubes and C channels. The channels and tubes were designed in a way that allows water to collect on the top surface of the steel – this has contributed to the degradation of the paint coating and some rusting of these components. In addition, several of the handrail connections have serious corrosion, to the point where there may be failure in the joints of the handrails. A temporary solution for these components is to clean, repair, and paint them to prevent further rusting. A more permanent solution would be to replace the handrails with new ones which comply with the current UCF Standards and are not a painted material (aluminum, stainless steel, etc) to avoid the need for long term maintenance. This replacement primarily applies to the handrails on the east and west exterior convenience stairs where the deterioration is most prevalent.

A13 – handrail corrosion

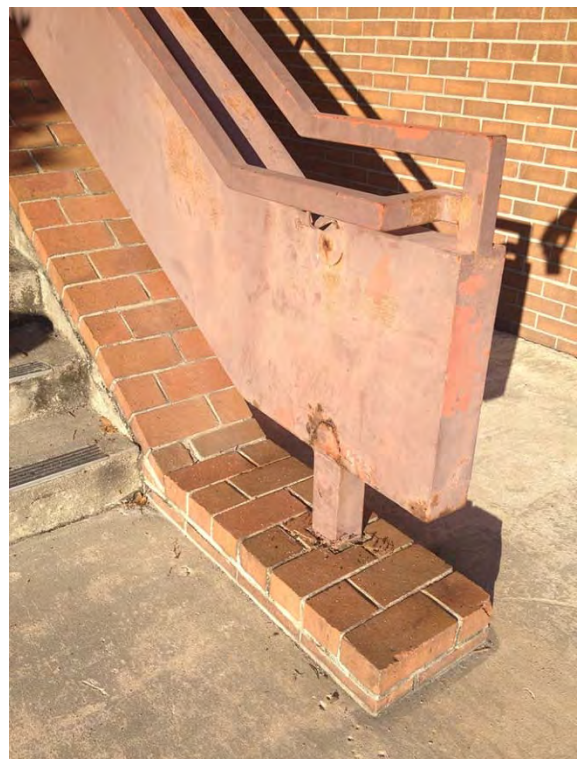
A14 – handrail corrosion

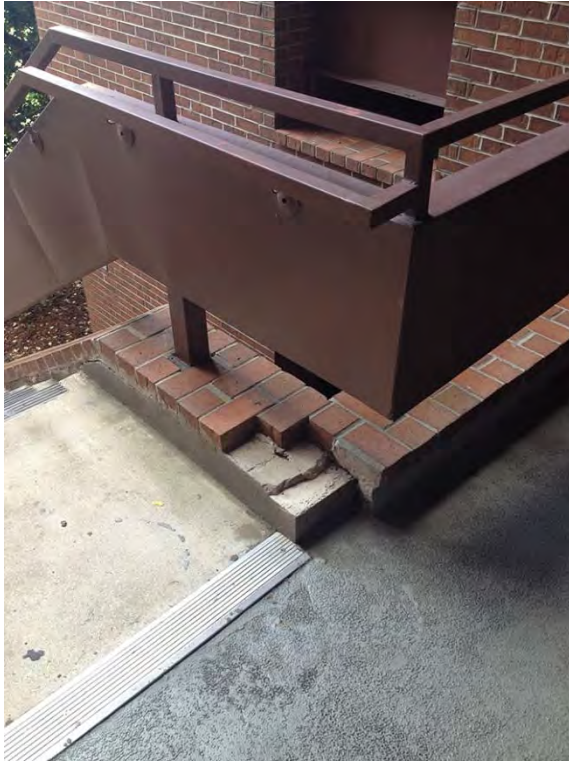
A15 – handrail base brick missing (several places)

- b. **PRIORITY 2** – the existing brick curb underneath the handrail is missing several bricks around the second floor walkway. We recommend that these bricks be replaced.

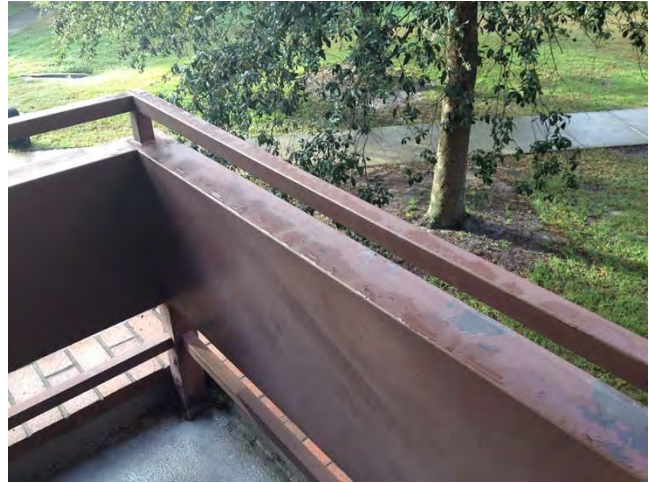
A16 – handrail standing water

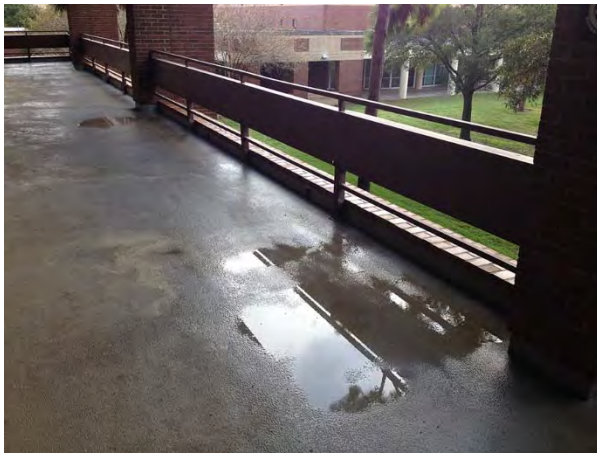
- a. **PRIORITY 3** – the exterior walkways of the project have standing water during rain events, due to improper sloping of the walkways to the scupper drains. The second floor has a relatively newly installed elastomeric coating which has helped to contain

A17 – standing water

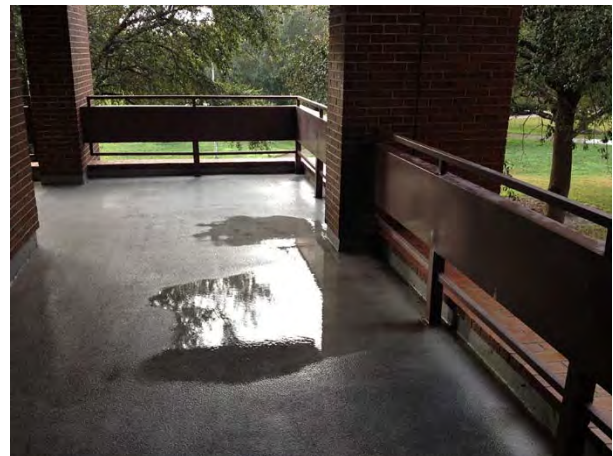
A18 – standing water

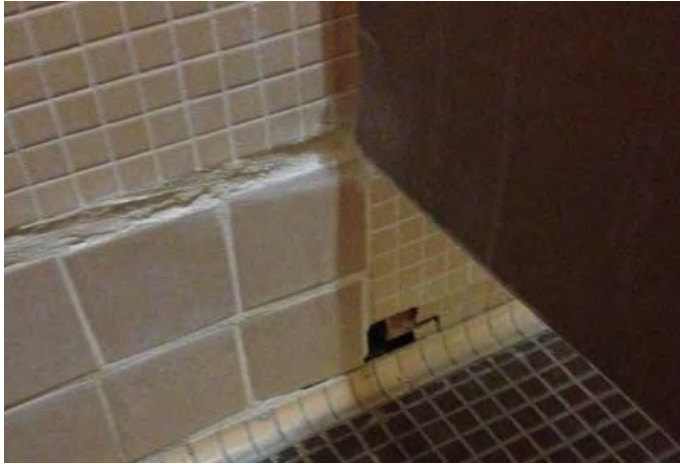
- VII. Restroom Conditions – see pictures A19 and A20
- a. PRIORITY 2 – the restrooms in the project are in sore need of remodeling. Their condition is poor. The tile and grout appears dirty, which we believe is not from lack of cleaning but from the age of the building. The entries to the restrooms and several of the fixtures do not meet current ADA clearances – see the Life Safety Analysis for more information. As there are more fixtures than required for this building type (see Life Safety Analysis), it is possible to remodel these restrooms and gain space by eliminating fixtures. These restroom improvements will provide a significant increase in the building occupant's health and welfare.

A19 – restroom, hole in wall, patch

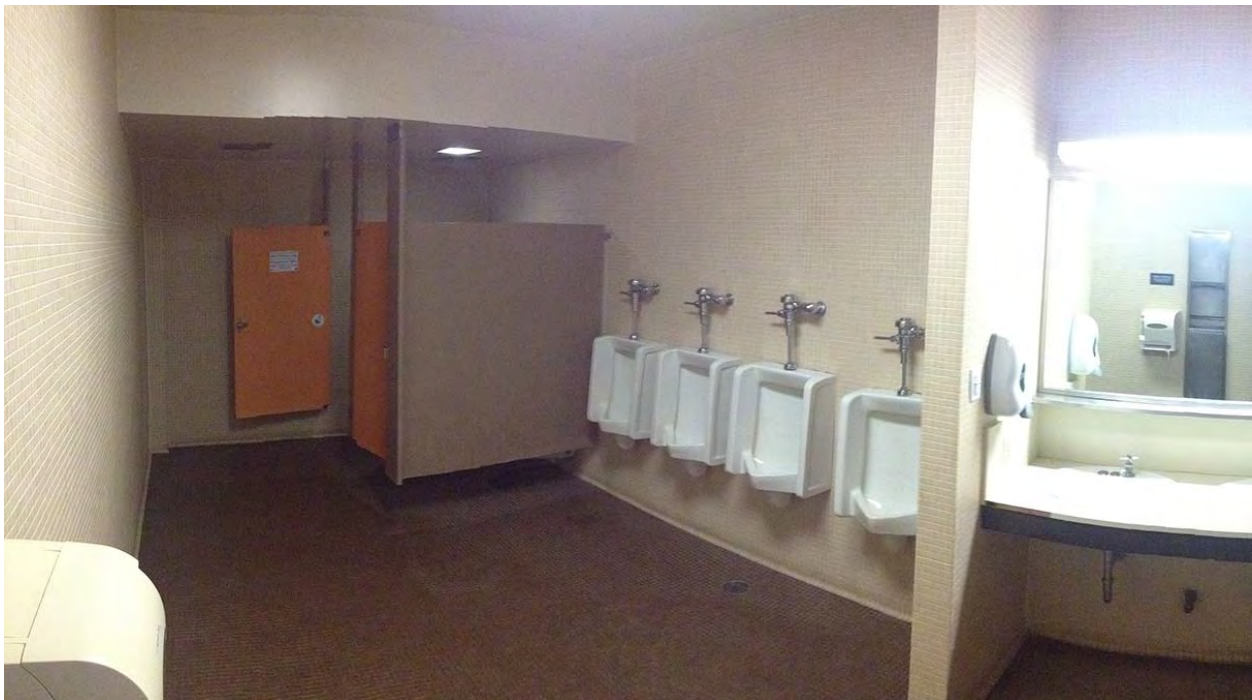
A20 – restrooms

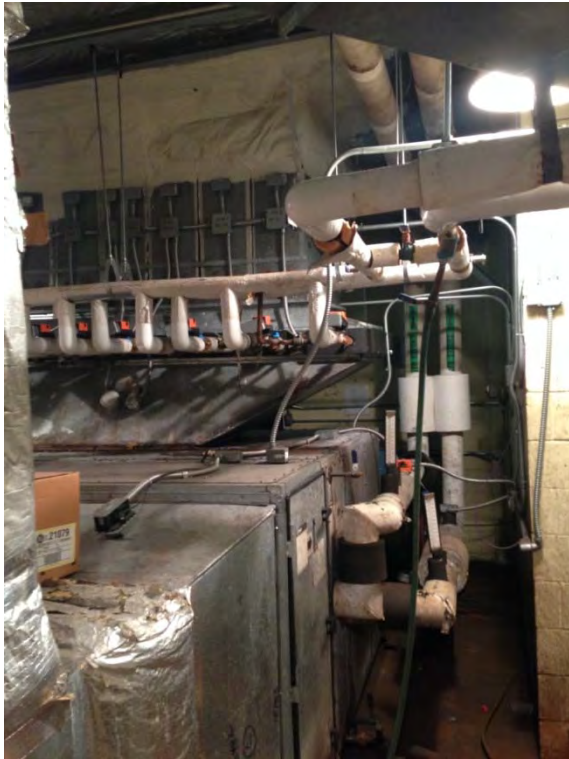
- III. Mechanical Air Handling Unit Access – see picture M1
  - a. PRIORITY 3 - FBC Mechanical Section 306.1 Access for maintenance and replacement. There is not adequate coil pull access or a means of removal for any of the five (5) existing AHU's. Per Section 306.1, "Appliances shall be accessible for inspection, service, repair and replacement without disabling the function of a fire-resistance-rated assembly or removing permanent construction, other appliances, venting systems or any other piping or ducts not connected to the *appliance* being inspected, serviced, repaired or replaced." To allow for replacement of the equipment, double doors with a

M1 – insufficient AHU coil pull clearance

removable center column would need to be installed or mechanical OA louvers can be installed large enough to allow for removal of the equipment. Providing proper access for maintenance is more difficult and would require relocation of the AHU and an entire reconfiguration of the room. This report also discusses replacement of the entire HVAC system with a Chilled beam approach. If this recommendation is implemented, the mechanical room would be used to house possibly smaller 100% OA units and could allow for proper clearance for maintenance and accessibility.

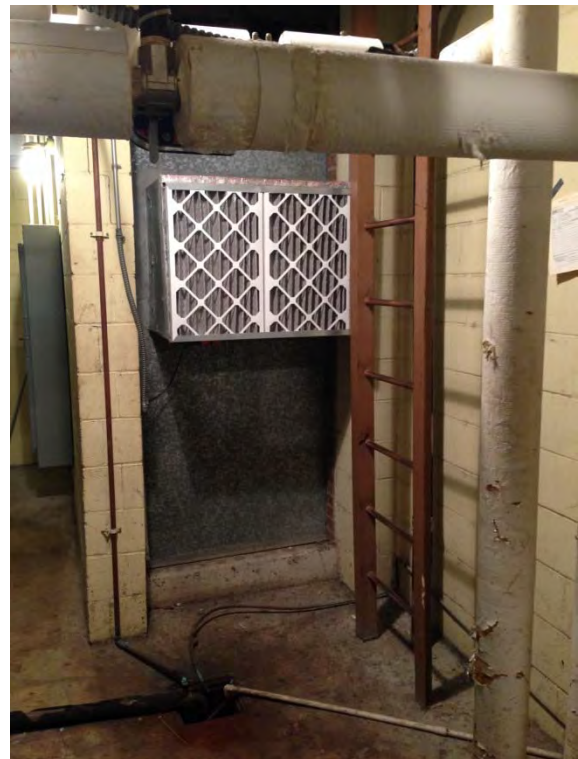
M2 – level 5 OA intake w/ no balancing

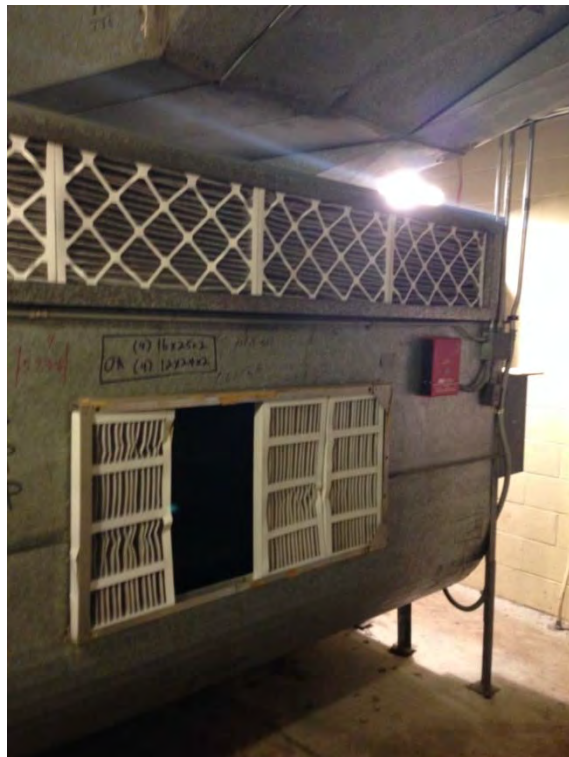
M3 – level 5 AHU return air opening

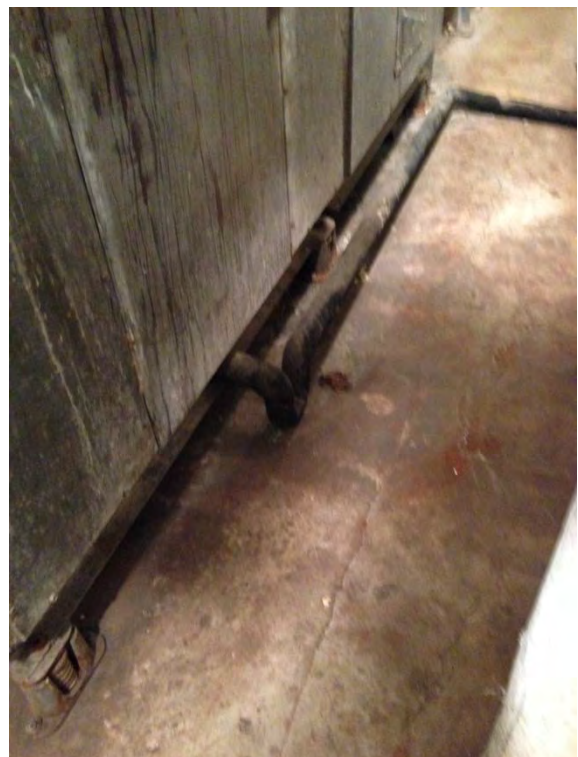
M4 – Level 5 condensate p-trap

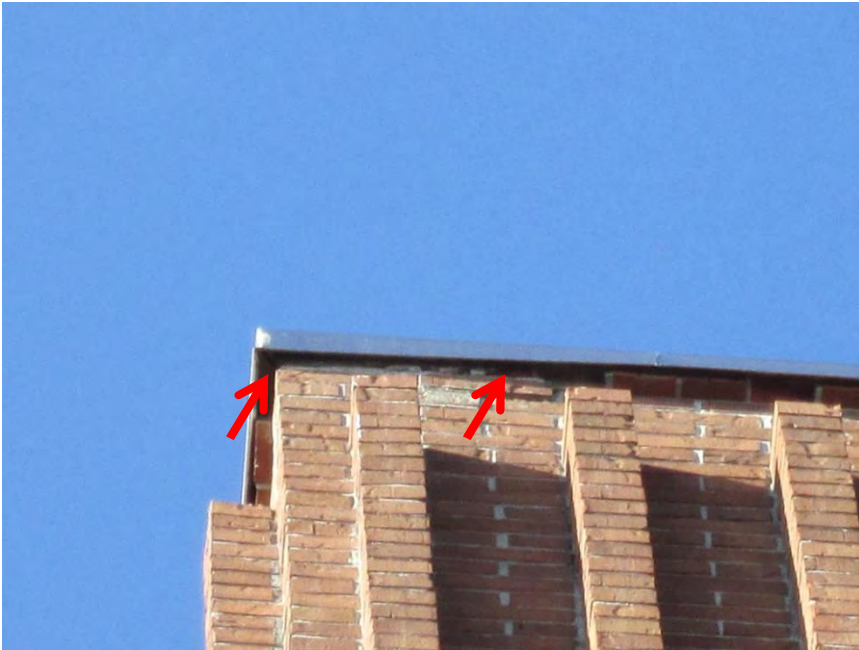
S1 – View of missing brick beneath Roof Level parapet wall coping cap

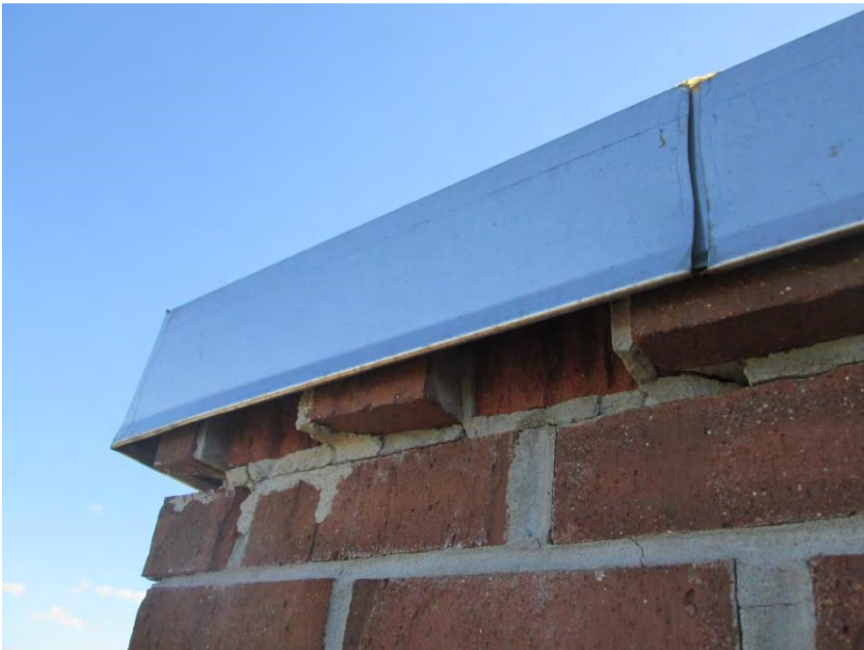
S2 - Close-up view of Photo S1 showing missing overhead brick below parapet wall coping

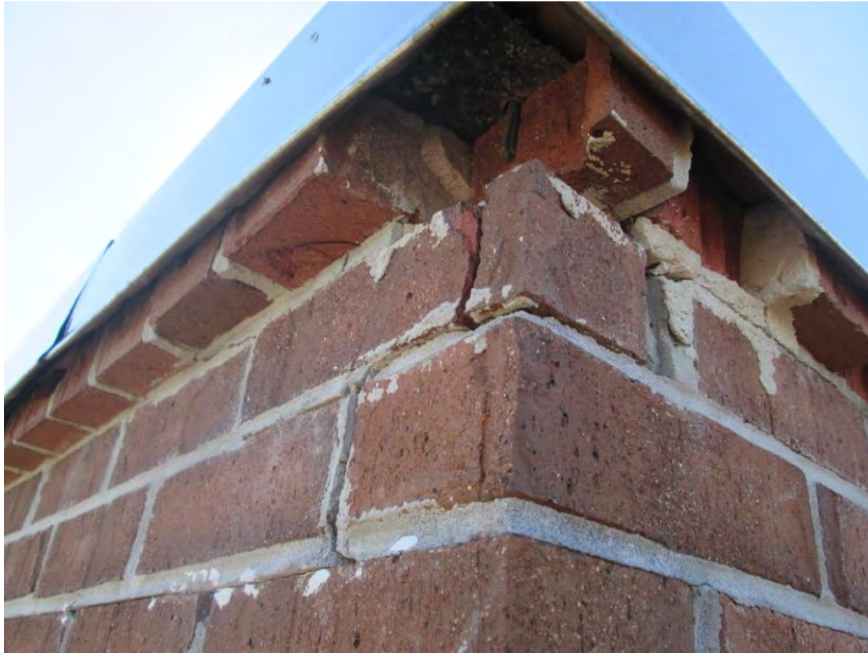
S3 - Cracked overhead brick noted beneath Roof Level parapet wall coping cap

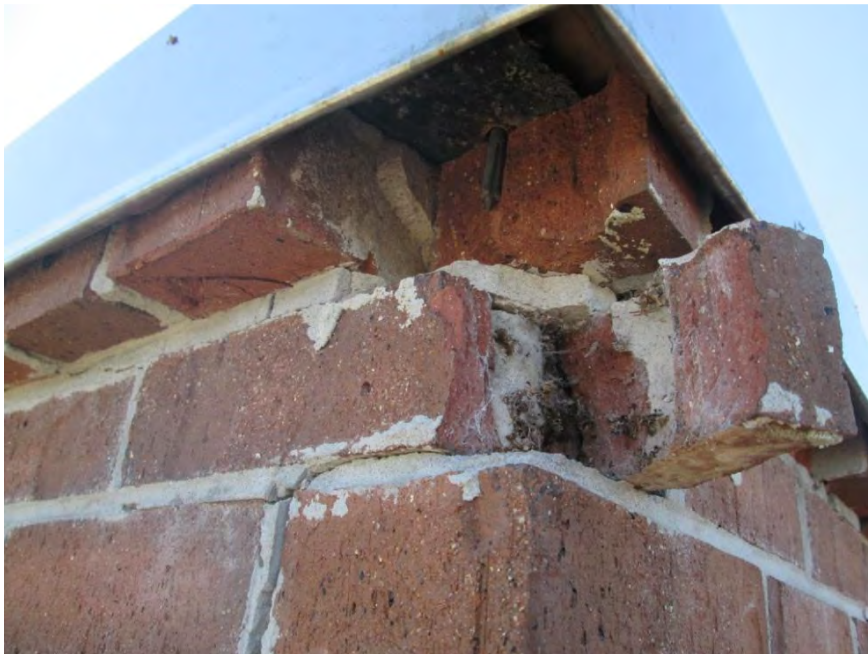
S4 - Cracked overhead brick shown in Photo S3 readily dislodged by hand

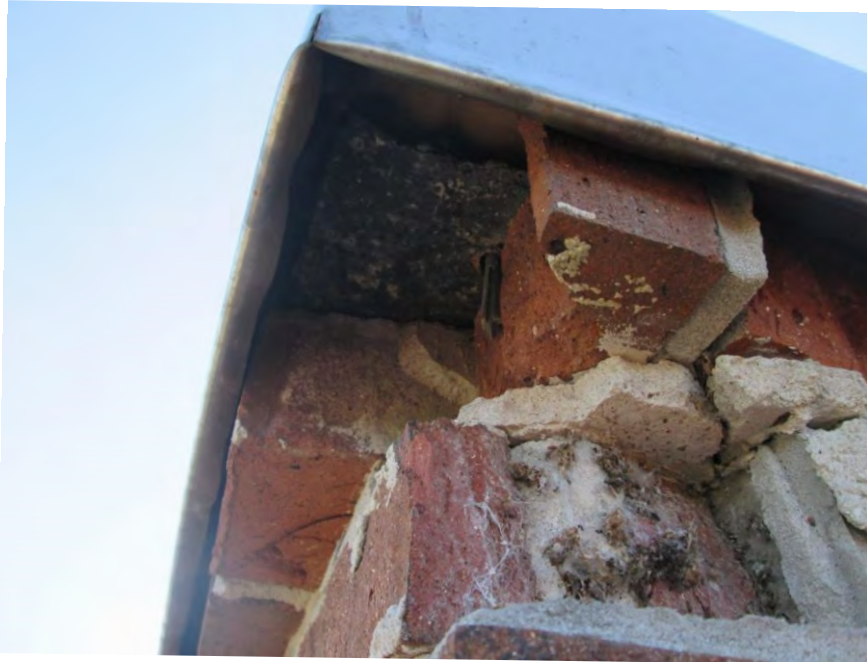
S5 - Disengaged fastener for parapet coping nailer attachment at missing brick location

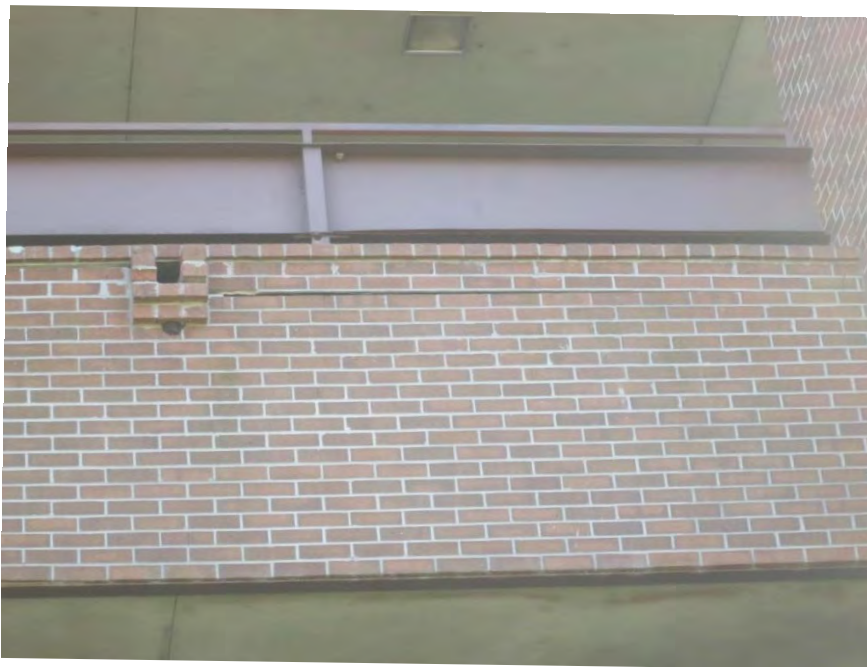
S6 – Separation along bed joint noted at top of Level 2 and Level 3 exterior corridor façade

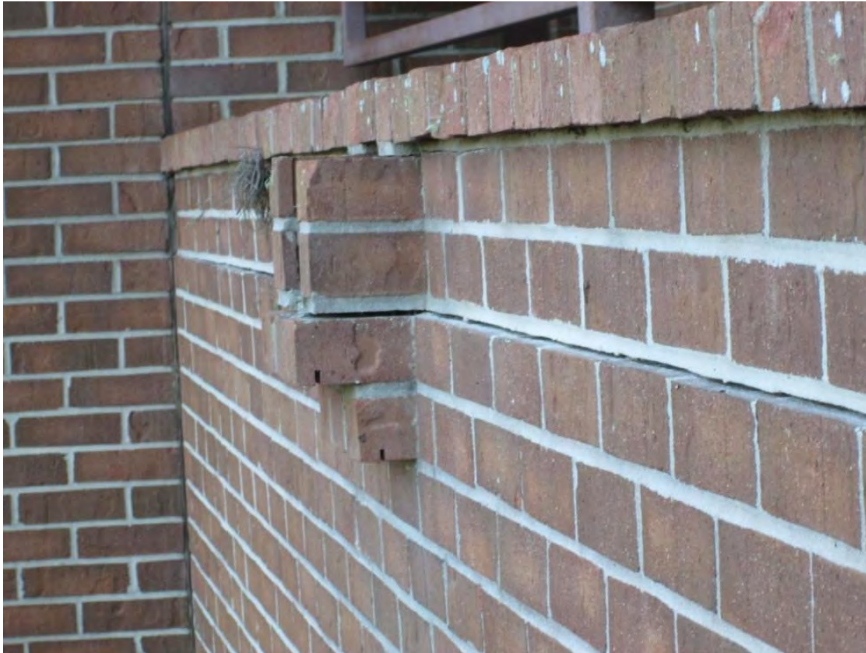
S7 – Separation at bed joint noted at top of Level 2 and Level 3 exterior corridor façade areas

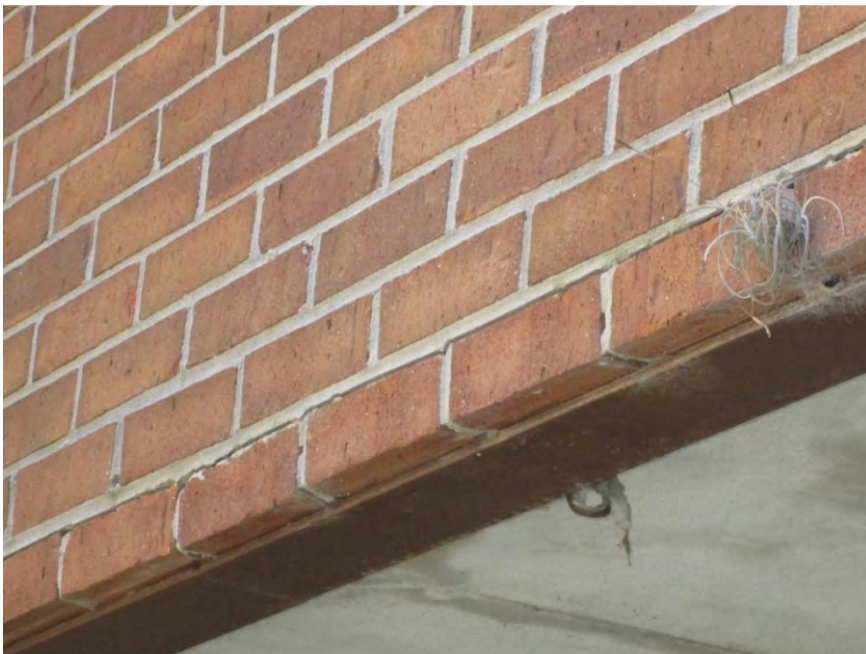
S8 - Potentially loose overhead brick at Level 2 exterior open corridor areas above Level 1 access walkways

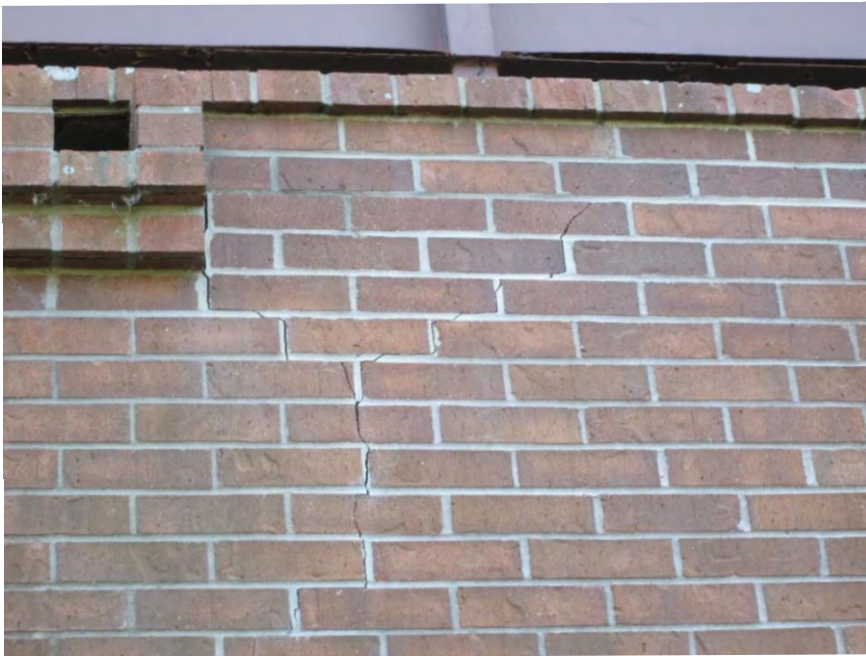
S9 - View of cracked brick

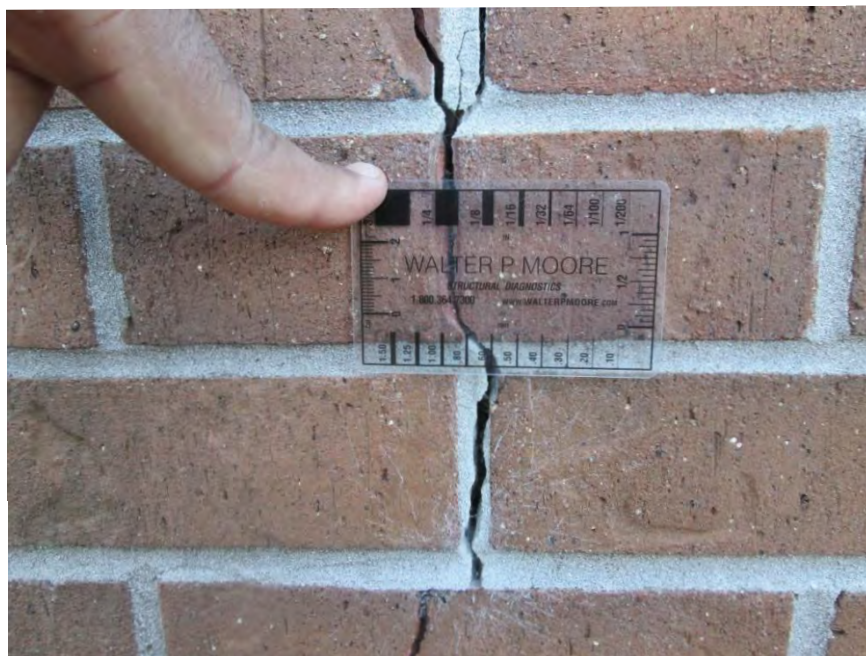
S10 - Close-up of Photo S9 showing 1/4-inch wide brick cracking

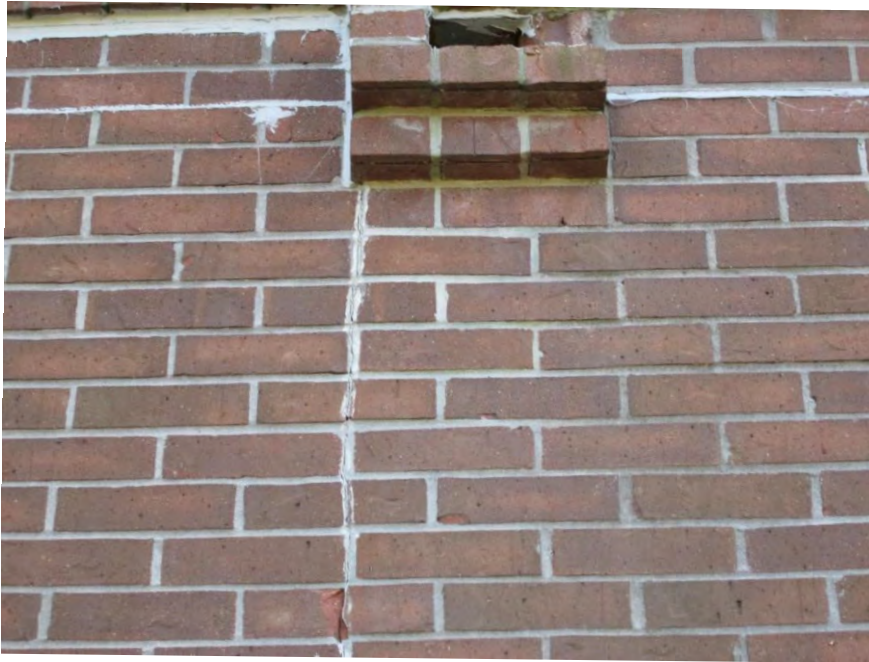
S11 - Cracked and spalled brick

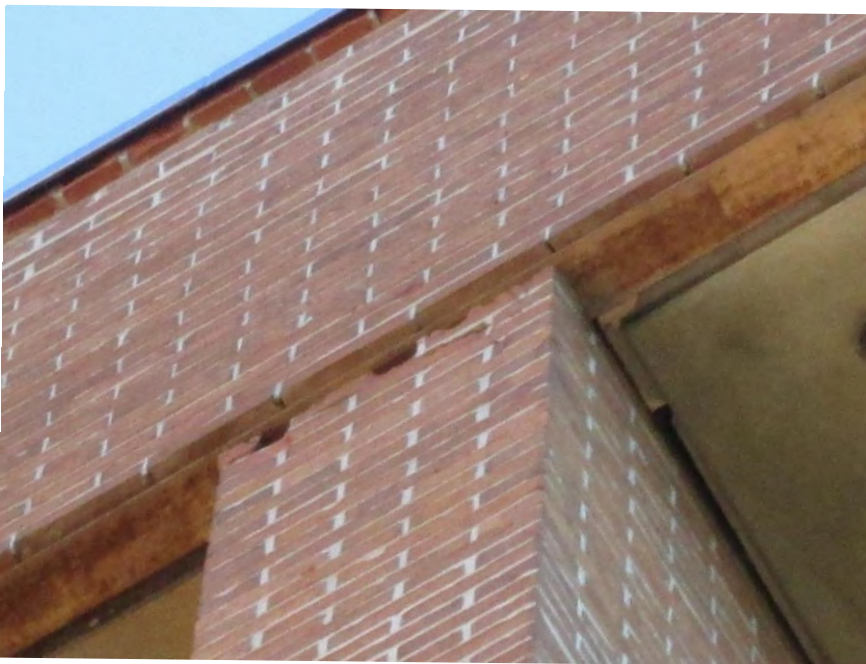
S12 - Spalled brick below shelf angle

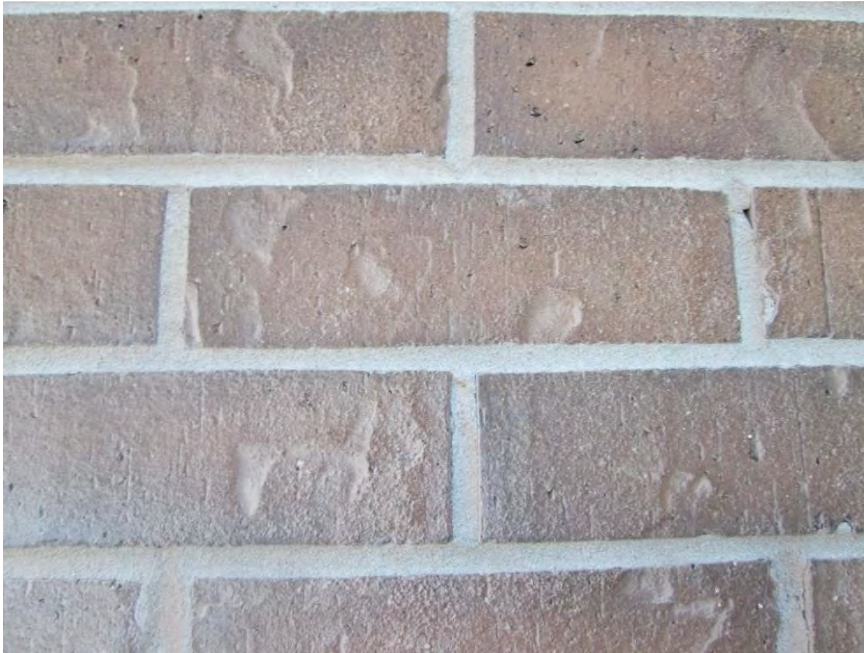
S13 - Mortar joints generally noted to be in fair condition

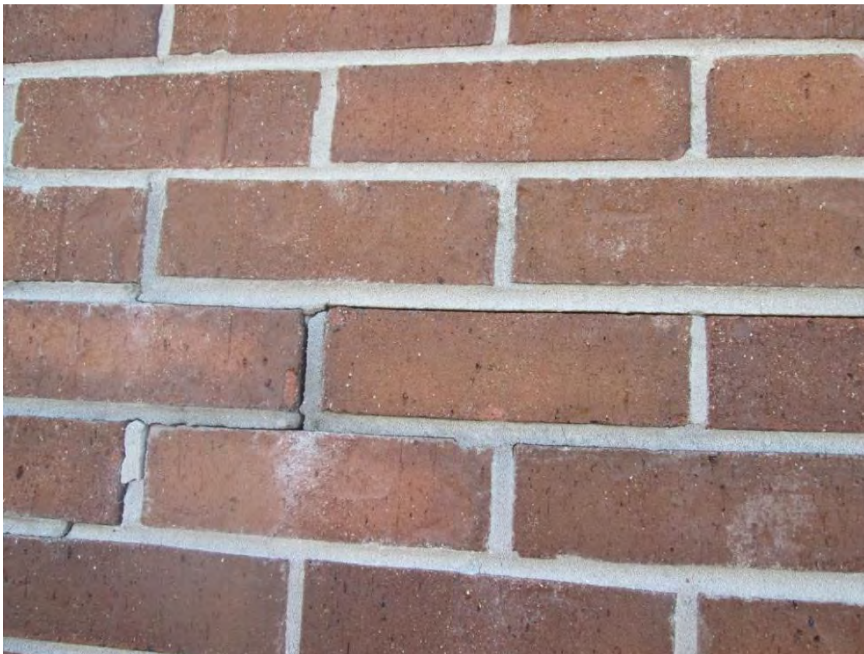
S14 - Brick mortar cracking
