# University of Central Florida Colbourn Hall Building Analysis

February 2014

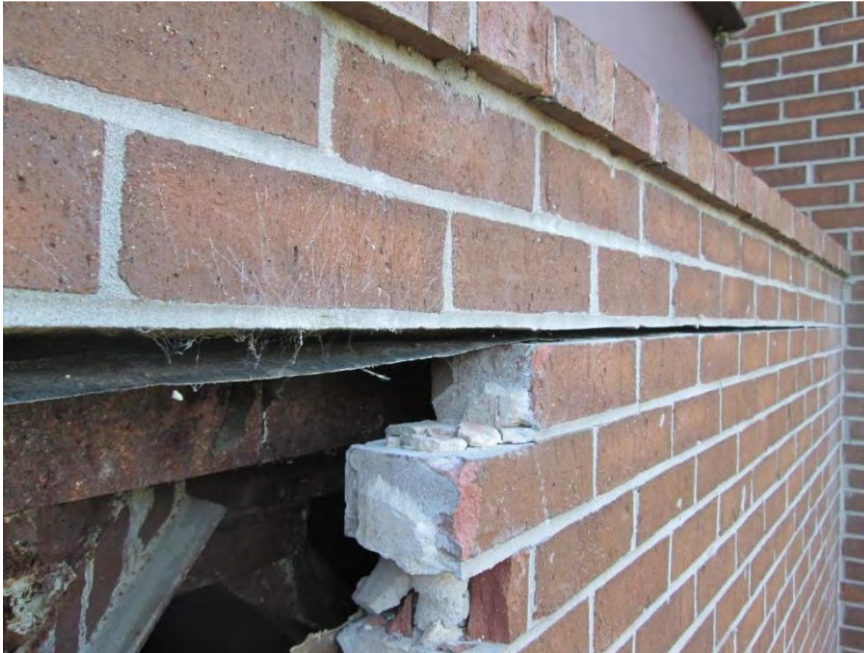
S15 - Mortar separation at exterior open corridor brick coping (note through-wall fabric flashing)

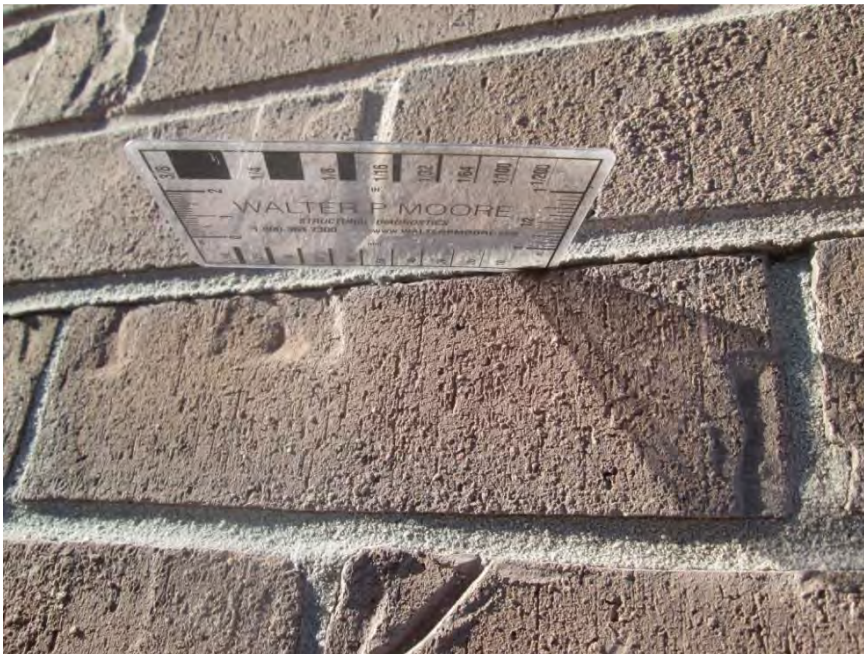
S16 - Mortar separation at brick courses below Roof Level parapet

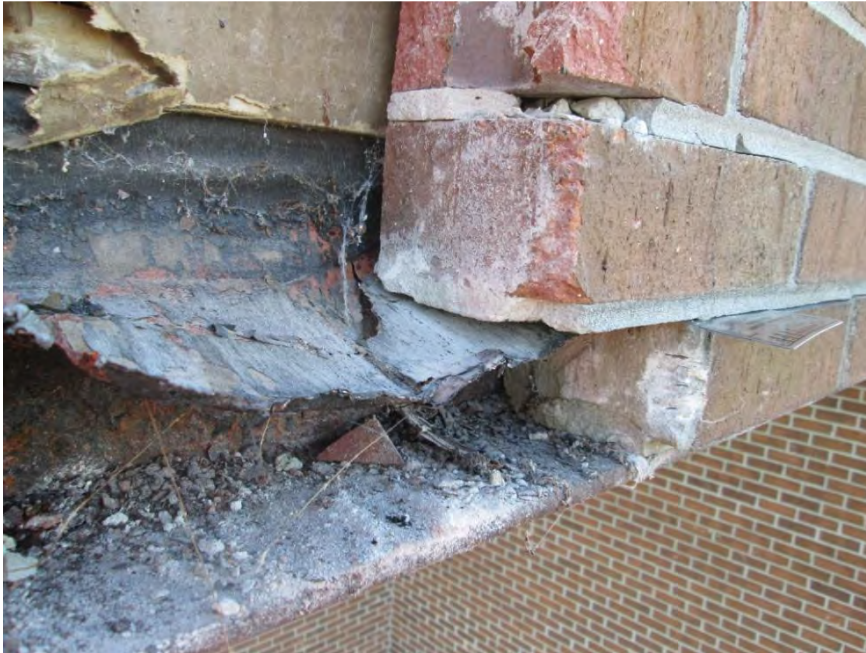
S17 - Mortar separation at brick courses below Roof Level parapet (note through-wall flashing)

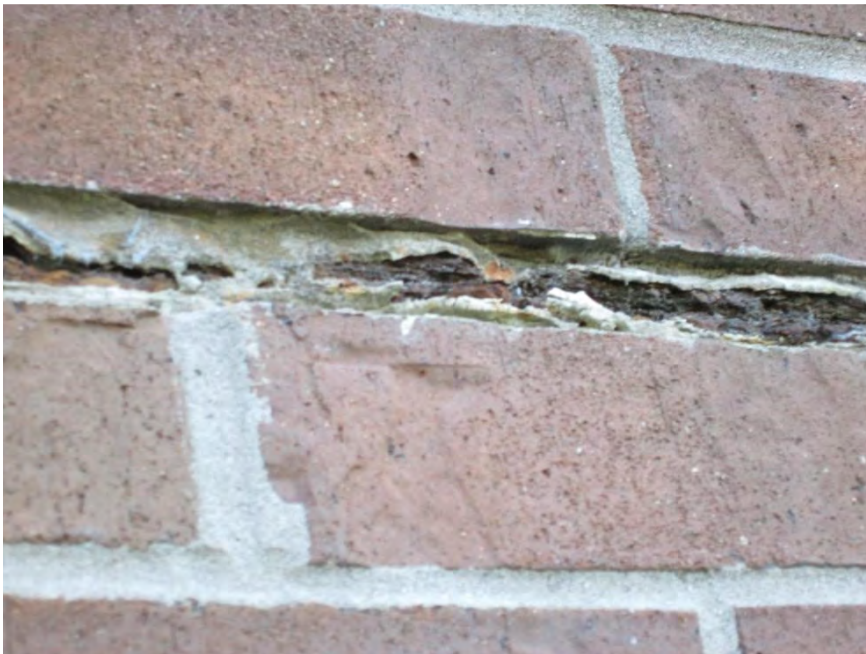
S18 - Corrosion at exposed shelf angle toe

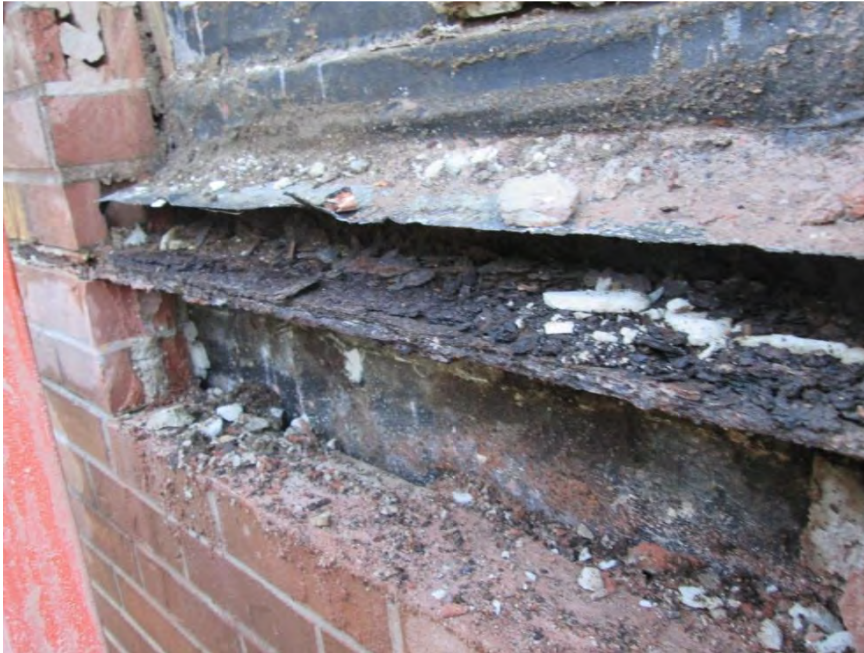
S19 - Corrosion product buildup at shelf angle

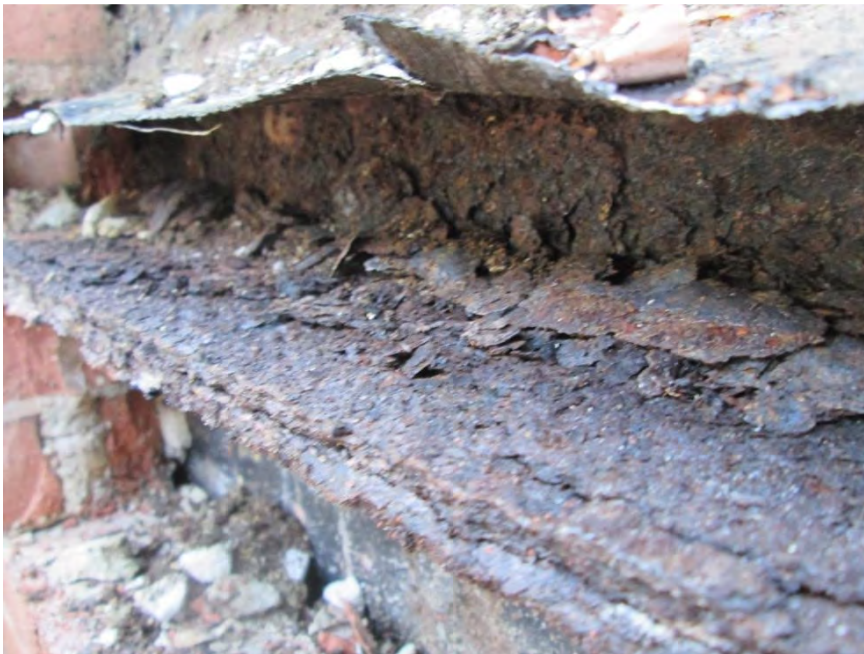
S20 - Close-up view of Photo 19 showing corrosion product buildup at shelf angle

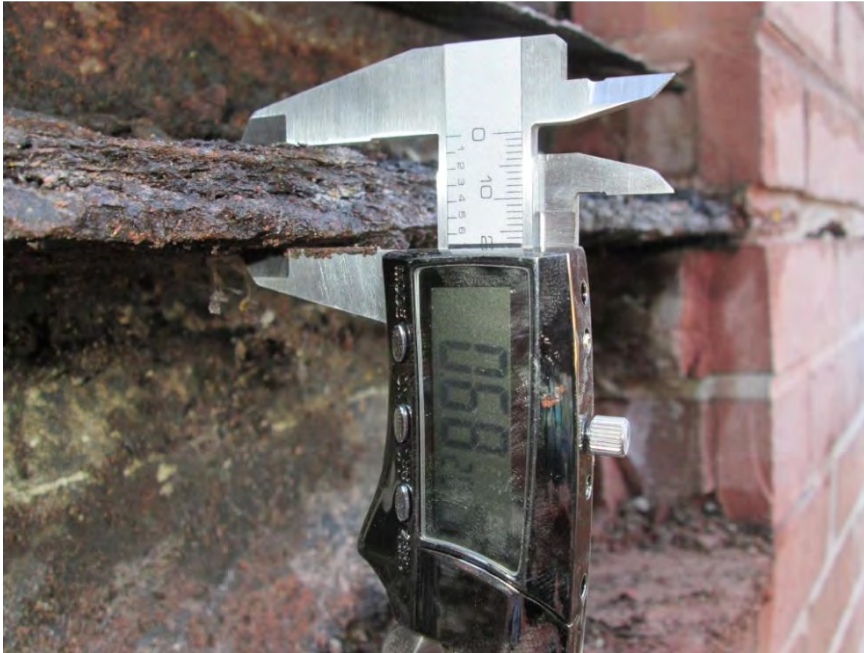
S21 - Caliper measurement of delaminated shelf angle leg (~0.68-inch)

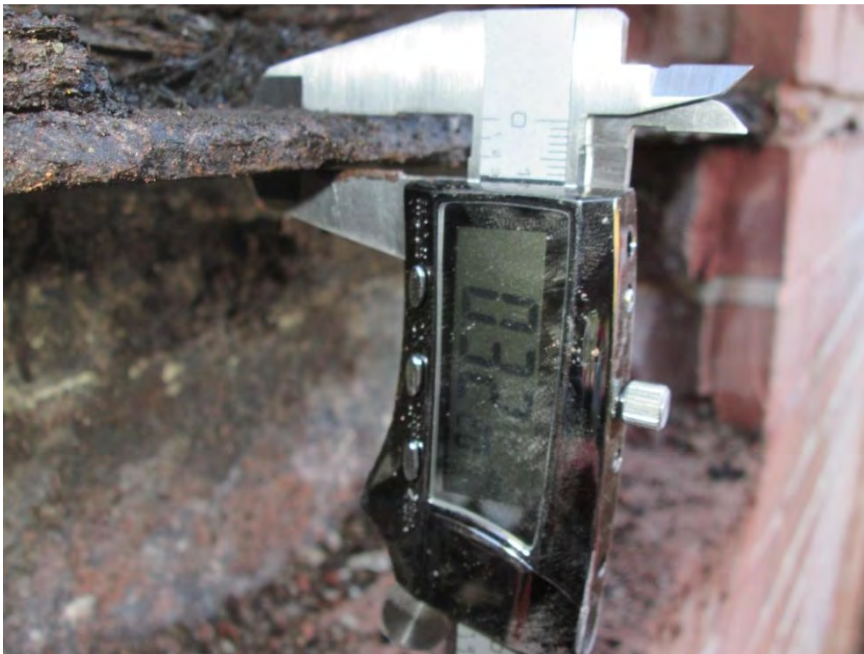
S22 - Caliper measurement of cleaned bare shelf angle leg (~0.32-inch)

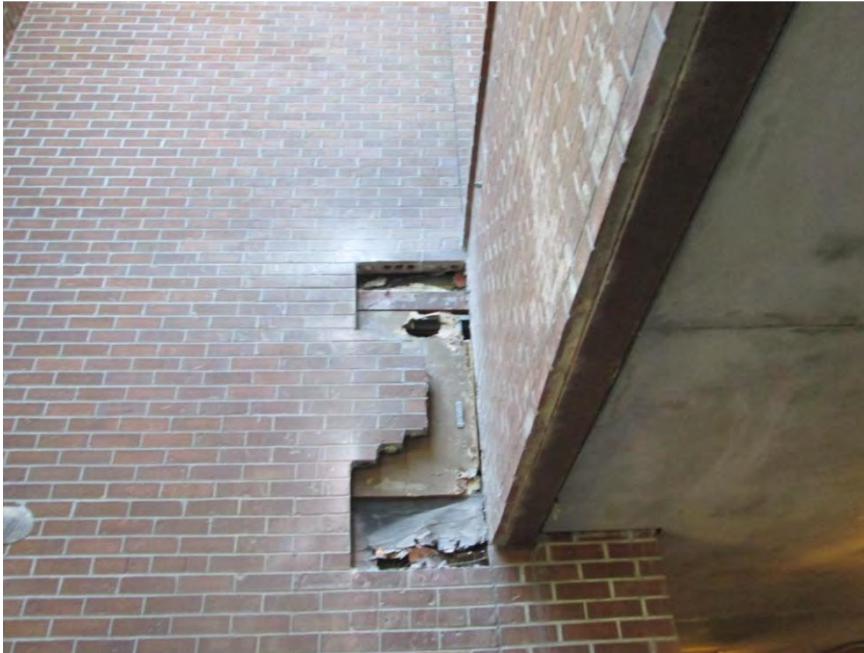
S23 - Shelf angles not noted in exploratory opening at attached tower structure

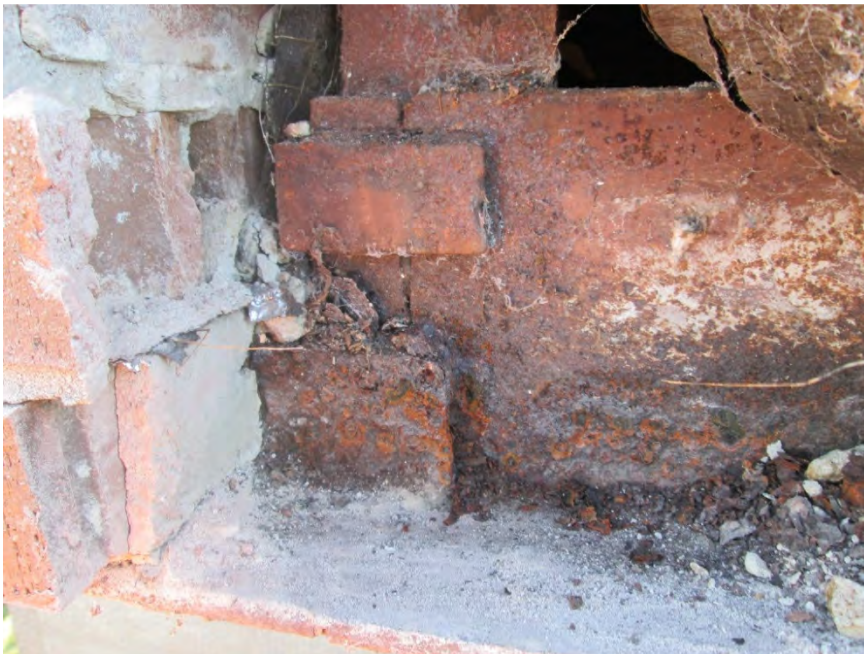
S24 - Spliced discontinuous shelf angle at Exploratory Opening 6
