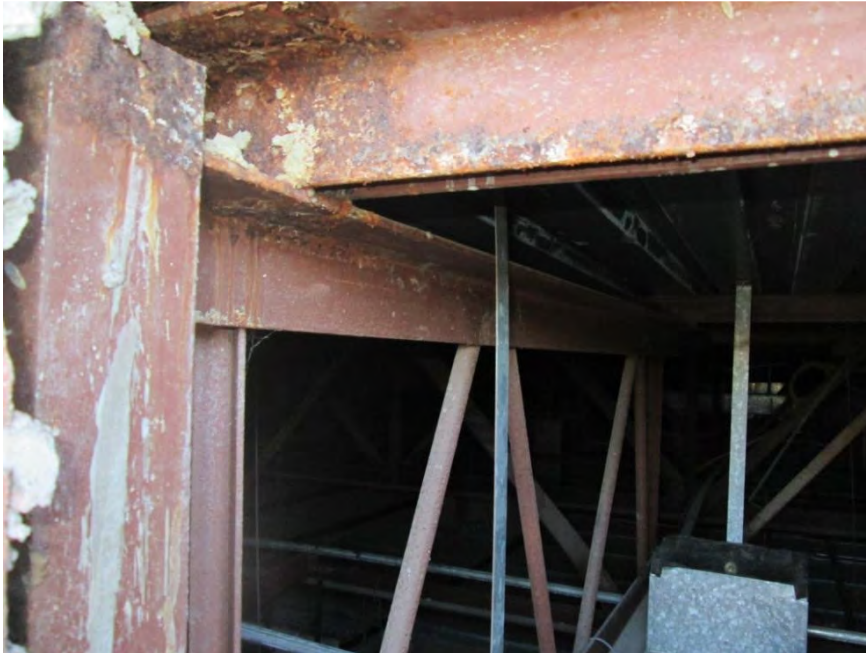
S26 - View of backup vertical steel angles tack welded to the metal deck steel closure angle

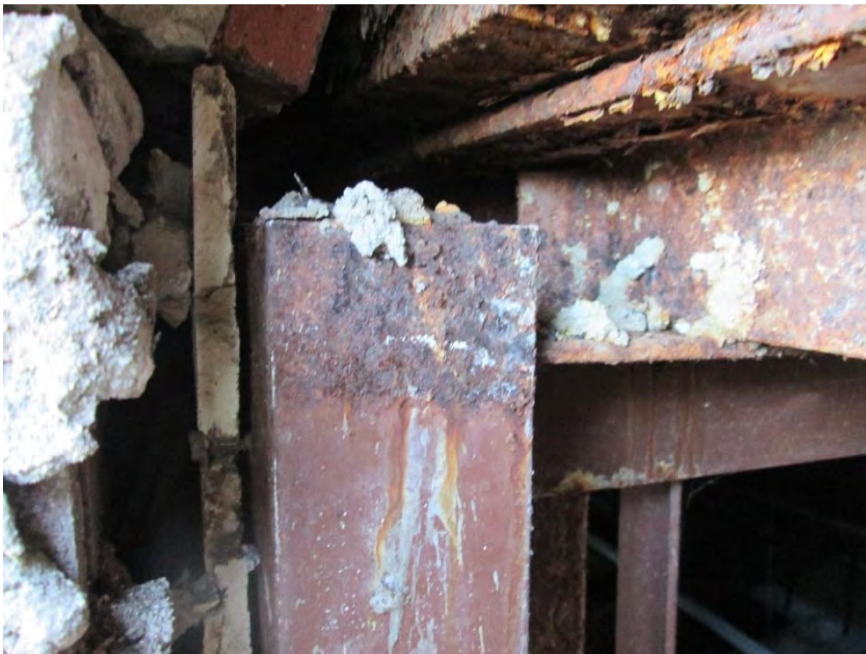
S27 - Corrosion of façade backup vertical steel and built-up joist bracing

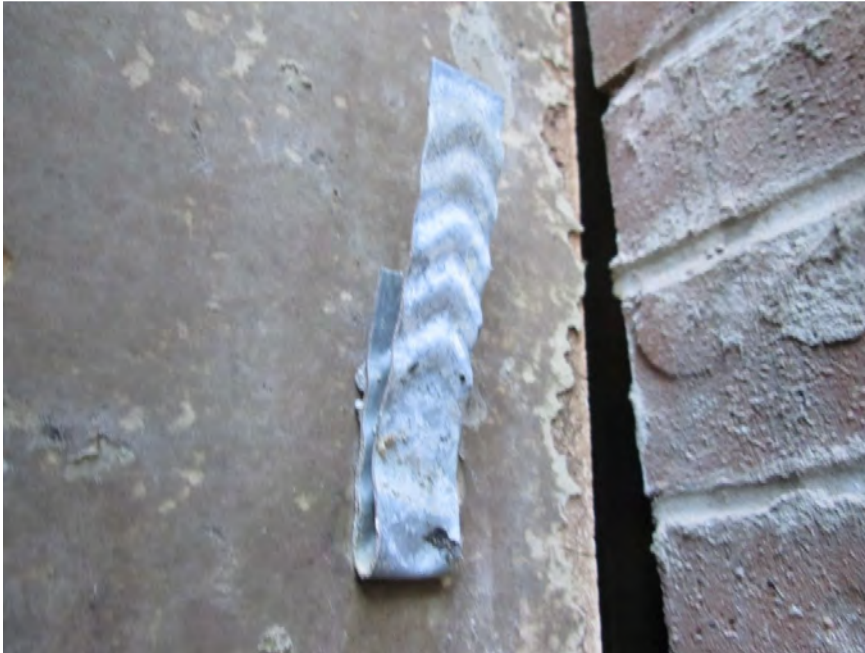
S32 - Corroded metal tie

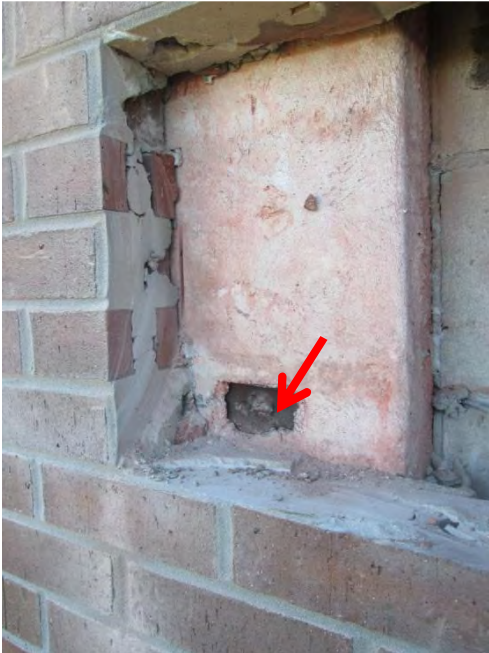
S34 - Missing corrugated brick tie at fastener to vertical steel angle backup

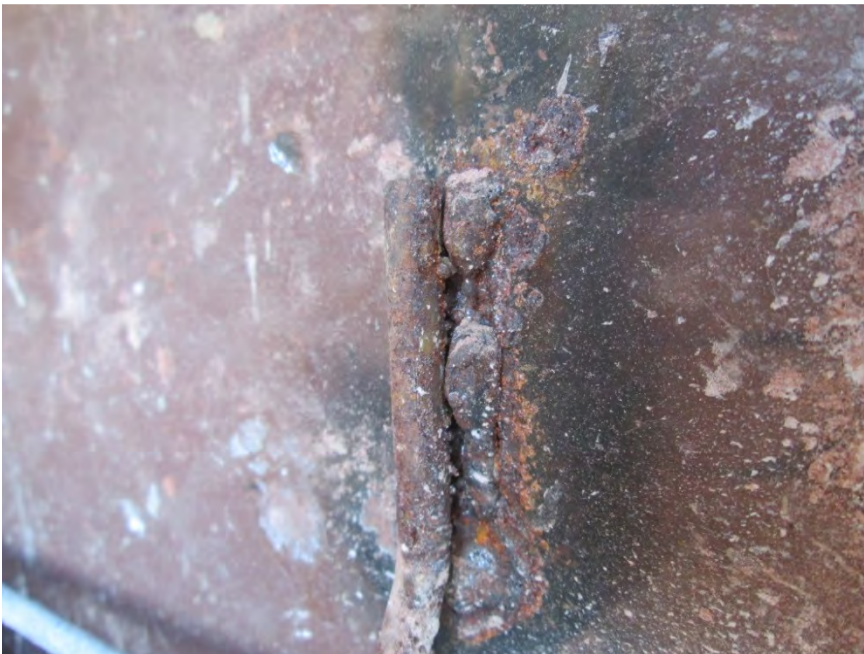
S35 - Missing welded wire tie at steel column backup

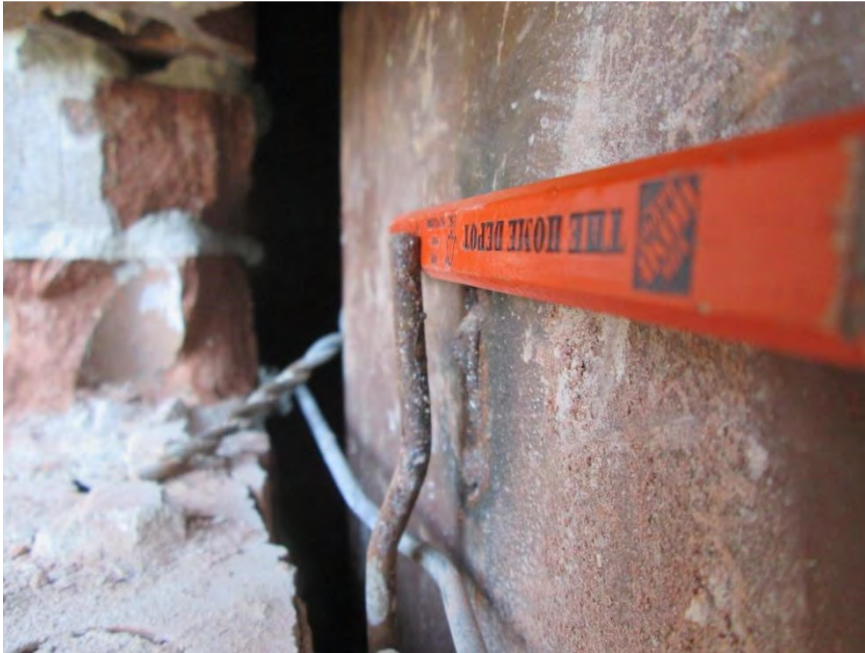
S36 - Corrosion noted at welded tie loop for brick tie connection

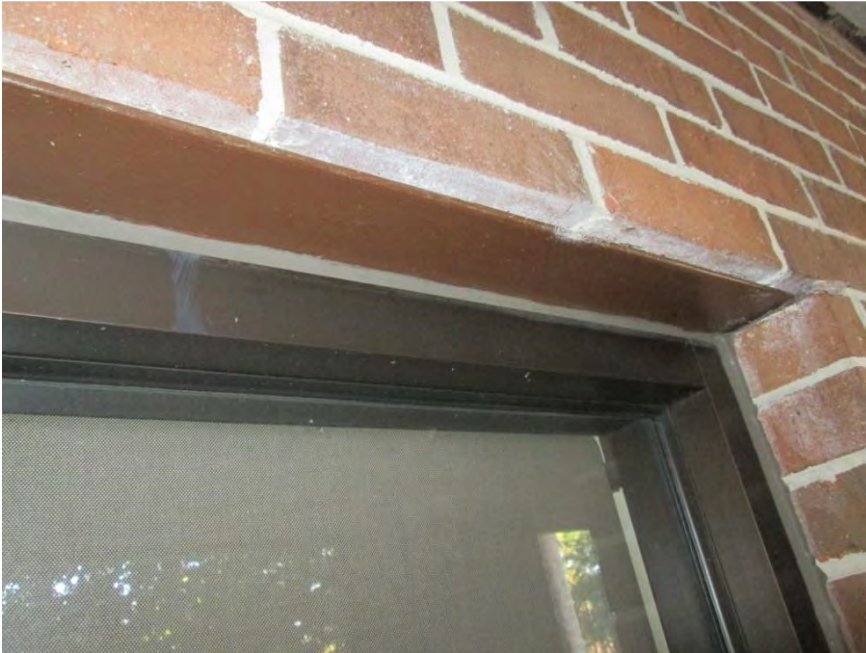
S44 - Sealant failure at brick façade transition to louver framing

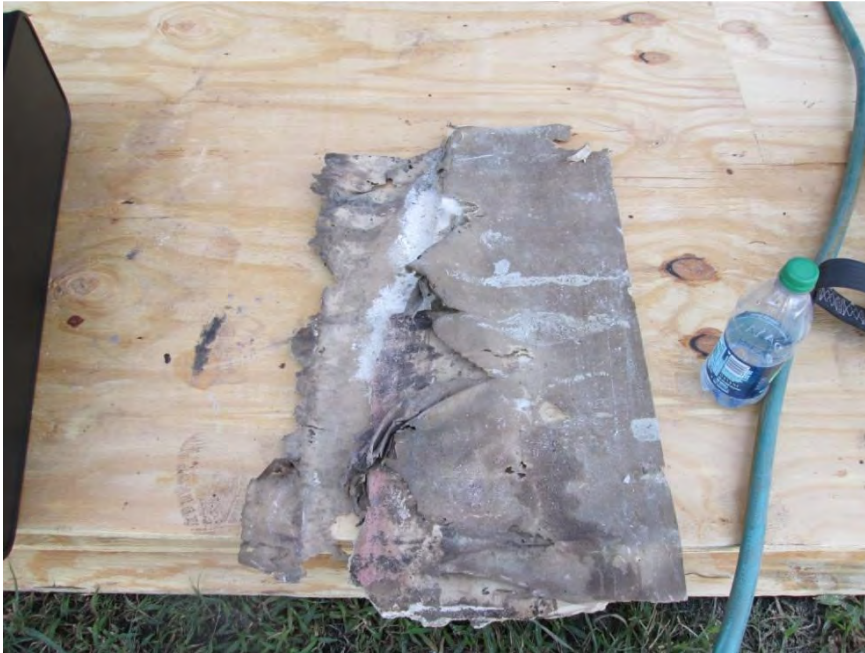
S46 - Cavity wall waterproofing consisting of gypsum sheathing and discontinuous flashing

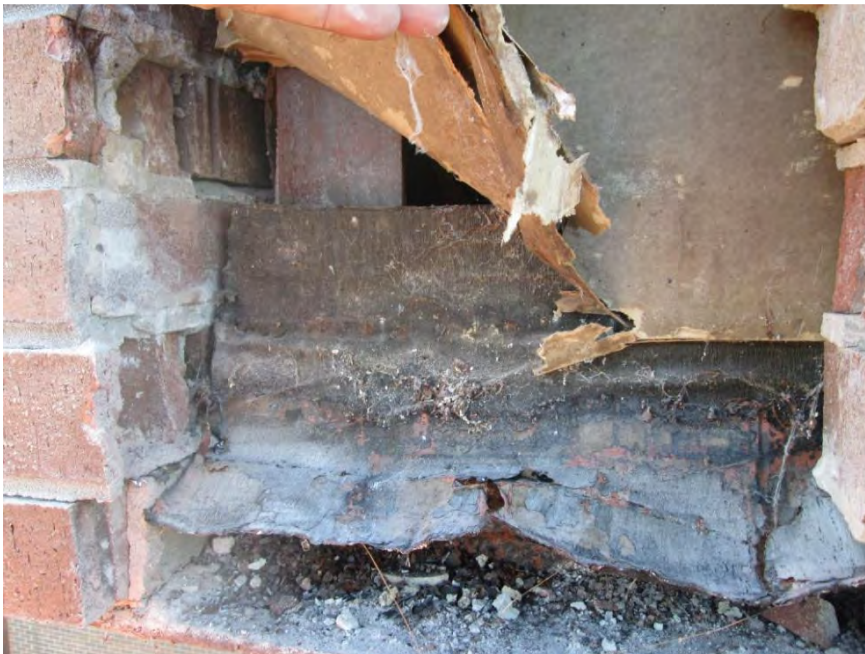
S47 - Moisture deterioration and caking of gypsum sheathing

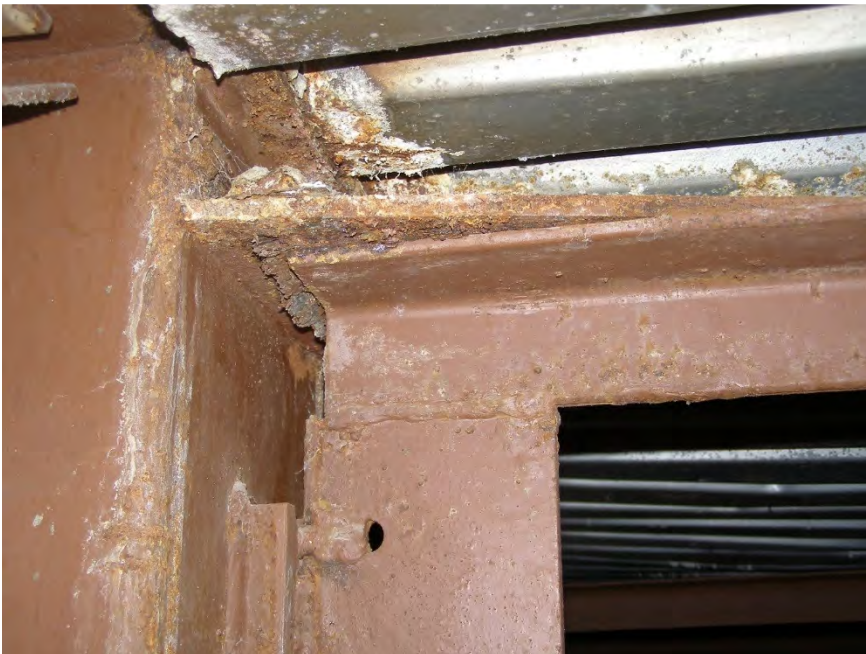
S65 - General view of area of long-term water intrusion at location shown in previous photo

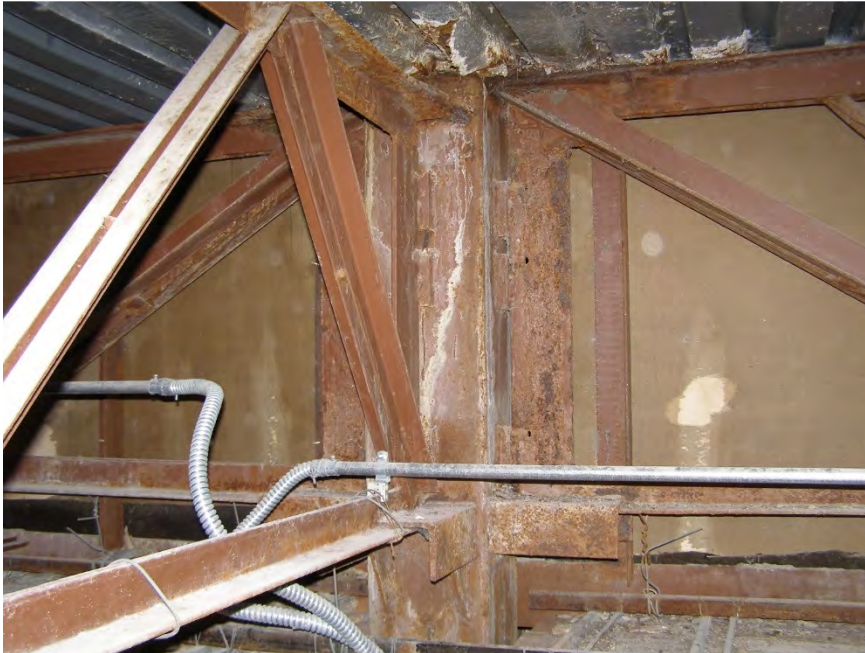
S66 - Close-up view of deck and structural steel corrosion shown in previous photo

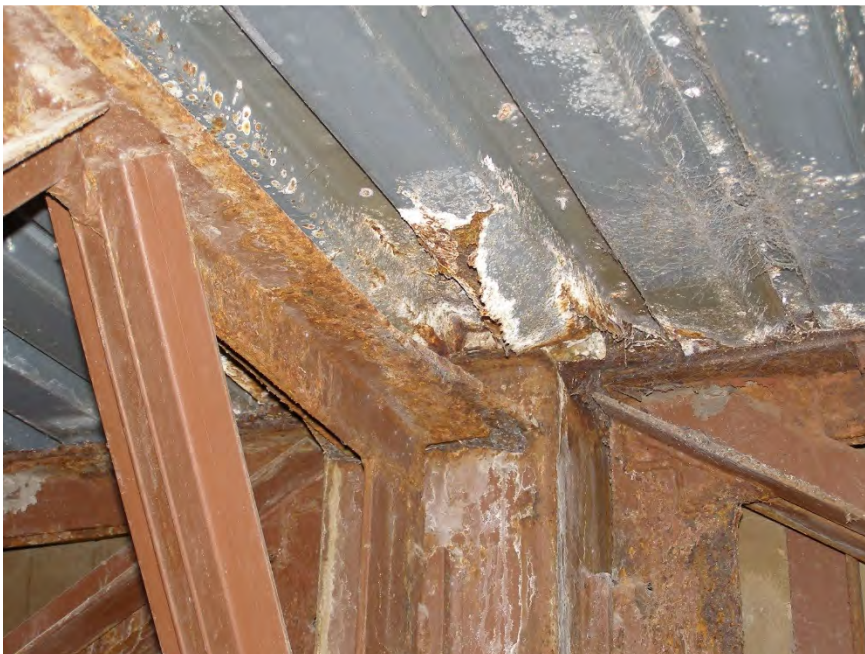
S67 - General view of corrosion of deck and steel framing below Level 2 exterior corridor

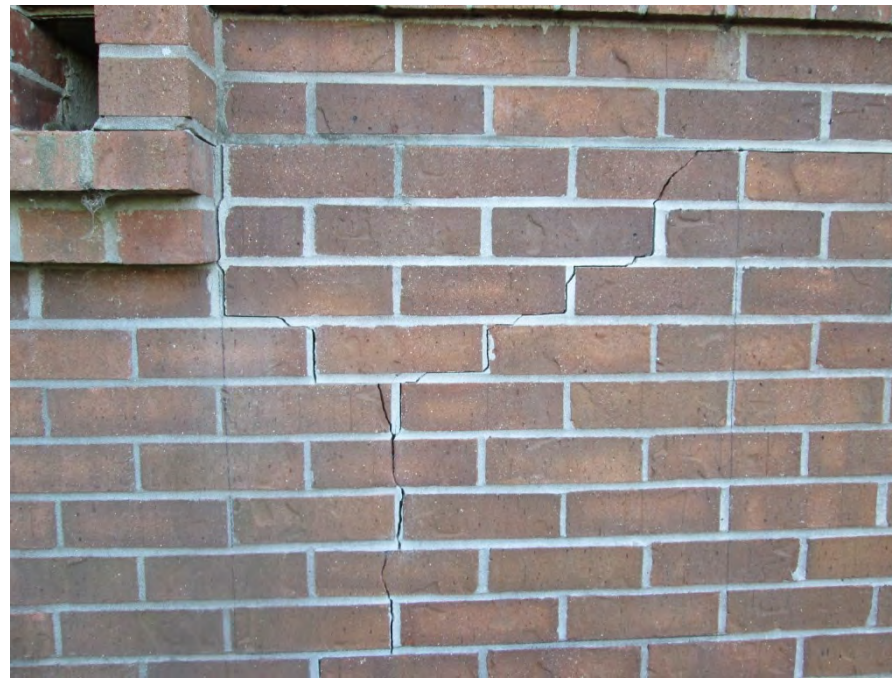
Brick cracking distress

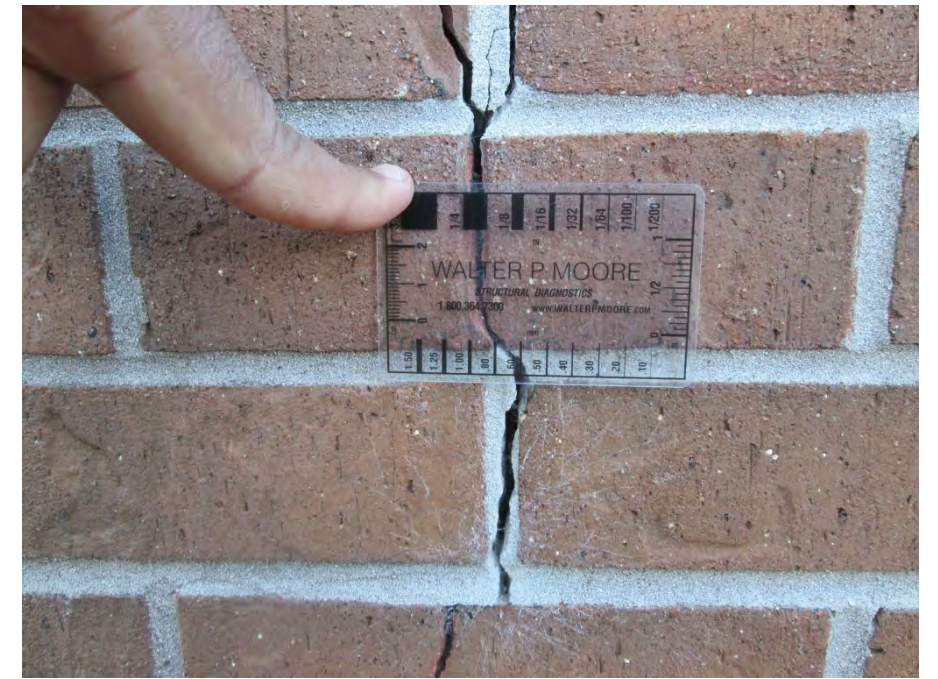
Brick crack width measured as 1/4- inch

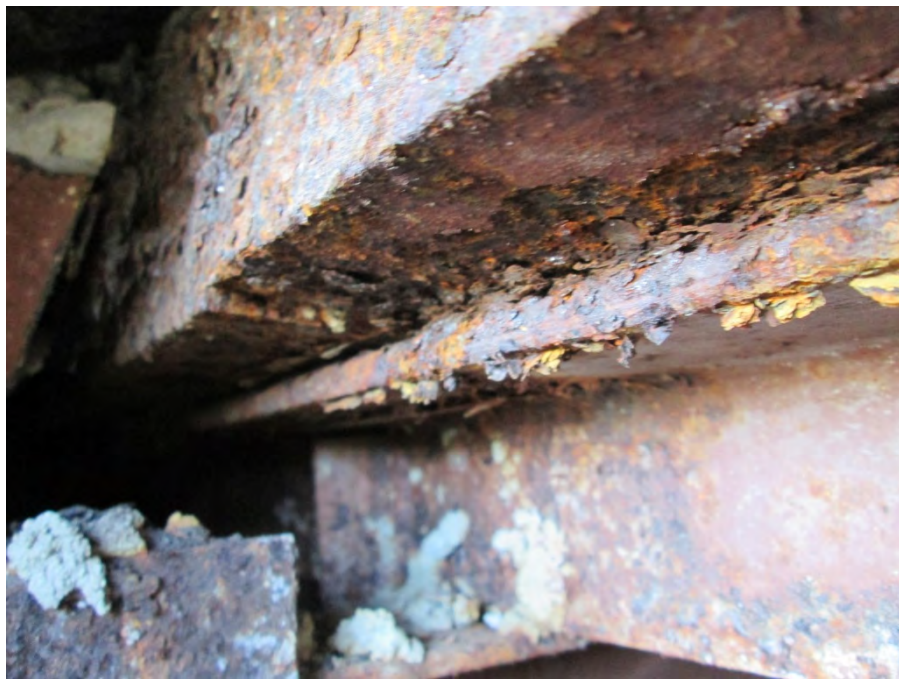
Corrosion distress at metal deck closure angle and joist girder top chord

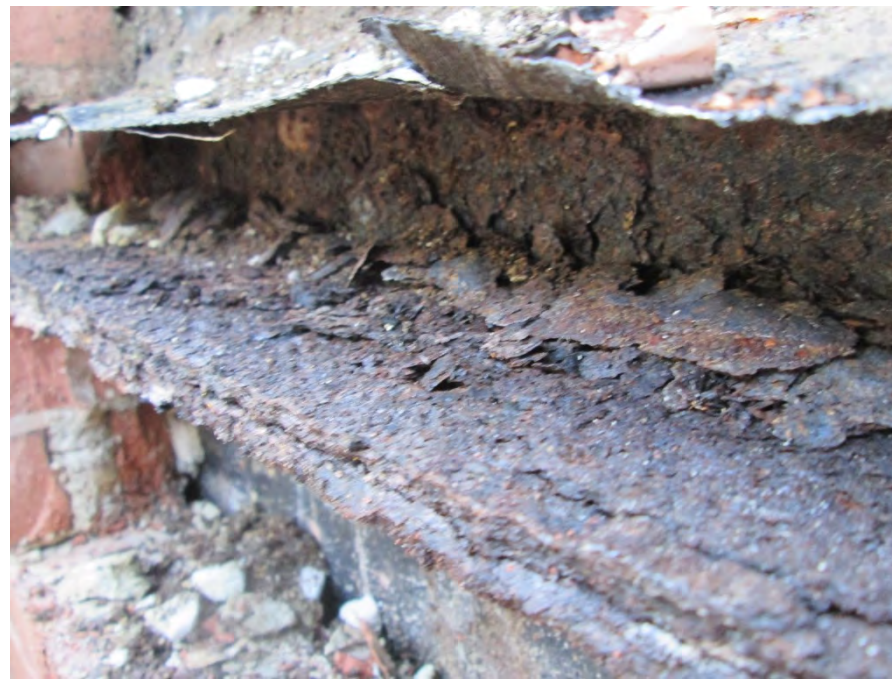
Corrosion distress at shelf angle

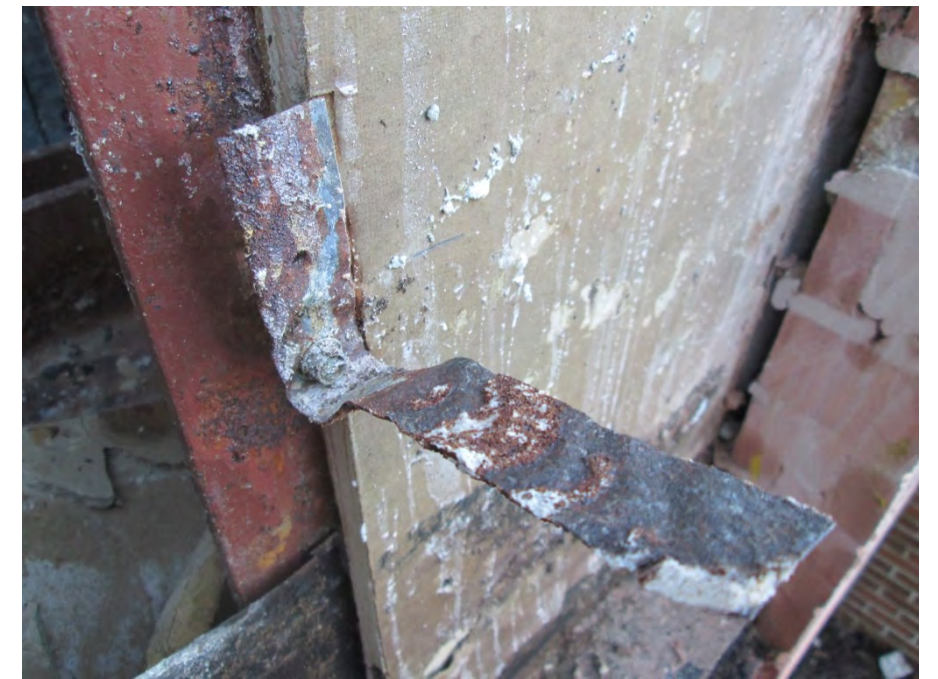
Corroded corrugated metal tie

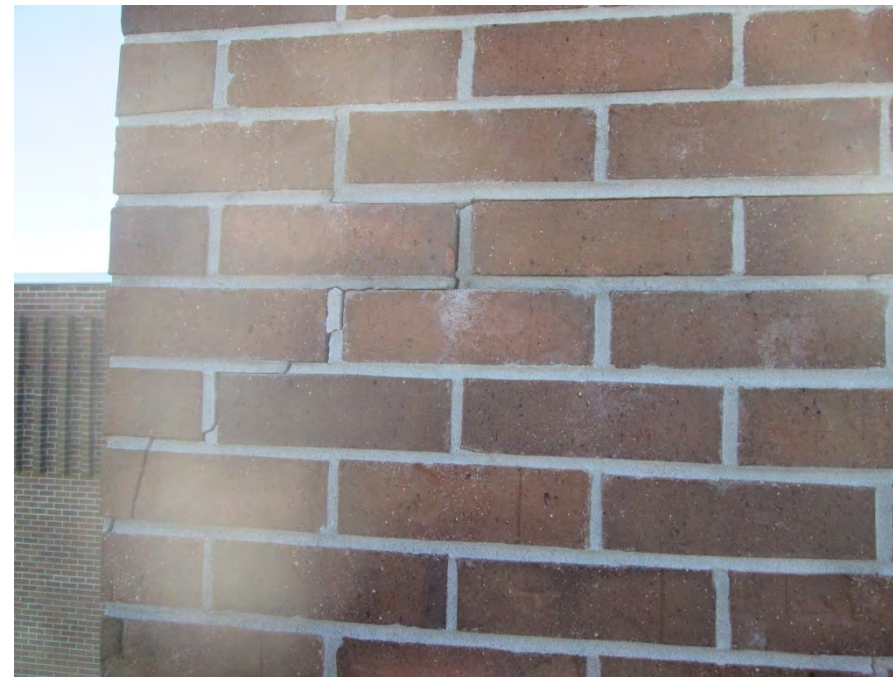
Brick cracking distress

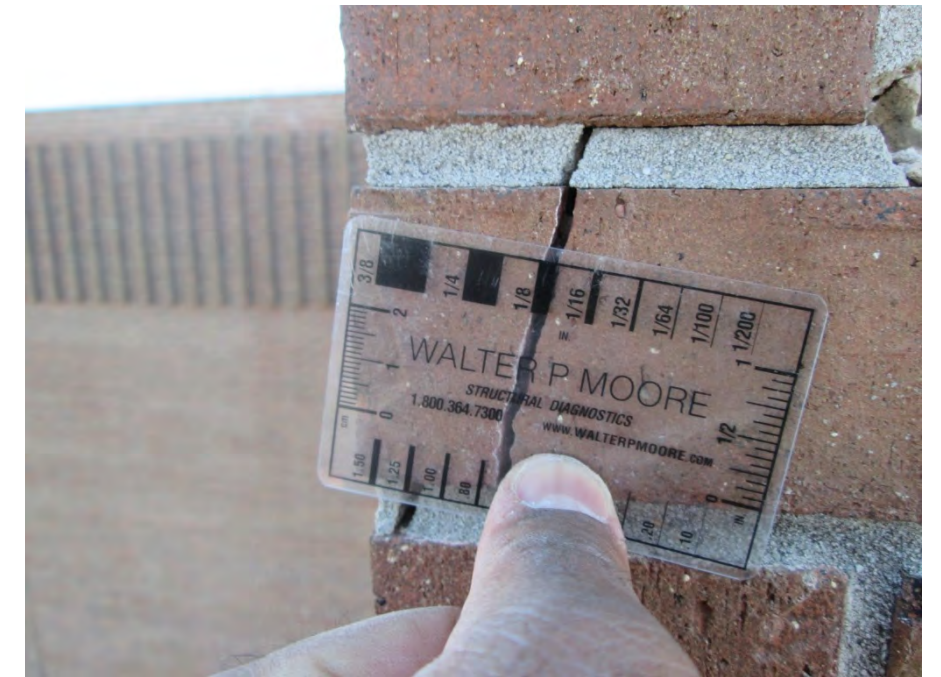
Brick crack width measured as 1/8- inch

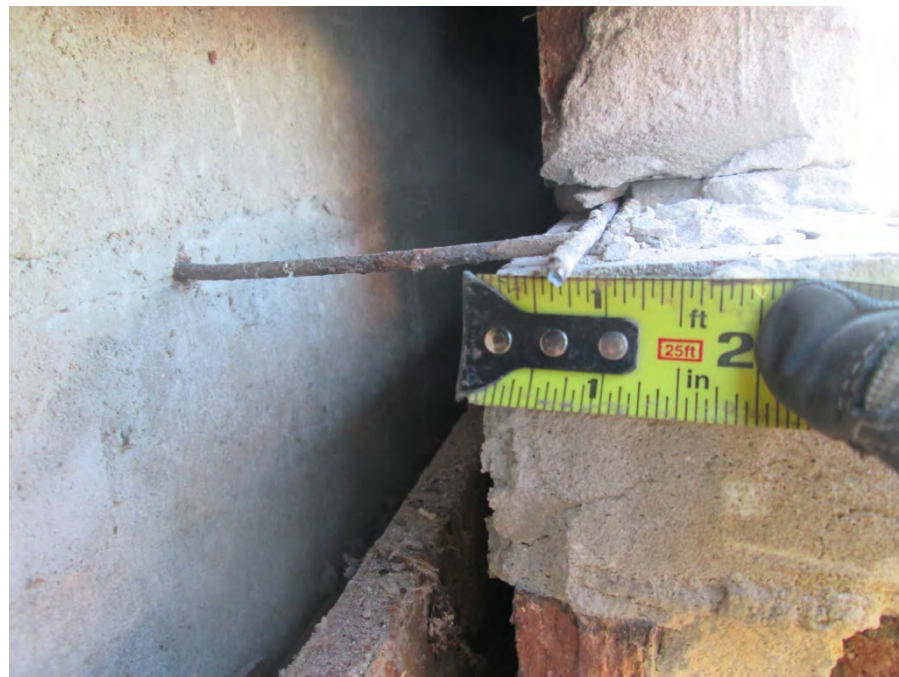
Ladder reinforcement tie not adequately embedded in brick masonry bed joint

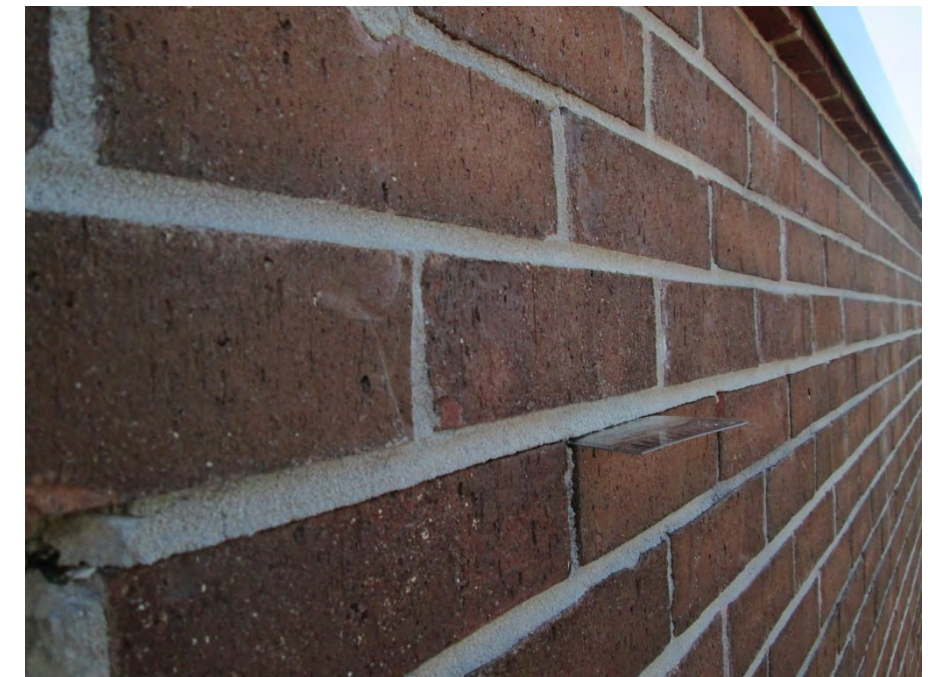
Mortar separation due to through-wall fabric acting as bond breaker

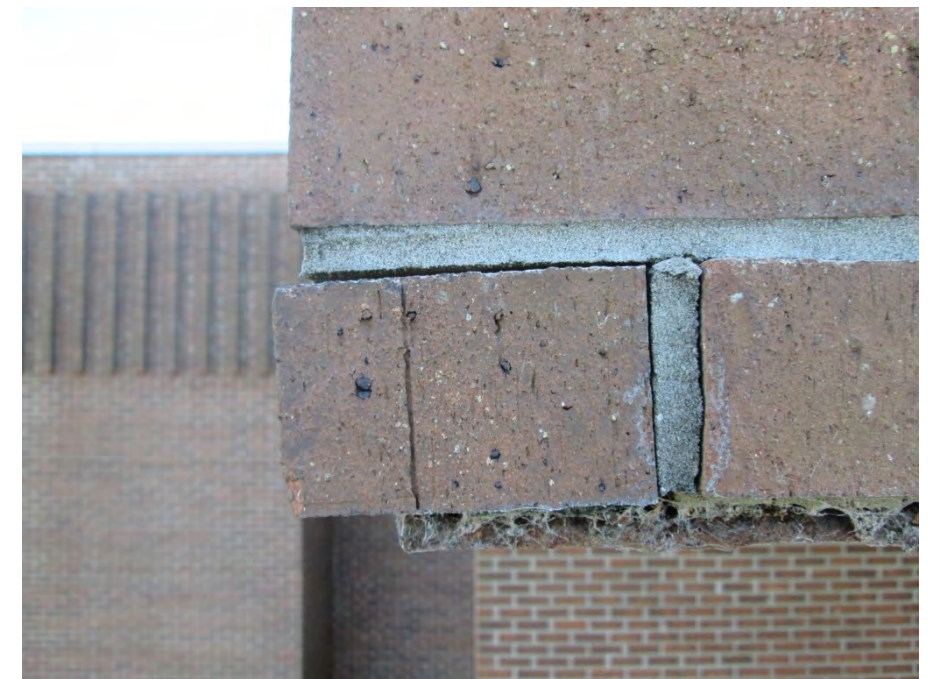
Rotated brick and mortar cracking at discontinuous shelf angle support

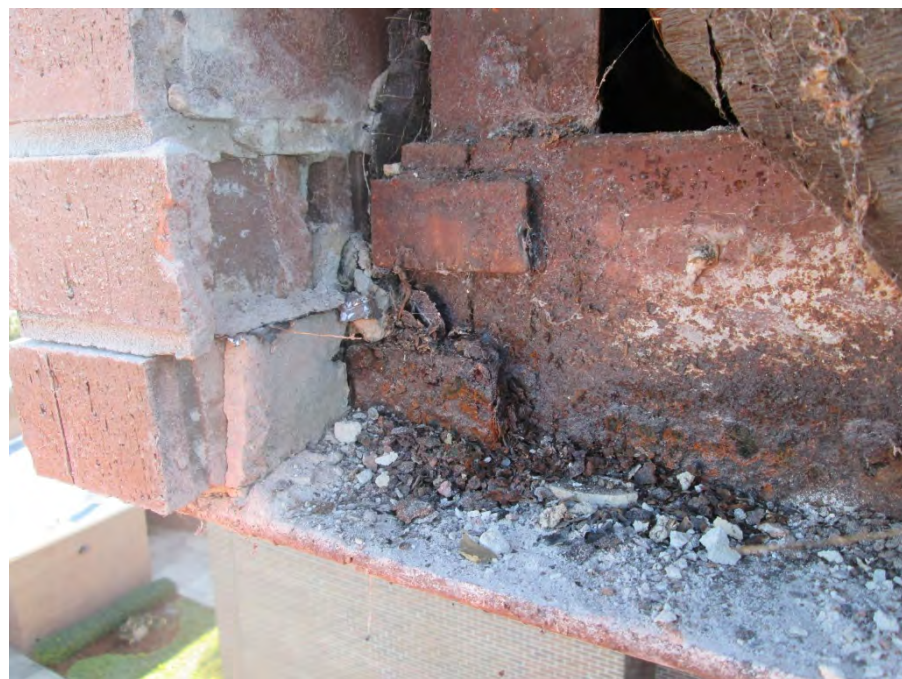
Corrosion distress of discontinuous shelf angle (note splice in shelf angle at location of rotated brick)

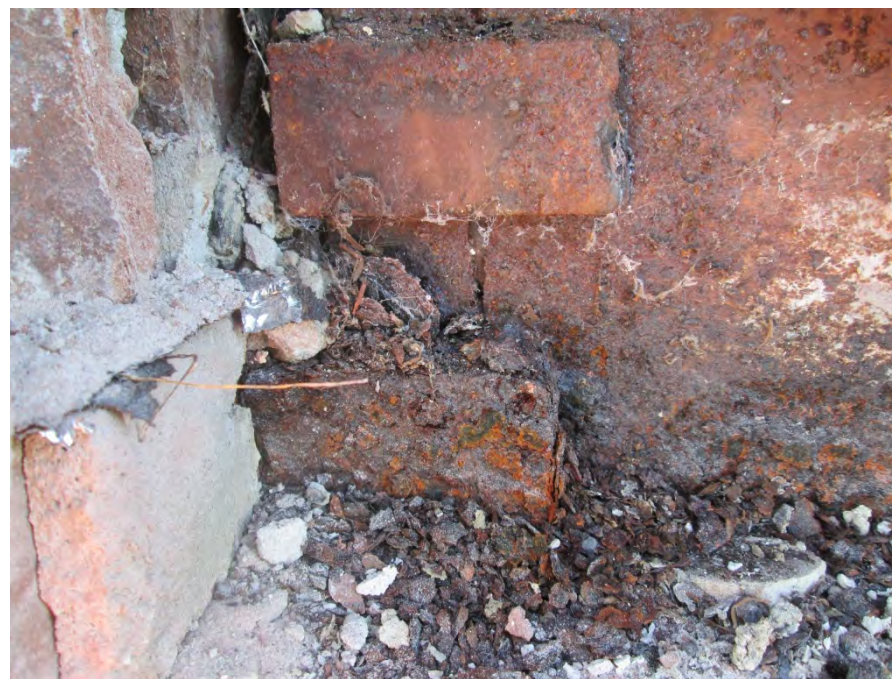
Corrosion distress at s discontinuous shelf angle splice connection

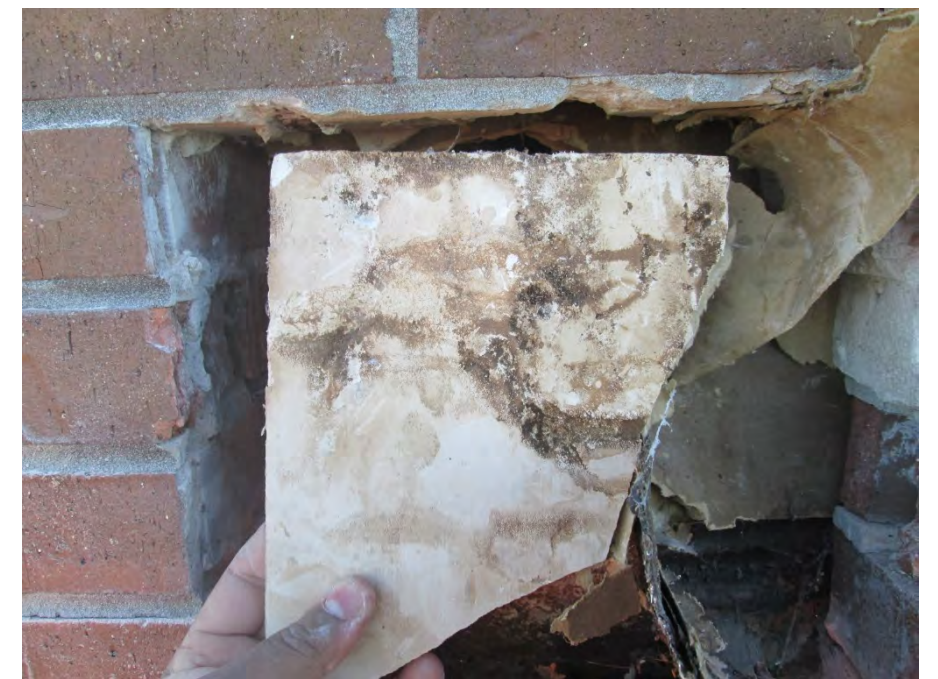
Signs of previous water infiltration as evidenced by water staining of gypsum sheathing

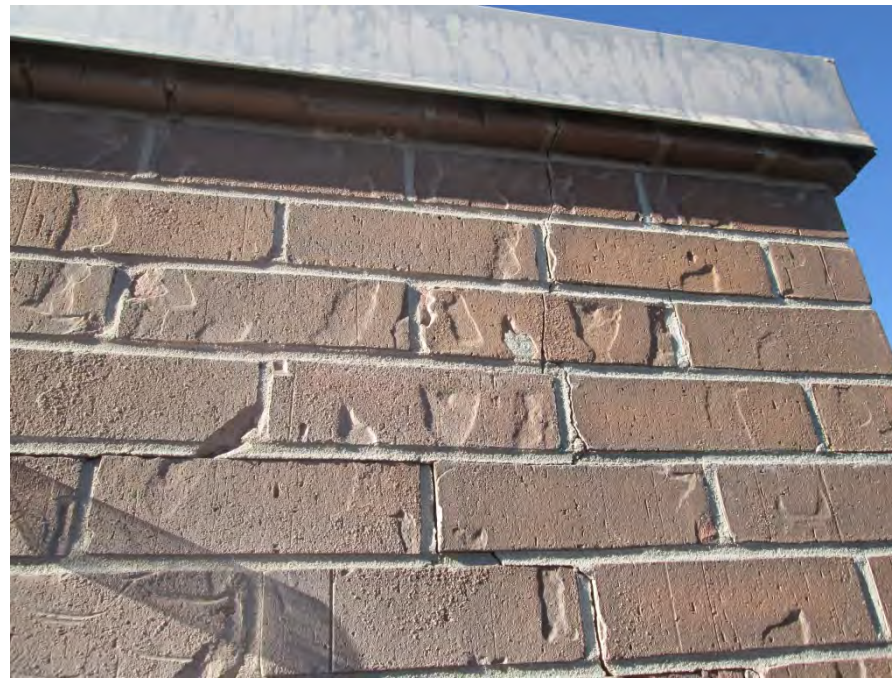
Brick cracking distress

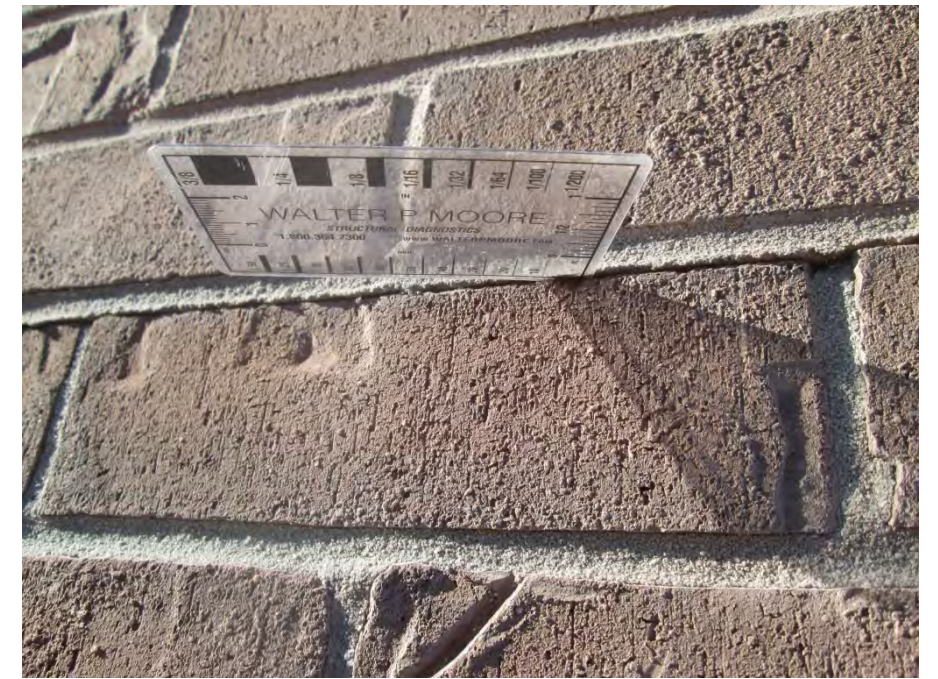
Brick crack width measured as 1/8-inch

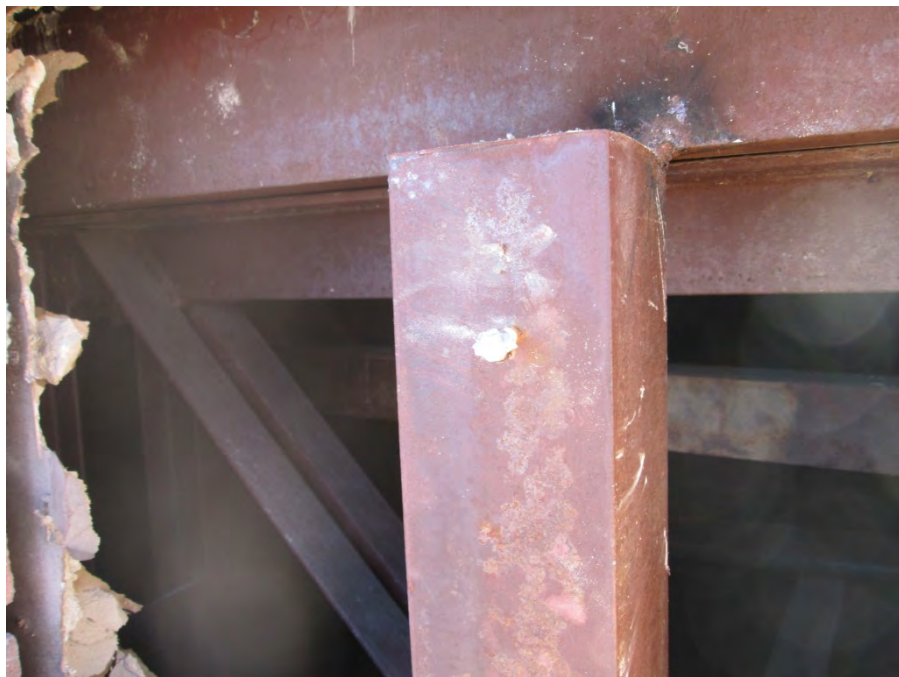
Uninstalled corrugated metal tie for lateral support of brick cladding

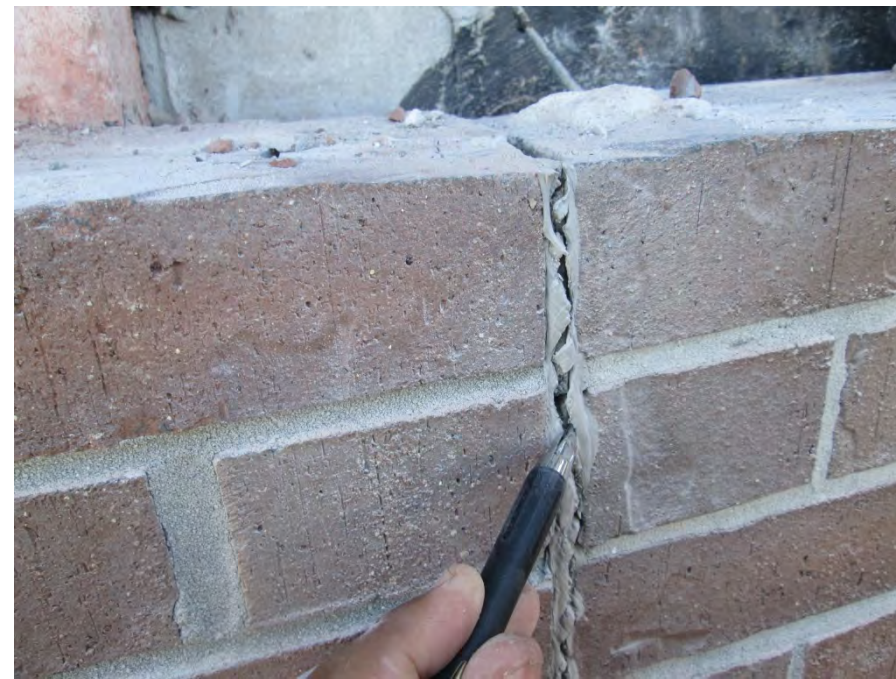
Failed joint sealant at expansion joint

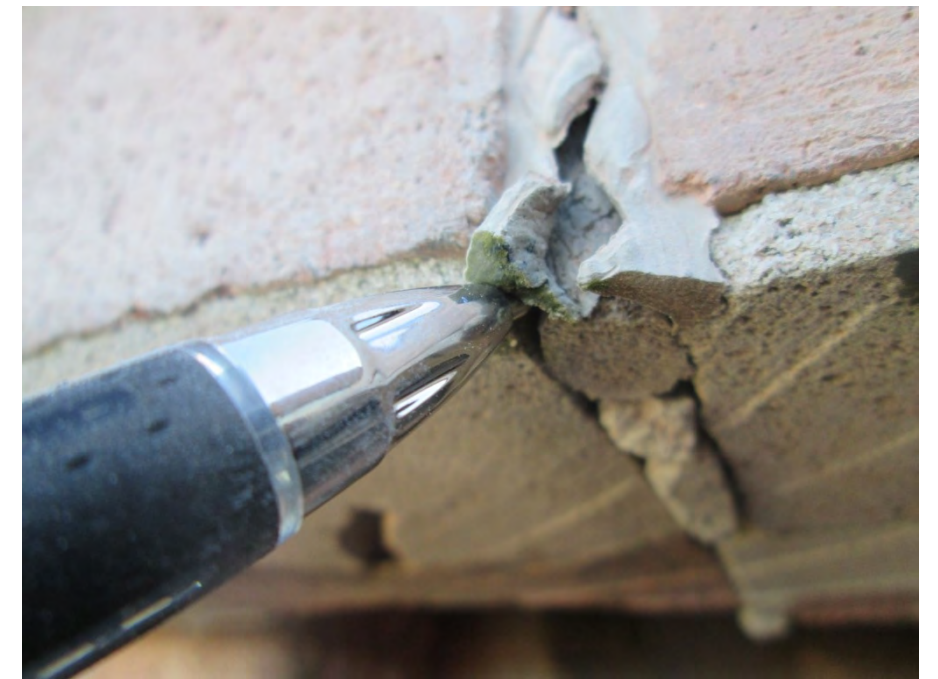
Joint sealant does not have an  
adequate width-to-depth profile ratio

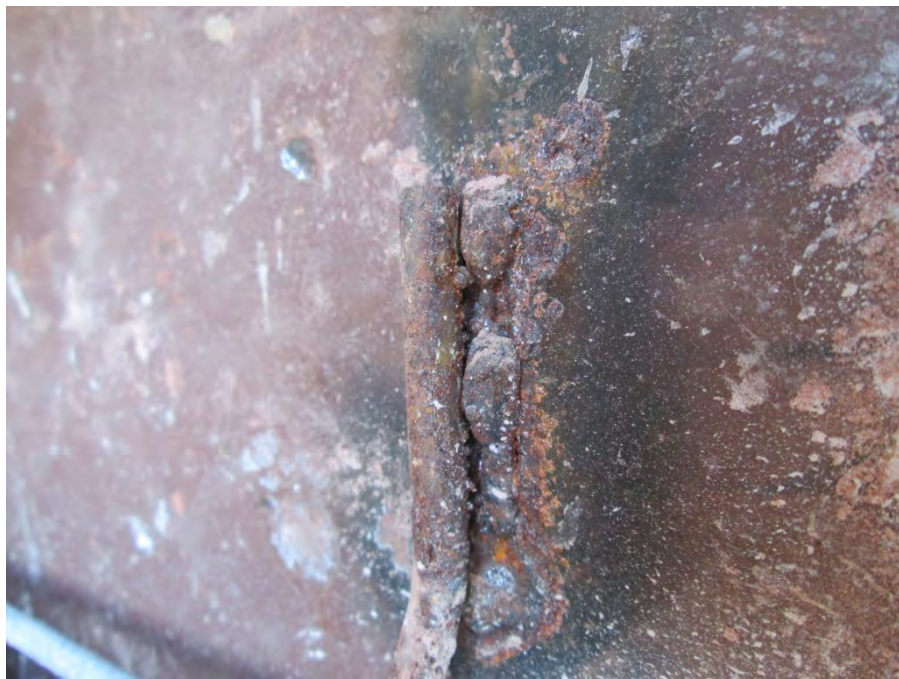
Corroded and broken weld at wire loop connection to steel tube column

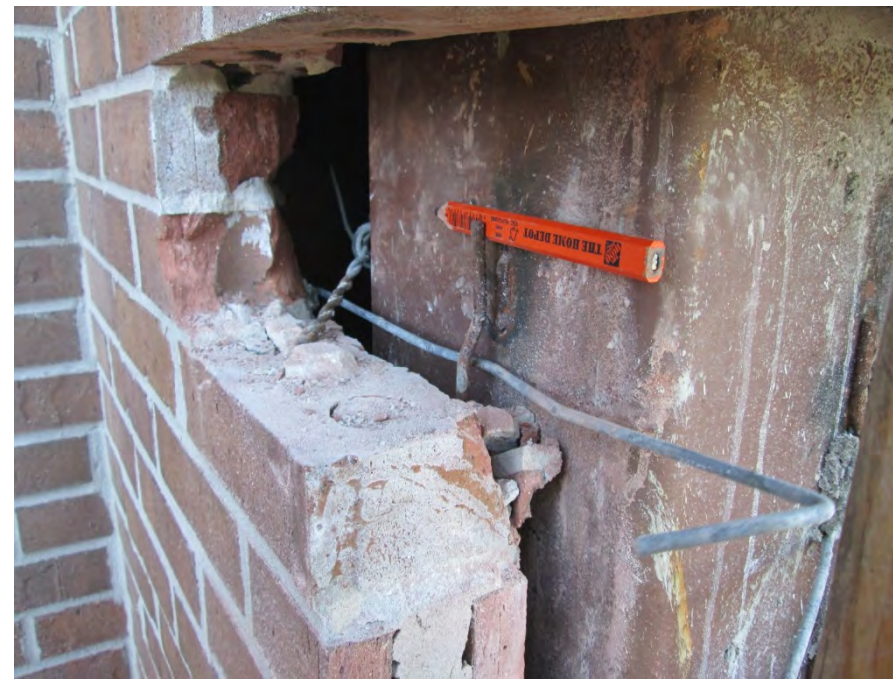
View of broken weld at wire loop connection to steel tube column

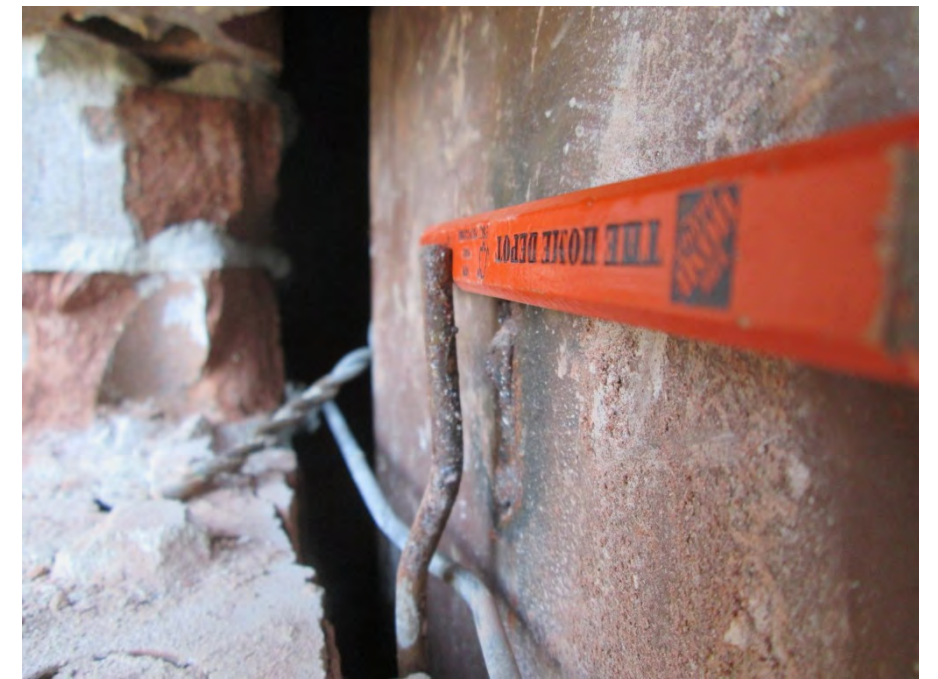
View of broken weld at wire loop connection to steel tube column

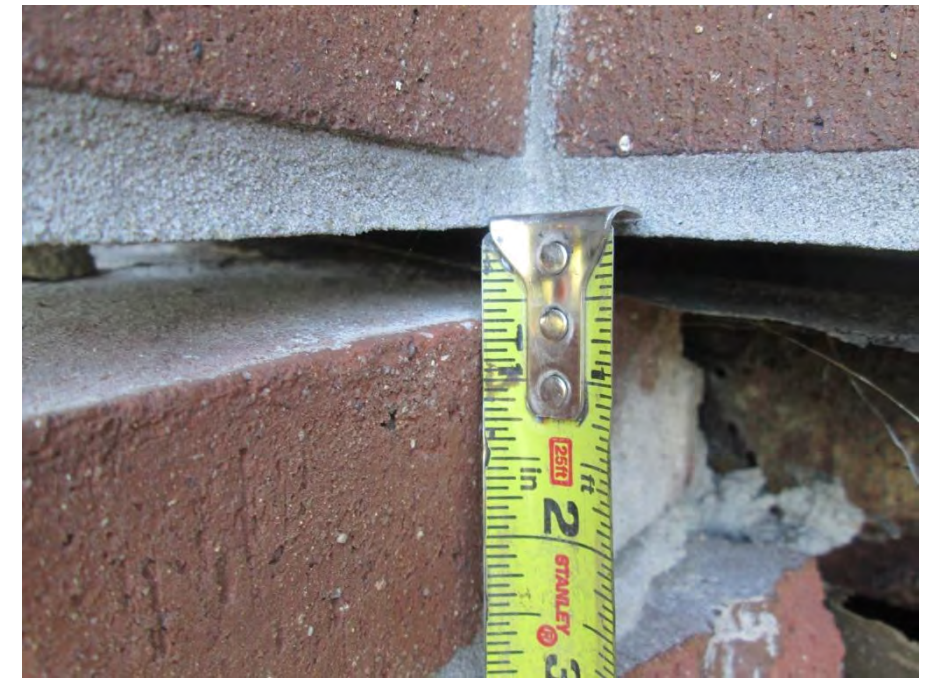
Separated mortar gap measured as approximately 5/8-inch

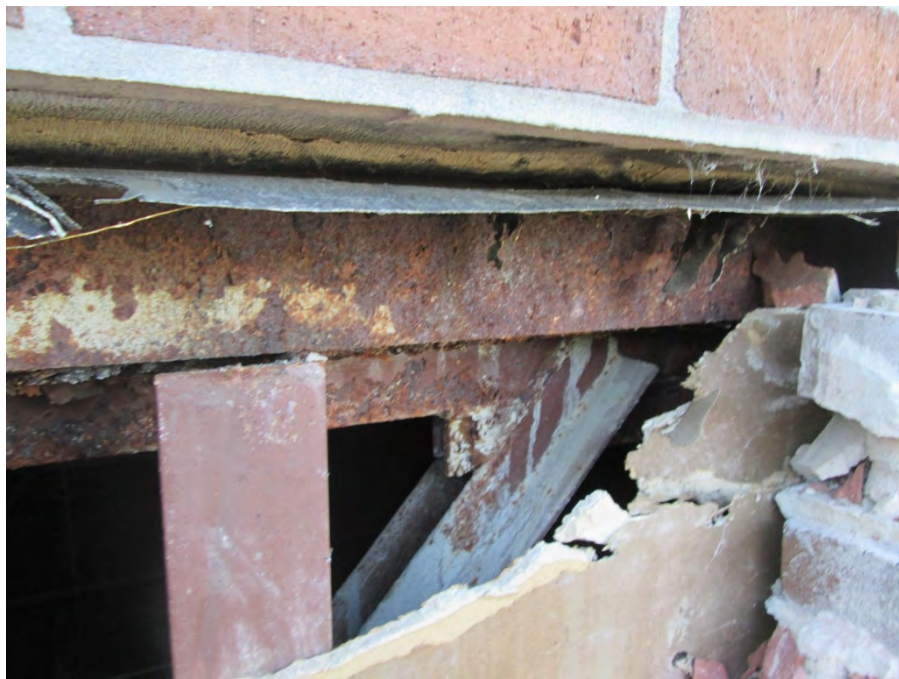
Corroded metal framing indicates previous water infiltration

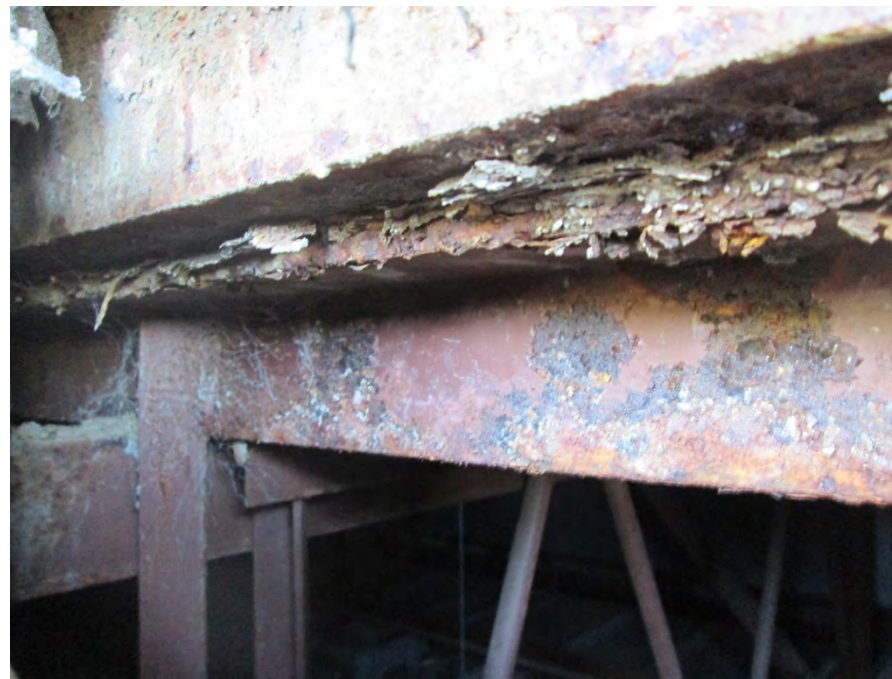
Corroded metal framing indicates previous water infiltration

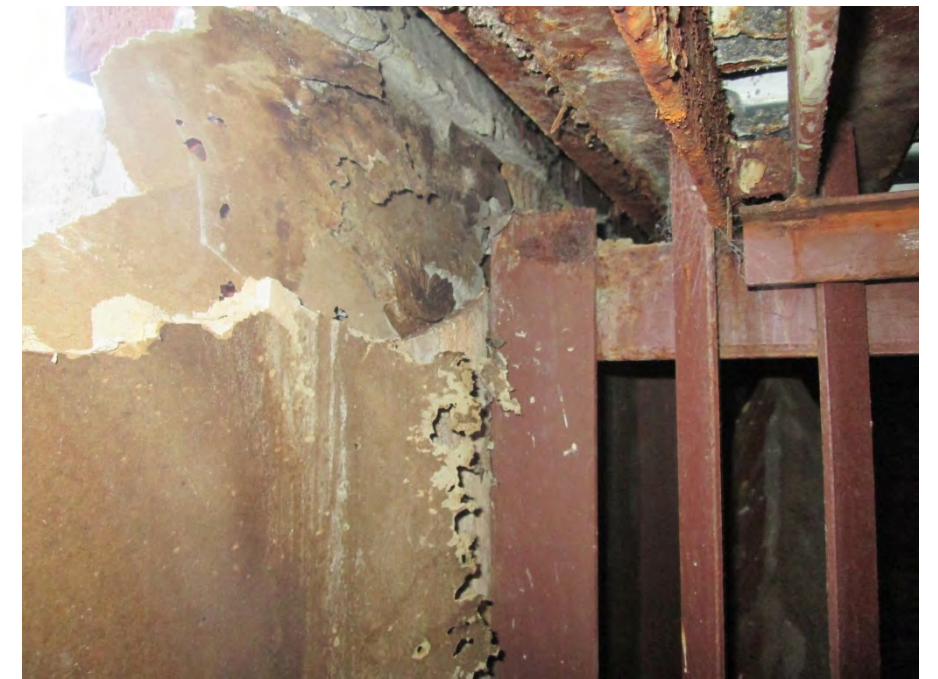
Corroded metal framing and deteriorated gypsum sheathing indicates previous water infiltration

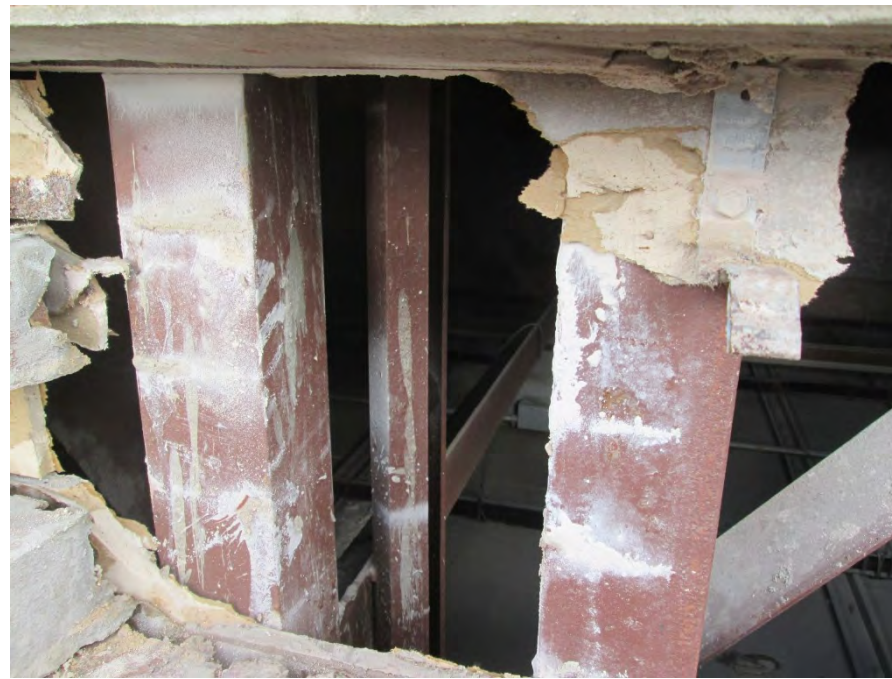
Surface corrosion noted at corrugated metal tie
