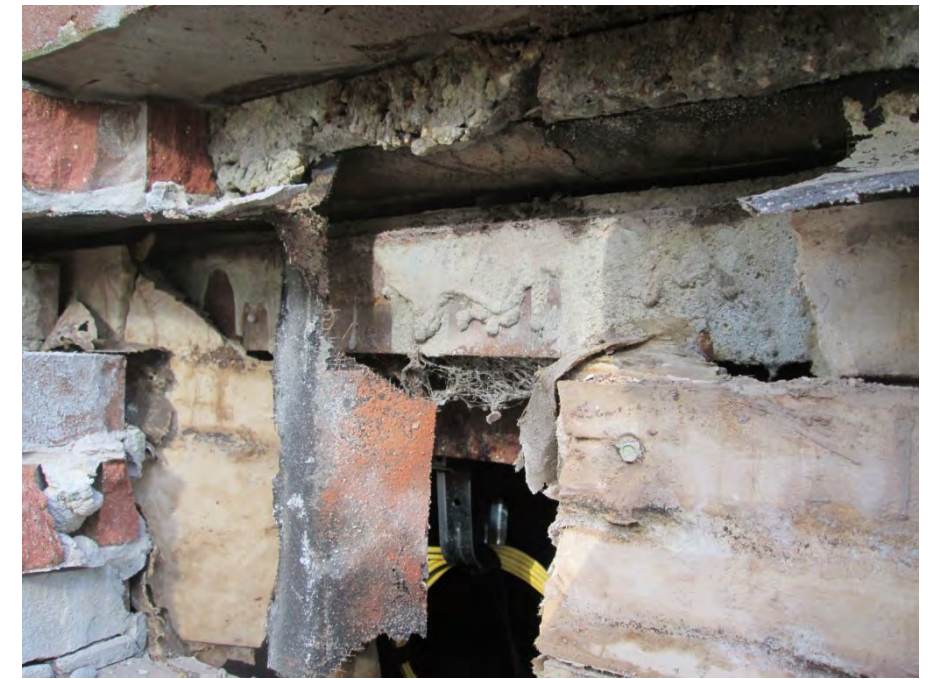
Gap between mortar bed joint for brick coping and concrete curb support

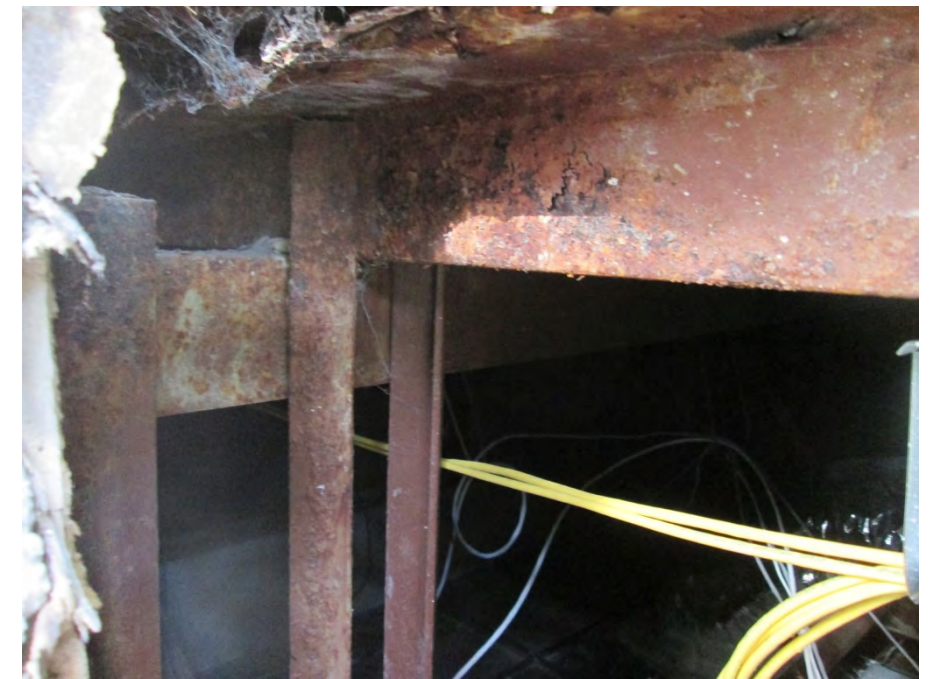
Corroded metal framing indicates previous water infiltration
