On-Site Structural Assessment of Existing Building (Exterior Facades) for the Colbourn Hall University of Central Florida Orange County

**RE:** VISUAL STRUCTURAL ASSESSMENT / BUILDING ENVELOPE (EXTERIOR FACADES) COLBOURN HALL AT THE UNIVERSITY OF CENTRAL FLORIDA

VISUAL STRUCTURAL ASSESSMENT (EXTERIOR FACADES) FOR THE COLBOURN HALL AT THE UNIVERSITY OF CENTRAL FLORIDA

#### RTEG'S PROJECT NO.: 212-1005

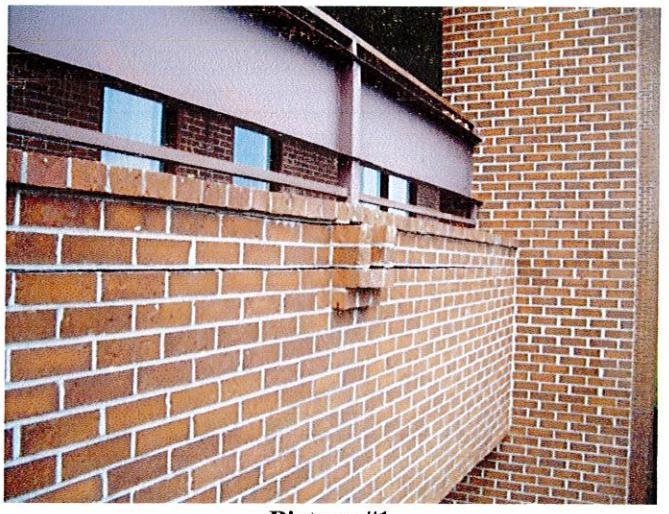
The brick spandrel panels between vertical brick piers on the  $2^{nd}$  and  $3^{rd}$  floors have cracked and along with the secondary concrete curbs have separated from the primary concrete slab at the floor level (see Pictures #1, #2, #3, & #4). This damage is consistent for the entire perimeter of the exterior walkway at the  $2^{nd}$  and  $3^{rd}$  floors.

Picture #1 Damage to Exterior Brick Spandrel along 3rd Floor Walkway

• The existing brick spandrels and concrete curbs in their damaged state do not appear to present a potentially dangerous or unsafe condition, but these areas should be investigated further to determine the

actual extent of damage. Until the full extent of the structural damage in these areas is determined, we recommend that access to the areas be limited to construction personnel.

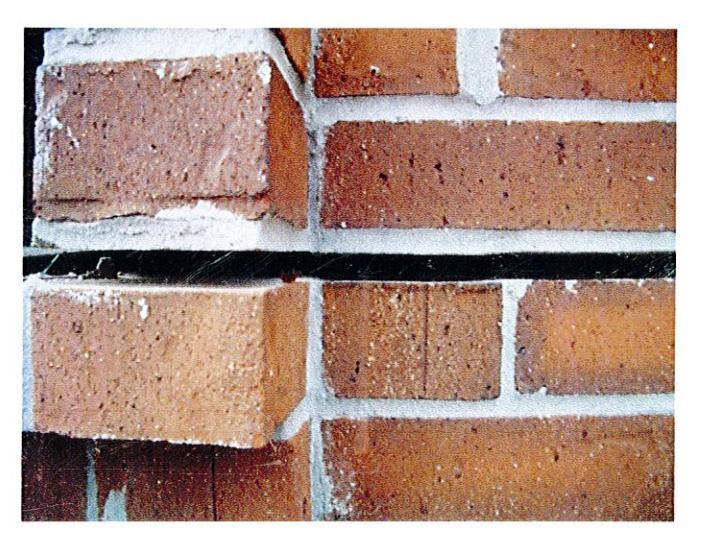
<u>Picture #2</u> Damage to Exterior Brick Spandrel along 3rd Floor Walkway

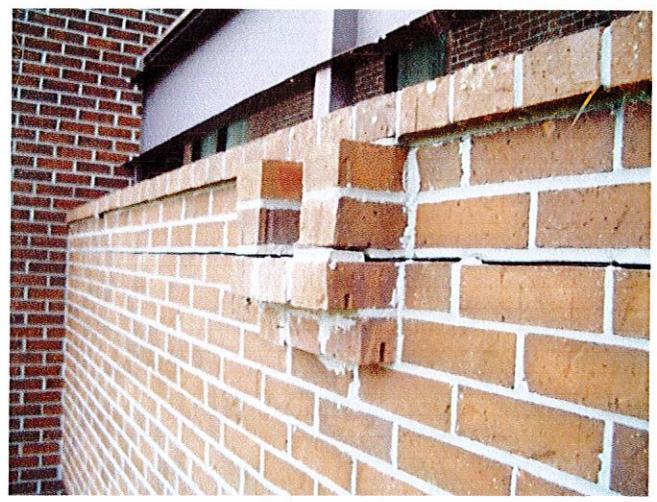
Picture #3 Damage to Exterior Brick Spandrel along 2nd Floor Walkway

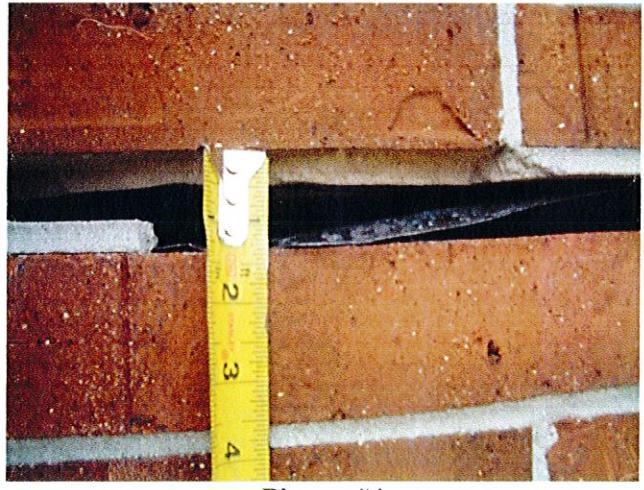
Picture #4 Damage to Exterior Brick Spandrel along 2<sup>nd</sup> Floor Walkway

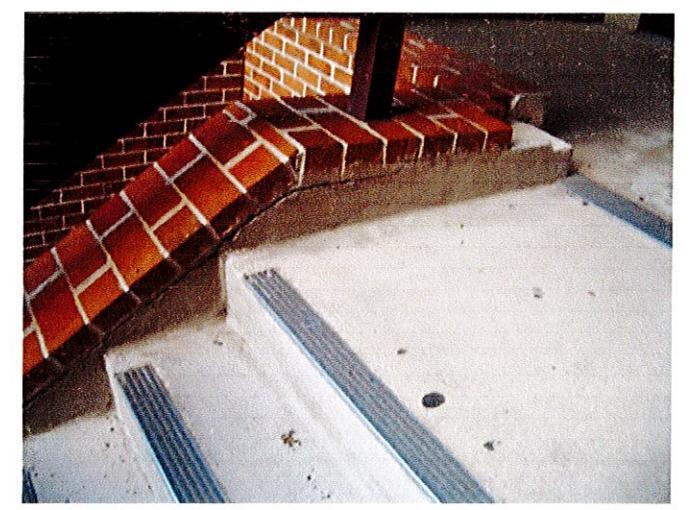
The cast-in place access stairs from the  $1^{st}$  floor to the  $2^{nd}$  floor on the east and west sides of the building exhibit delamination of the brick cap and secondary concrete pour from the main concrete stair (see Pictures #5 & #6).

Picture #5 Damage to Exterior Brick Cap at West Access Stair 2nd Floor

• The referenced damage to the brick cap and curb on the concrete access stairs does not appear to present a potentially dangerous or unsafe condition. These areas should be repaired per the architectural and specifications requirements of the University of Central Florida.

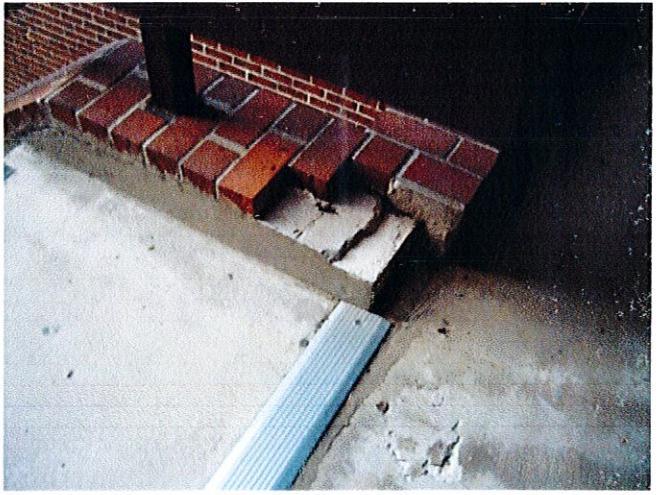
Picture #6 Damage to Exterior Brick Cap at West Access Stair 2nd Floor

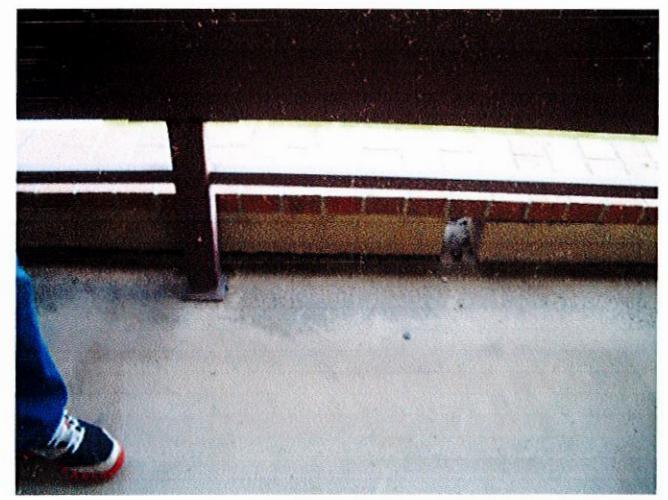
• The structural steel handrail is rusting from exposure to weather and the structural steel posts supporting the handrail are rusting at the base (see Pictures #7 & #8). Some vertical posts have base plates and some do not exist. This damage is consistent for the entire perimeter of the exterior walkway at the  $2^{nd}$  and  $3^{rd}$  floors.

<u>Picture #7</u> Structural Steel Handrail & Post at 2nd Floor Exterior Walkway

• The structural steel handrail system does appear to present a potentially dangerous condition as the rusted bases of the vertical posts will most likely not withstand the 50lb./ft. or 200 lb. concentrated load required by the Florida Building Code. These areas should be investigated further to determine the extent of the damage to the posts and should be repaired or replaced as required.

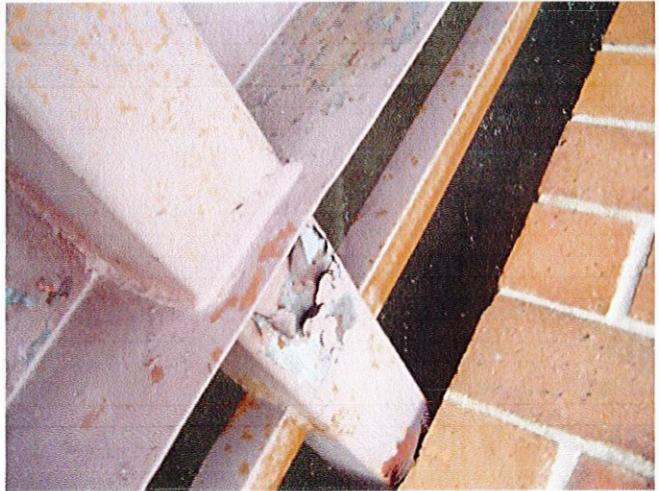
<u>Picture #8</u> Structural Steel Handrail & Post at 2nd Floor Exterior Walkway

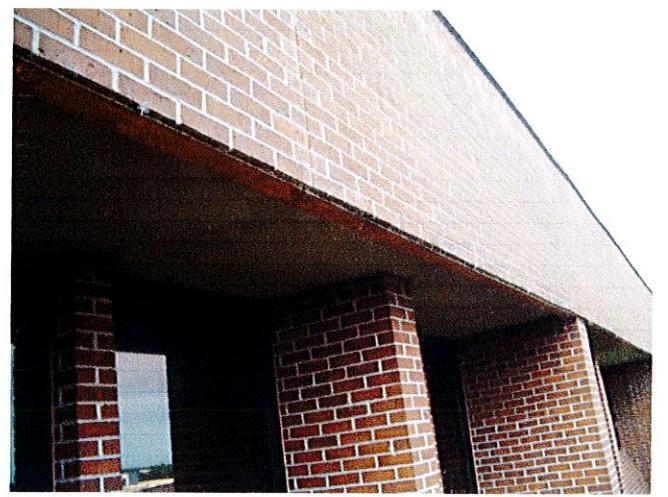
The brick façade at the 4<sup>th</sup> floor, 5<sup>th</sup> floor, and roof levels appeared to be in good condition with minimal cracking of the mortar joints. The structural steel shelf angle however is rusting from exposure to weather (see Pictures #9, #10, #11, and #12). It is not clear from the exterior whether this damage is limited to the exposed steel shelf angle or if there is further damage behind the wall and above the soffit.

<u>Picture #9</u> Structural Steel Brick Shelf Angle Supporting Soffit at Roof Level

$\cdot$  The referenced damage to the brick shelf support angles may potentially present a dangerous or unsafe condition. These areas should be investigated further to determine the actual extent of damage. Until the full extent of the structural damage in these areas is determined, we recommend that access to the areas under these building soffits be limited to construction personnel.

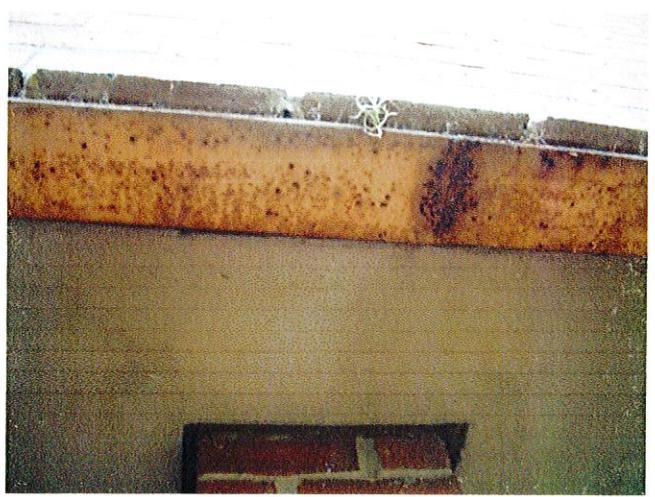
<u>Picture #10</u> Enlarged View of Structural Steel Shelf Angle at Roof Level Soffit Framing

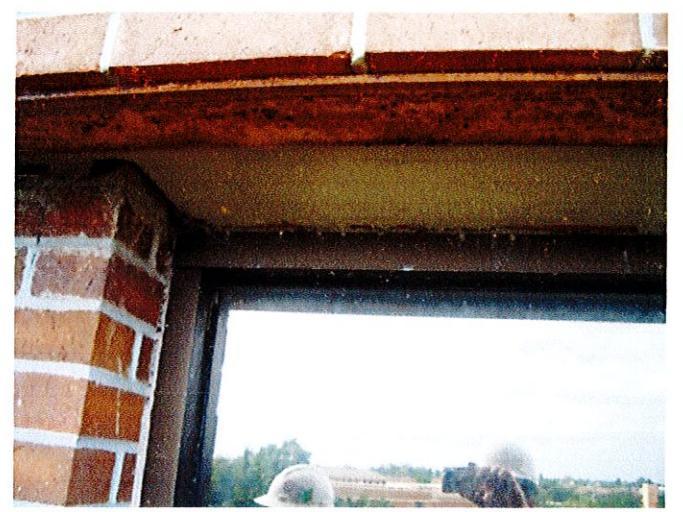
<u>Picture #11</u> Structural Steel Brick Shelf Angle at 4th Floor Soffit Level

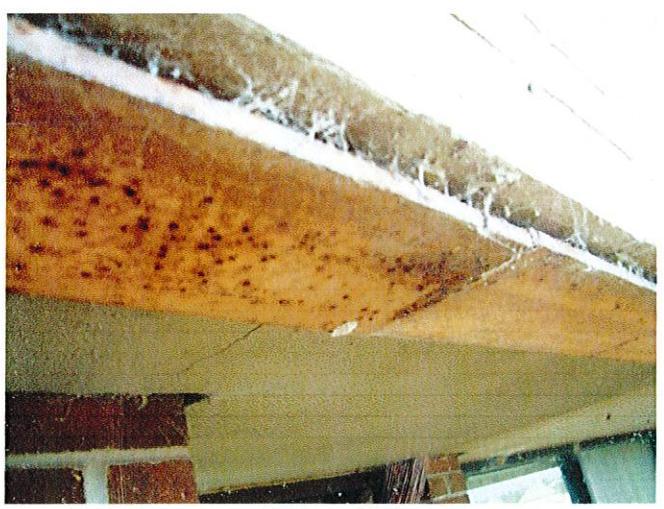
<u>Picture #12</u> Enlarged View of Structural Steel Shelf Angle at 4th Floor Soffit Framing

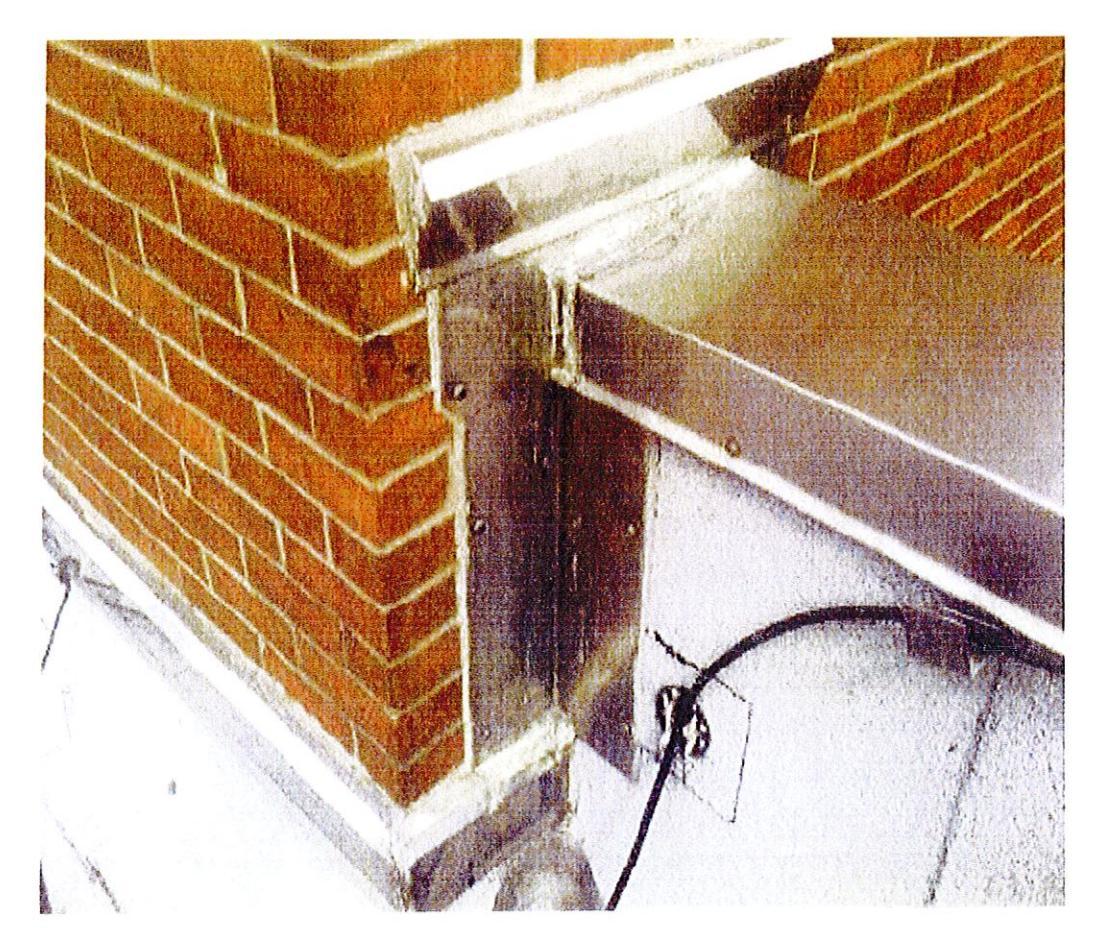
- 1. Roofing system appears to be recently installed.
- 2. Coping cap installation in a few areas does not allow for building expansion/contraction. (Photo #1)
- 3. VTR's and lightening protection are correctly installed.
- 4. Mechanical unit raised pads are intact.
- 5. Roof top internal drains appear to be watertight, but DBY was unable to verify below deck connection.
- 6. (2) low roof areas were discovered, but no residual water observed.
- 7. Roof Hatch appears to be from original construction. Seals and internal curbing were not verified, numerous patches. (Photo #3)
- 8. Corners appear to be reworked (overlayed patch). (Photo #2)
- 9. Parapet top connection to elevator brick face relies on sealant, which is starting to crack.

## **Coping Cover Minus Expansion Joint**

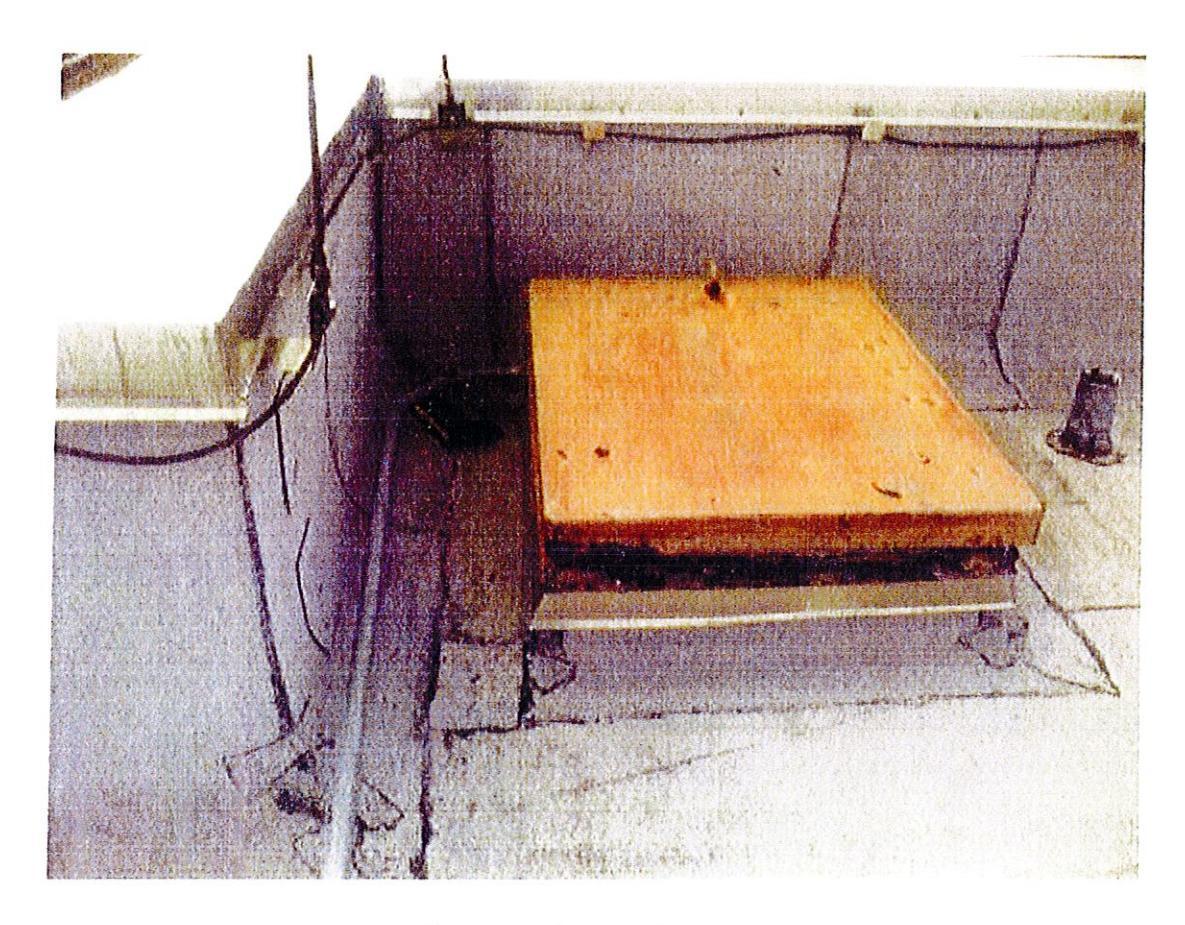
**Roof Hatch & Roof Patches**

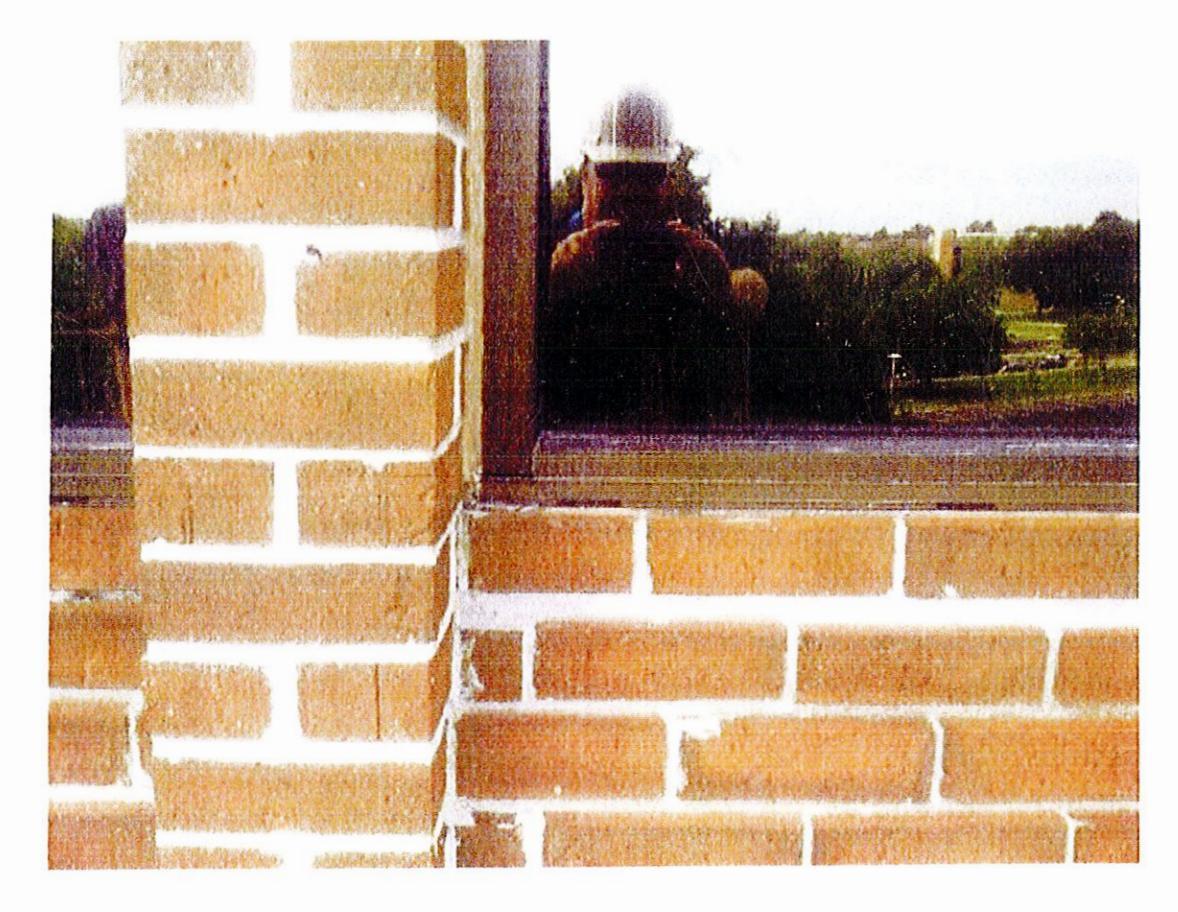
- 1. Window joints appear to be water tight. Section cut detail of windows installation has been requested.
- 2. No drip edges were observed.
- 3. Windows appear to have internal drainage system. (Photo #4)
- 4. West face openings have more UV /Weather damage to joint material.

Window Drainage System at Sill

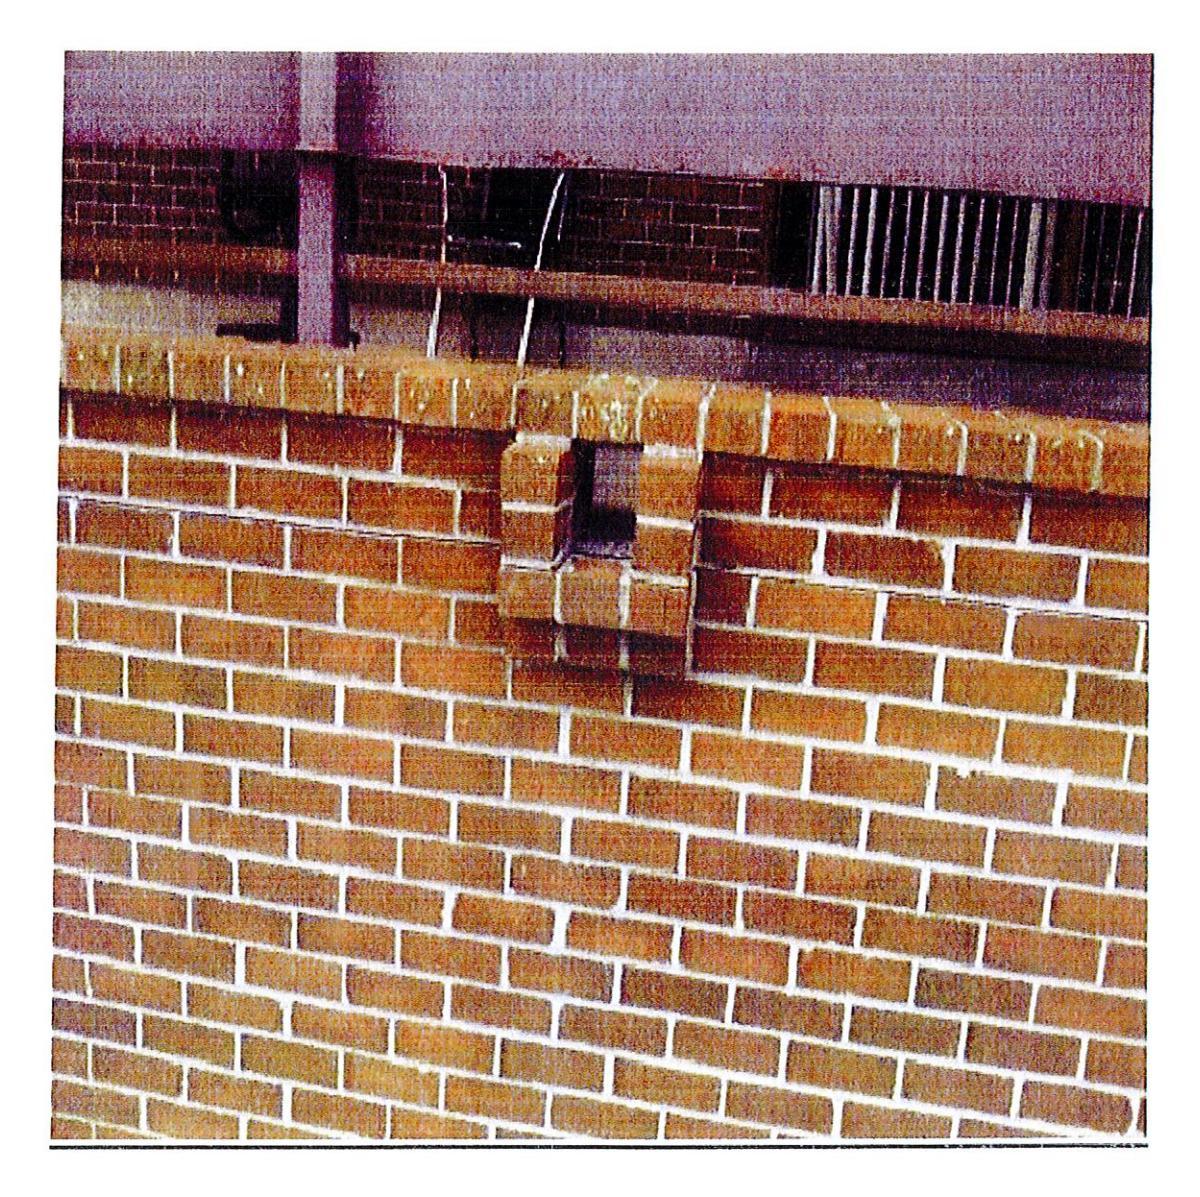
**Deteriorated Mortar Joint at Slab Elevation**

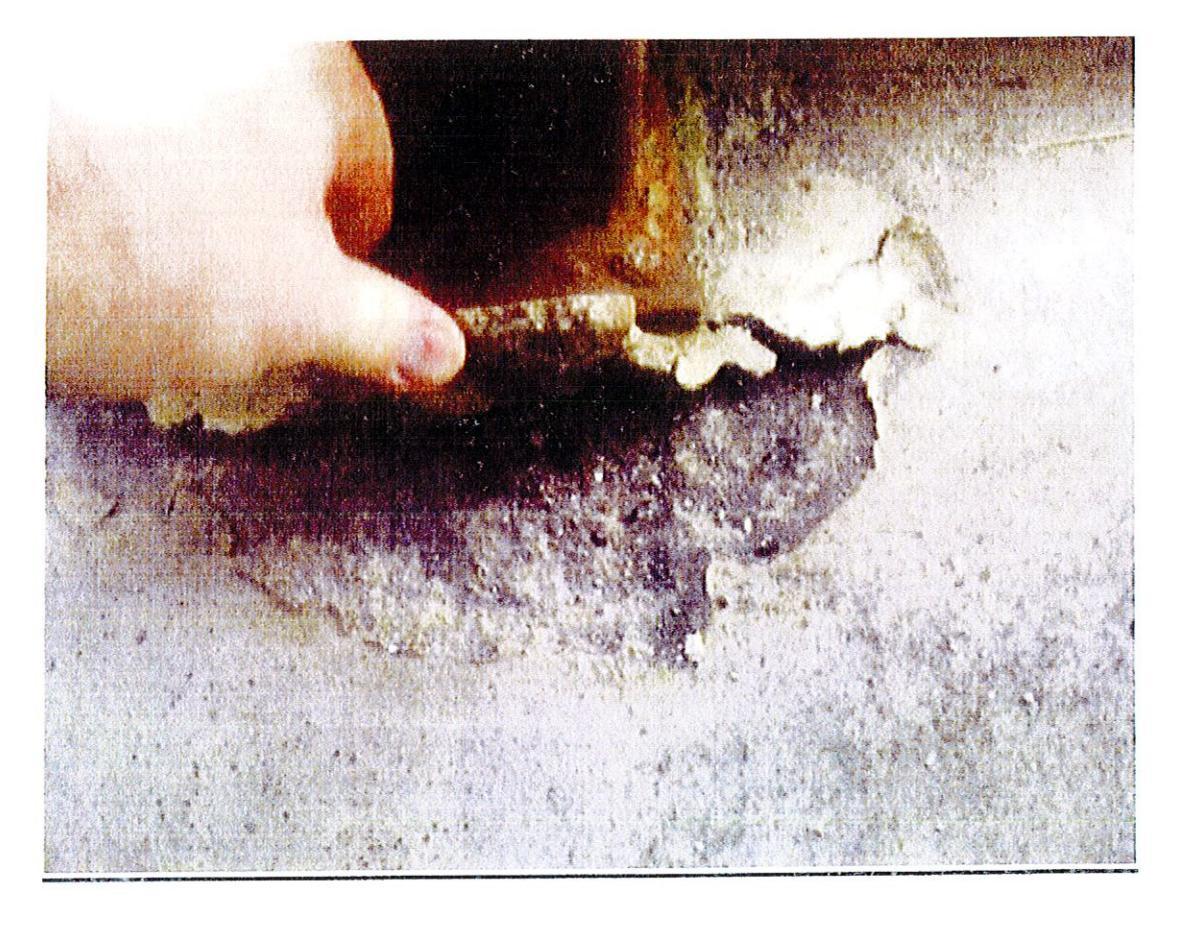
**Rusted Rail Support**

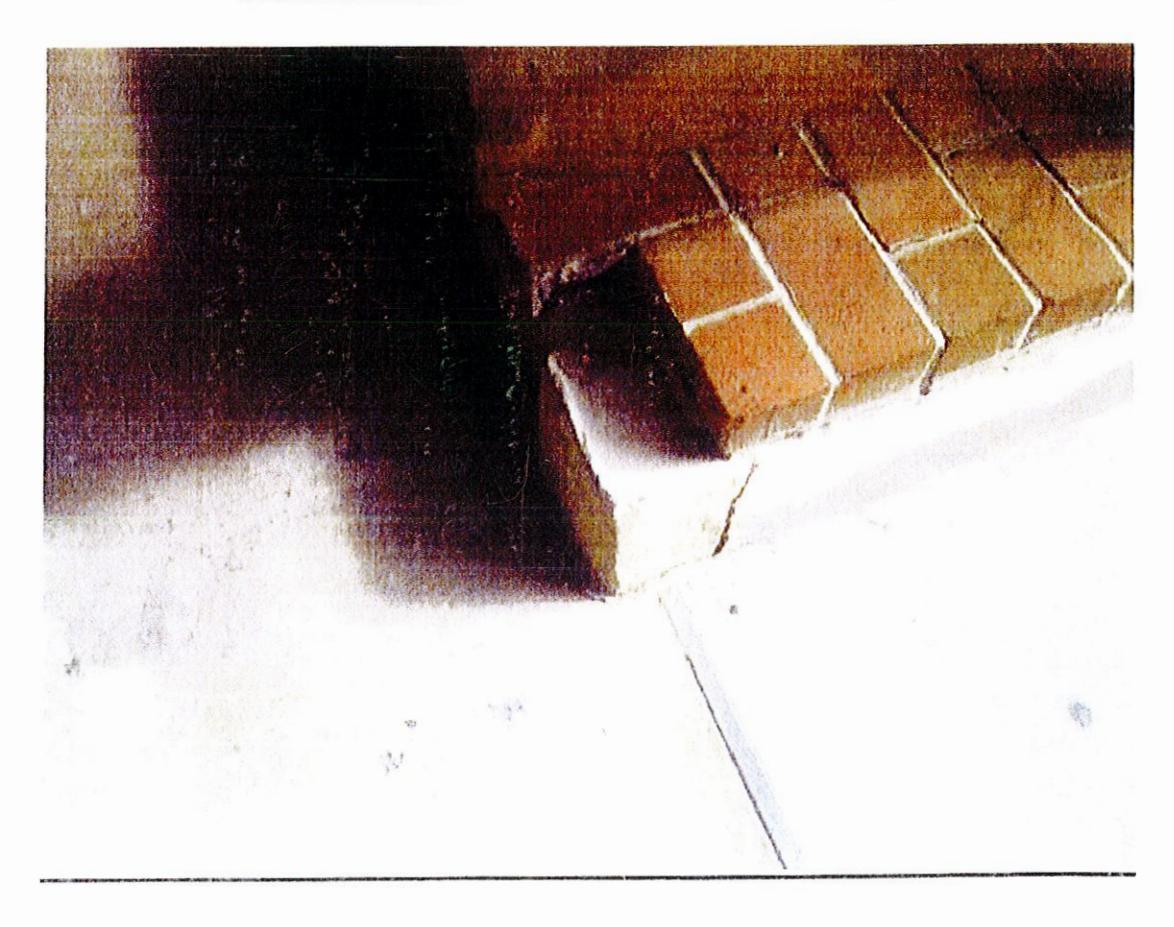
Loose, Missing Brick

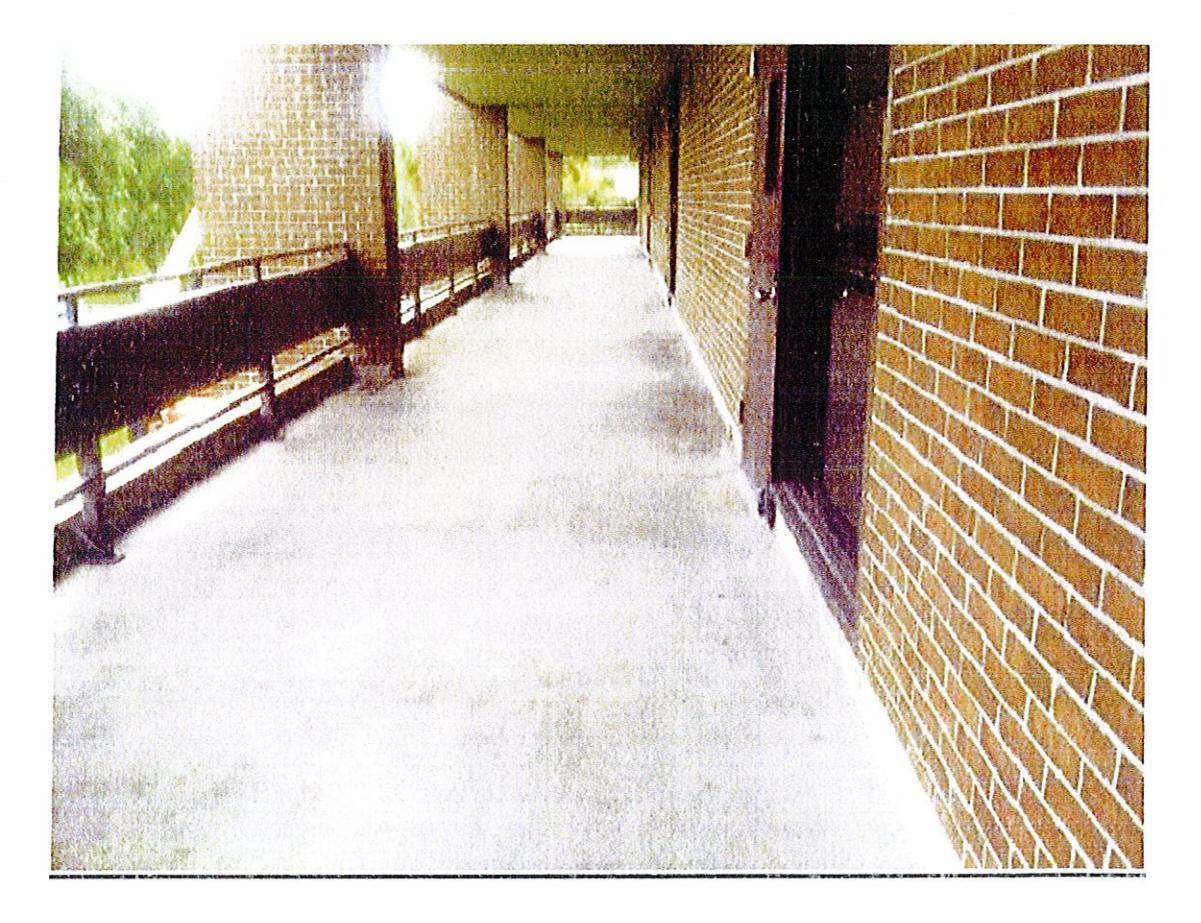
## Back Pitched Open Walkways

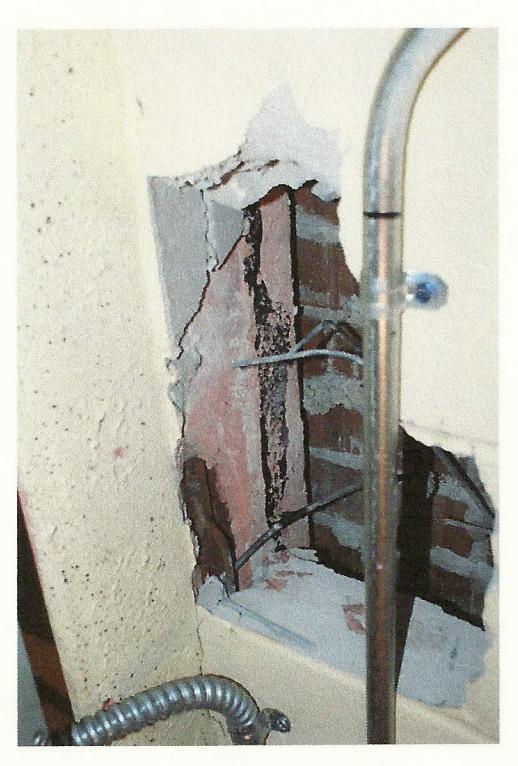
<u>Picture #1</u>: Horizontal Ladder Reinforcing at Brick/CMU Wall

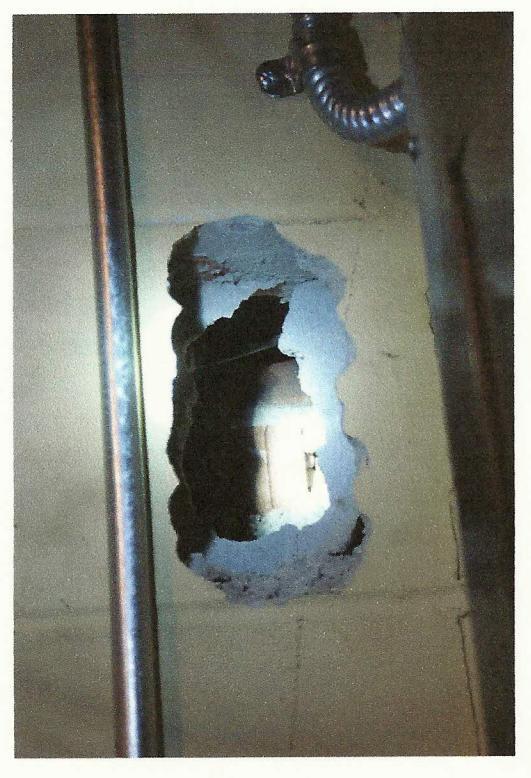
Picture #3: Void Cells in Exterior CMU Wall

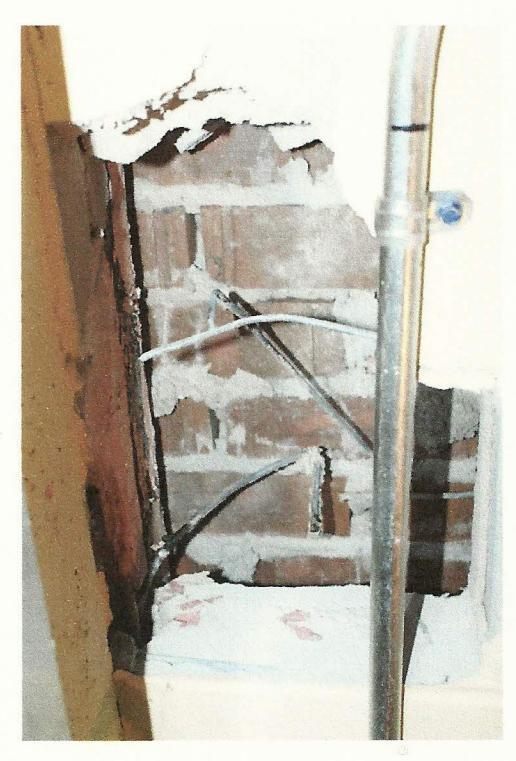
Picture #2 Horizontal Ladder Reinforcing at Brick/CMU Wall

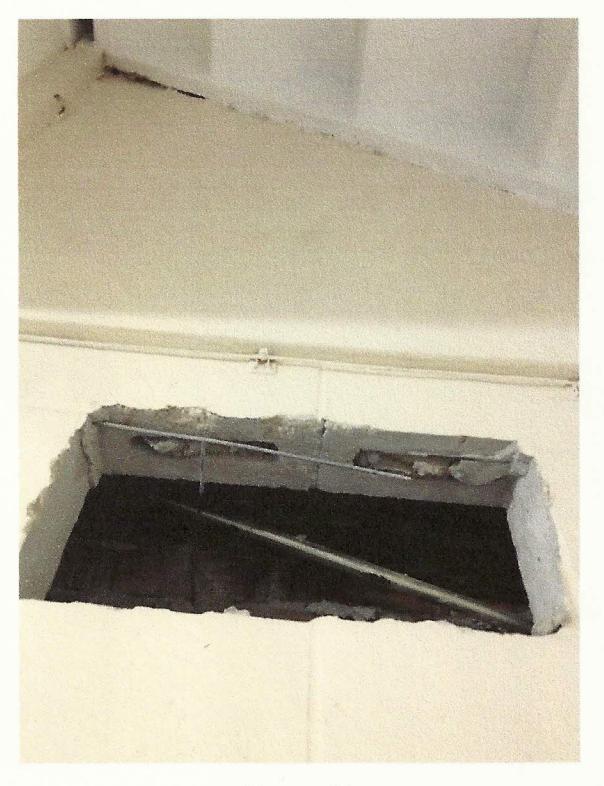
Picture #4: Void Cells in CMU Exterior Wall

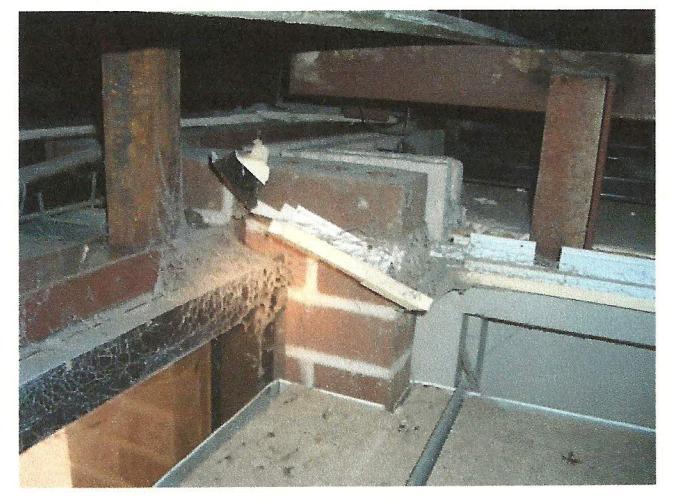
- 3. There is not a continuous solid grouted masonry course at the top of the CMU walls as required by the original Architectural drawings. Consequently, the ½" diameter anchor bolts at 2'-6" on center bracing the CMU wall back to the steel joist are not connected to anything creating an un-braced condition at the top of the non-bearing CMU wall (see Picture #5).

Picture #5: Top of CMU Wall is not Grouted Solid

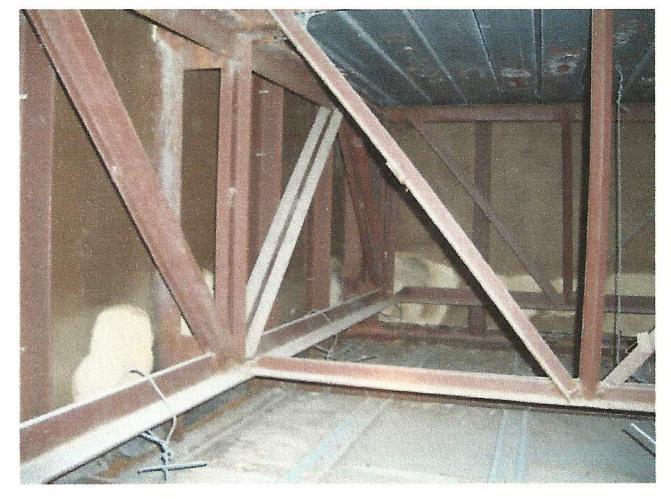
<u>Picture #6</u> No Metal Studs behind Sheathing at Joists/Brick

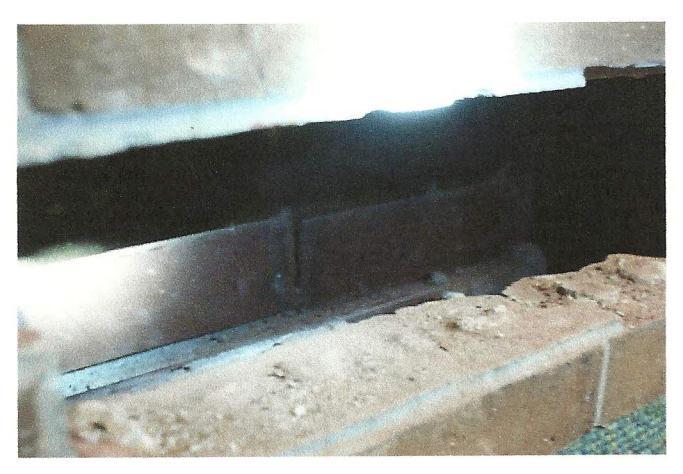
<u>Picture #7</u>: Dis-continuous Steel Angle

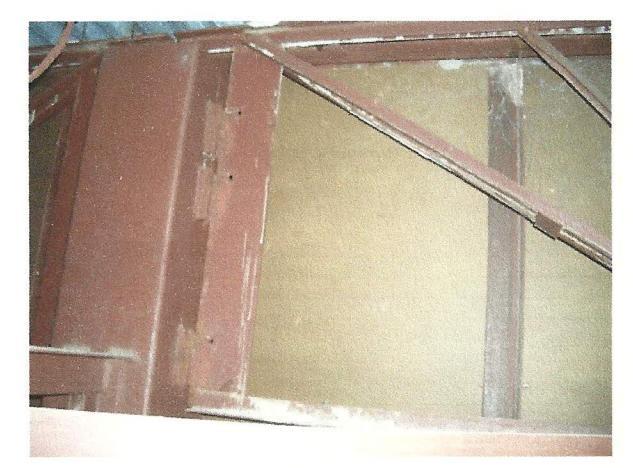
- 7. Welded connections appear to be inadequate in various locations (see Picture #8).
- 8. Steel king posts and masonry walls at the high roof projection areas at the corners of the building are supported by steel roof joists with minimal connections. These areas also appear to have water intrusion issues due to the condition of the supporting structural steel (see Pictures #9 & #10).

<u>Picture #8</u>: Typical Joist/Joist Girder Welds to Steel Column

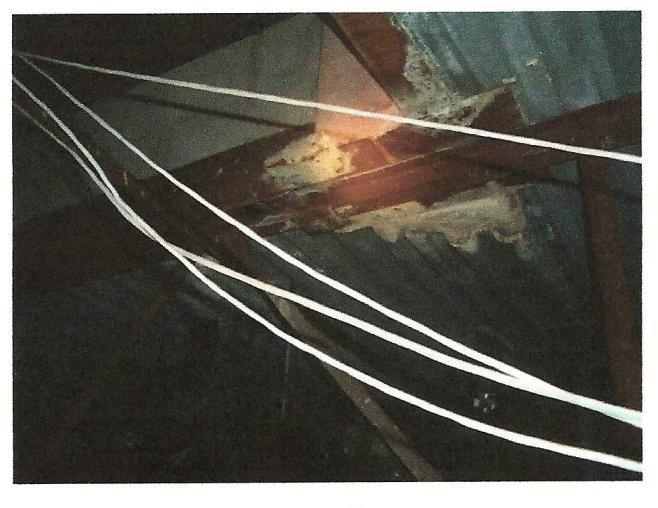
<u>Picture #9</u>: Steel King Post & CMU Wall on Joist @ High Roof

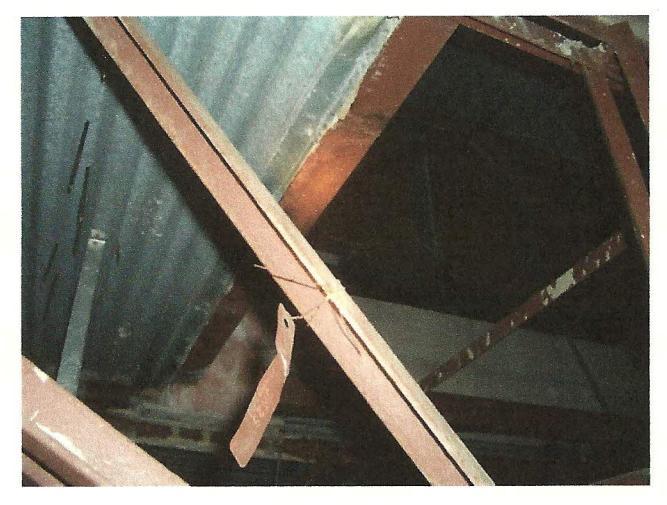
Picture #10 Steel King Post & CMU Wall on Joist @ High Roof

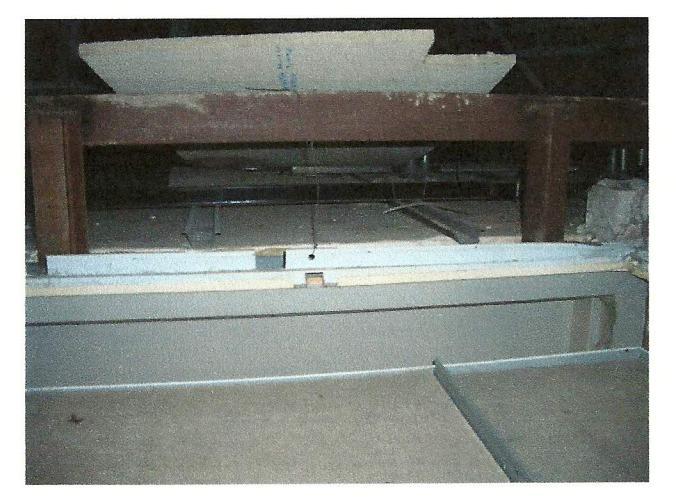
- 9. There appears to be inadequate lateral support at the top of the windows, typically. In some locations there is structural steel framed down from the bottom of the joists but there does not appear to be a continuous member at the top of the window nor is there any diagonal bracing from the top of the window back to the joist or deck (see Pictures #11 & #12).

Picture #11: Steel Support at Top of Window Frame

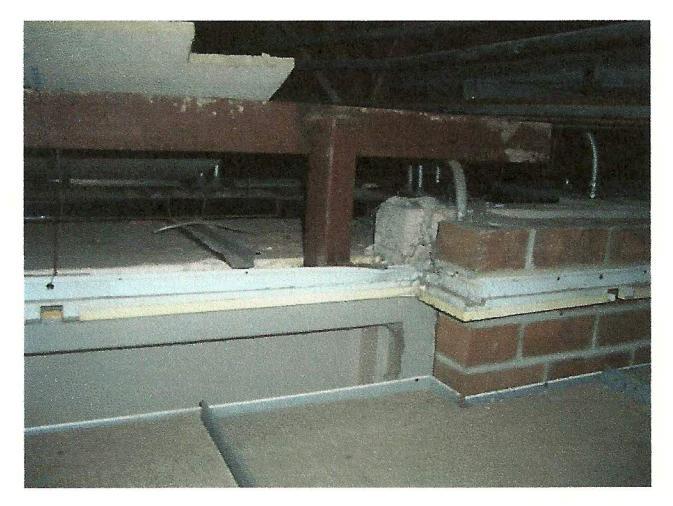
Picture #12 Steel Support at Top of Window Frame

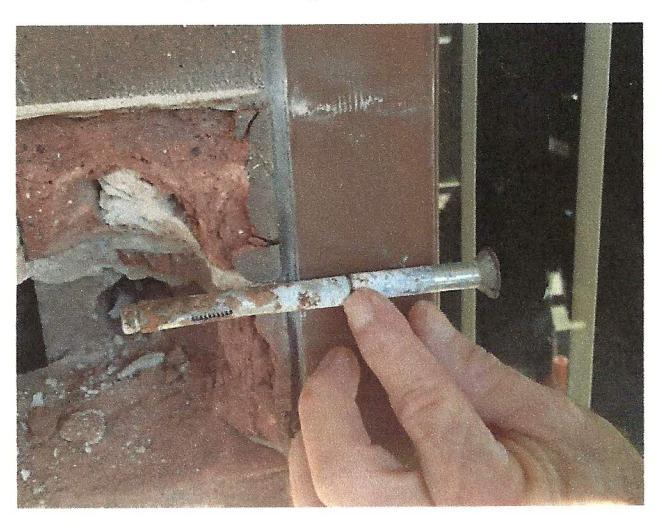
- 10. The door and window frames along the exterior corridors on the 2nd and 3rd floors are anchored into brick that has inadequate anchorage to the CMU wall to resolve the wind loads. The CMU wall in turn is unsupported at the top as there is no solid grouted bond beam and connection to the steel joist above (see item #3 above and Pictures #13 & #14).

Picture #13: Exterior Door Frames Anchored into Hollow Brick

- The existing exterior doors and windows should be removed and replaced with new products that meet the current Florida Product Approvals. The new exterior windows and doors should be properly anchored into solid grouted masonry cells and braced back to the building structure.

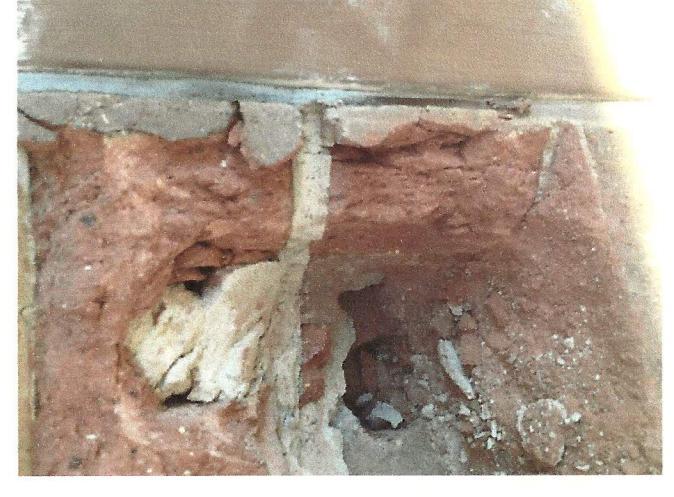
<u>Picture #14</u>: Exterior Door Frames Anchored into Hollow Brick

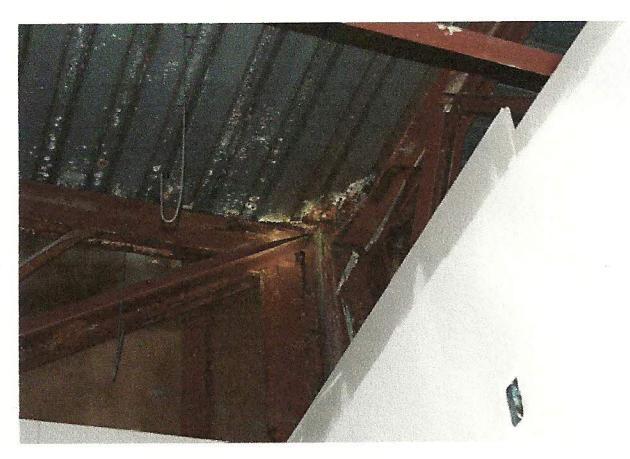
- 11. Water intrusion from the 2nd and 3rd floor exterior corridors has damaged the structural steel floor framing and column supports below (see Pictures #15 to #20).

Picture #15: Steel Floor Framing Damaged from Water Intrusion

- The visible damage to the structural steel joists and columns, specifically below the 2nd and 3rd floor exterior corridors, appears to be significant. These members should be cleaned and supplemented or replaced depending on the severity of the damage. The exterior walkways at the 2nd and 3rd floors should be reviewed with an Architect and/or waterproofing consultant to remediate the existing water intrusion issues and prevent any further damage. One possible solution is to enclose these exterior walkways and keep the building envelope at the vertical exterior face of the building.

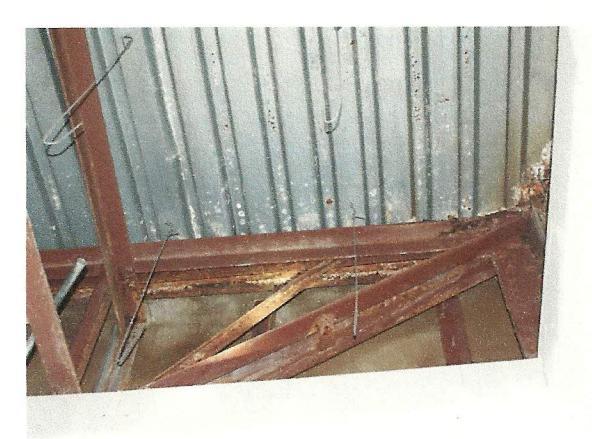
Picture #16 Steel Floor Framing Damaged from Water Intrusion

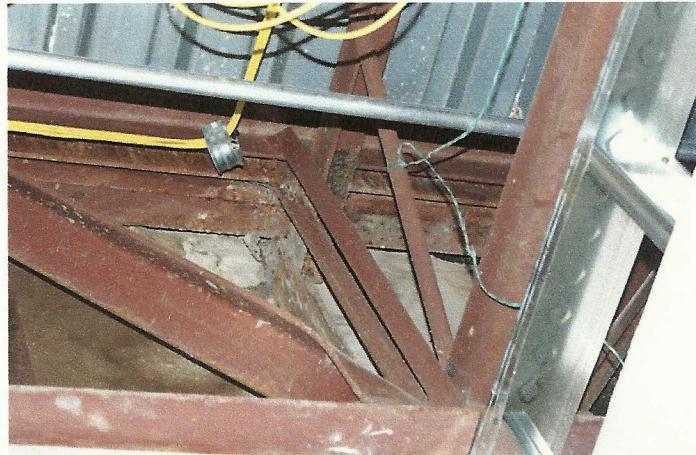
<u>Picture #18</u> Steel Floor Framing Damaged from Water Intrusion

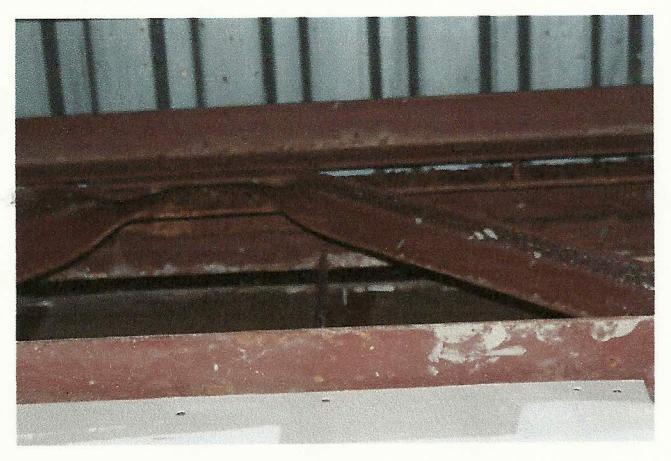
<u>Picture #19</u>: Steel Floor Framing Damaged from Water Intrusion

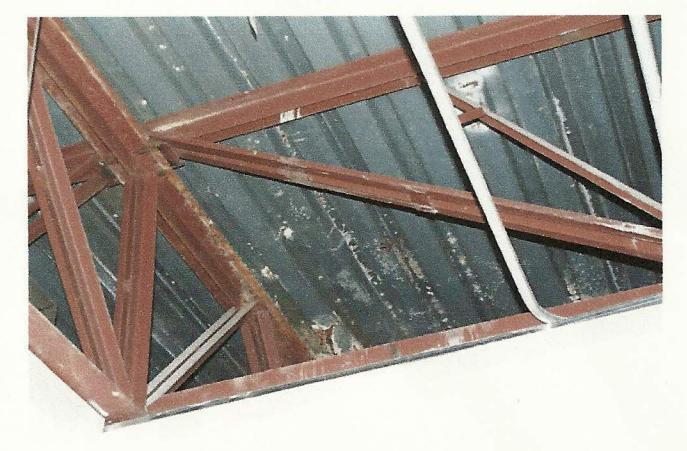
<u>Picture #20</u>: Steel Floor Framing Damaged from Water Intrusion

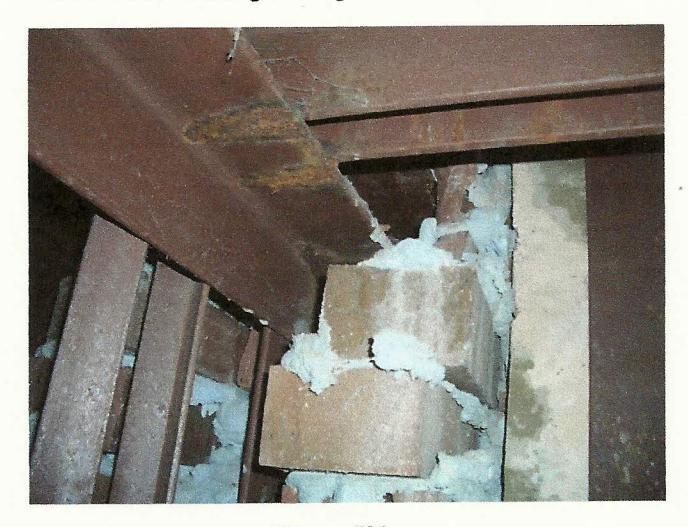
- 12. The corbelled brick column elements that start at the 4th floor and extend up to the roof level appear to be supported by a cantilevered steel angle at the top of the floor joist (see Picture #21). It is unknown if this condition repeats at the 5th floor as well to aid in support of the additional weight of this element. The two locations that these corbelled columns were accessible were constructed differently.

Picture #21: Corbeled Brick Column Construction Starting @ 4<sup>th</sup> Floor
