# University of Central Florida Colbourn Hall Building Analysis

February 2014

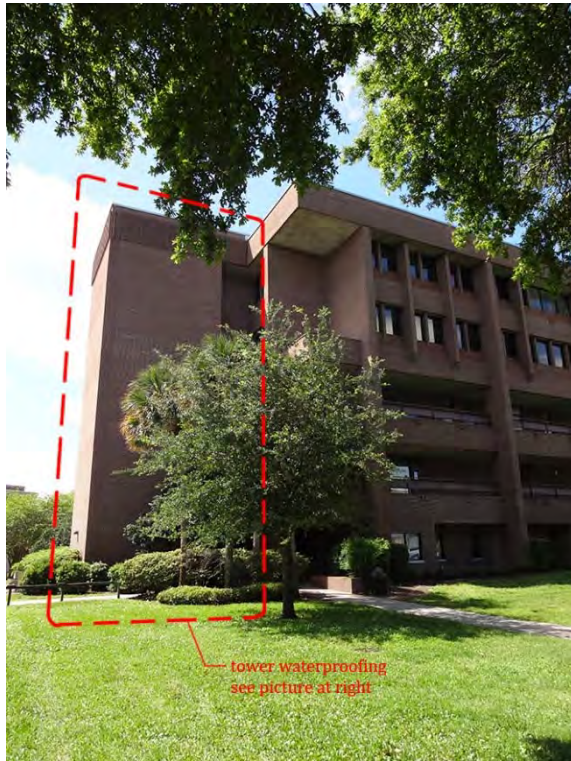
tower waterproofing – deteriorating and  
not consistently applied, no vapor barrier,  
no insulation

- a. **OPTION 1** - this option is to remove the brick and 4" non-reinforced CMU backup, and replace it with a properly installed backup system including cavity wall insulation, waterproof membrane, densglass backup, and cold formed framing structural metal studs tied to the existing building steel. This has the advantage of having a complete new exterior skin which has the desired vapor barrier, building insulation and waterproofing.

- b. **OPTION 2** – this option is to pin the brick to the backup structure using helical ties, and reinforce the 4" CMU backup structure as described in the structural section. This option avoids the demolition of the towers, but does not address the lack of waterproofing and vapor barrier at these portions of the building. However, as these towers are currently non-conditioned ventilated space, this may be acceptable to the University.

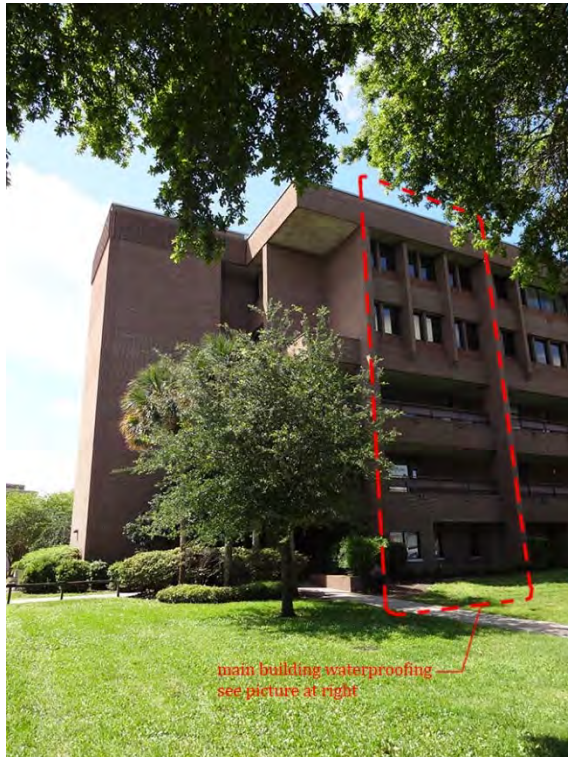
main building

deteriorating substrate, flashing,  
no insulation, no vapor barrier

gypsum wallboard  
used as backup (not an  
appropriate material)  
with no asphaltic  
coating, deteriorating

no insulation

no vapor barrier

1. **MAIN BUILDING** - At the middle of the building, we recommend the complete removal of the exterior skin, including the brick and sheathing, and replacement of the brick at the columns at roof parapet over a properly installed backup system including cavity wall insulation, waterproof membrane, densglass backup, and cold formed framing structural metal studs tied to the existing building steel. The existing windows and brick between columns from level 2 to level 5 will be removed and replaced with a curtainwall system, see renderings on the following pages. The second and third floor existing exterior circulation will now become interior circulation which will need additional fan coil units in the ceiling to condition the space. It should be noted that this solution will reduce the building's peak energy use tonnage by roughly 12.6 tons, saving the University approximately \$2,200.00 per year in energy cost.

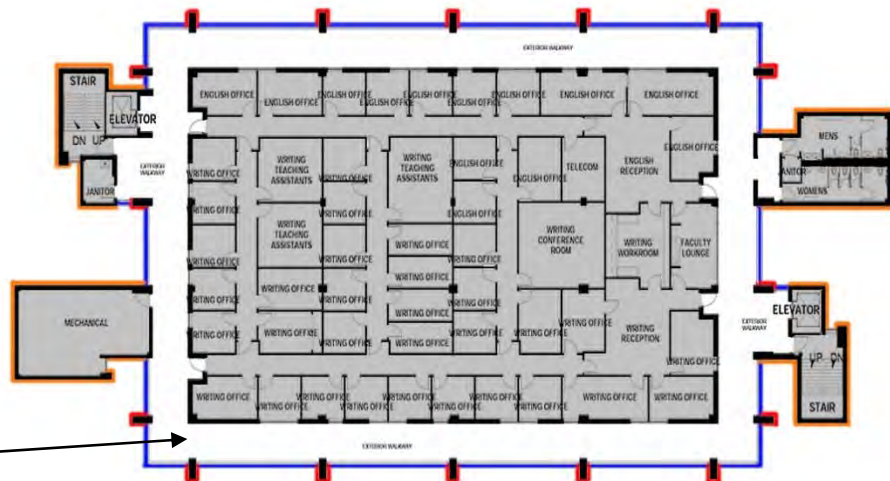
## LEVELS 2, 3

new interior corridor

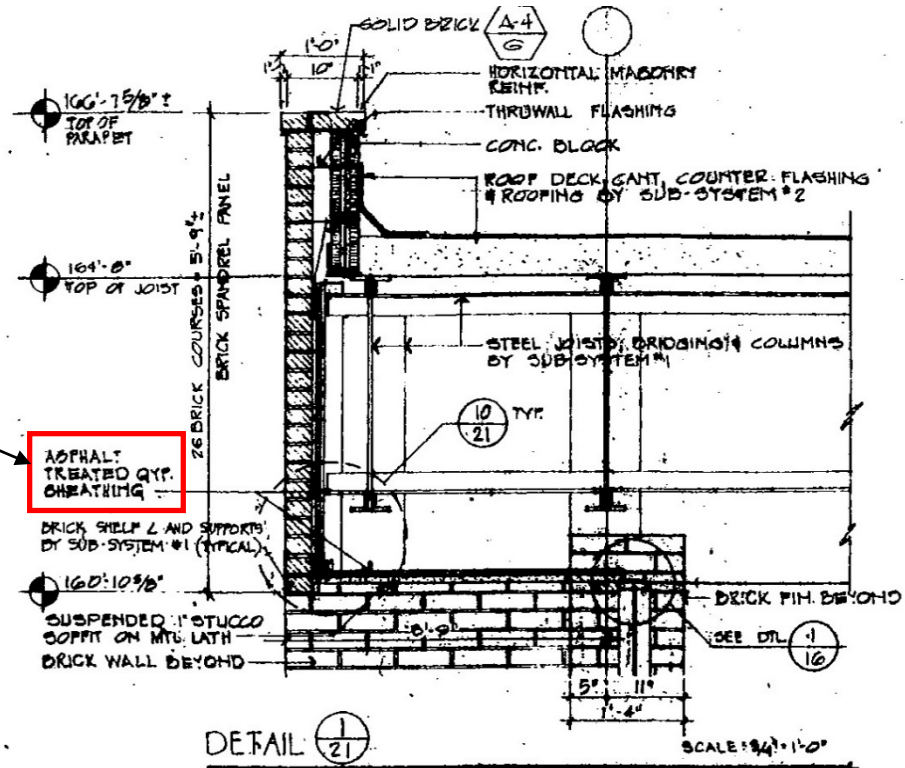
## Main Building Section

no asphalt  
in existing  
construction

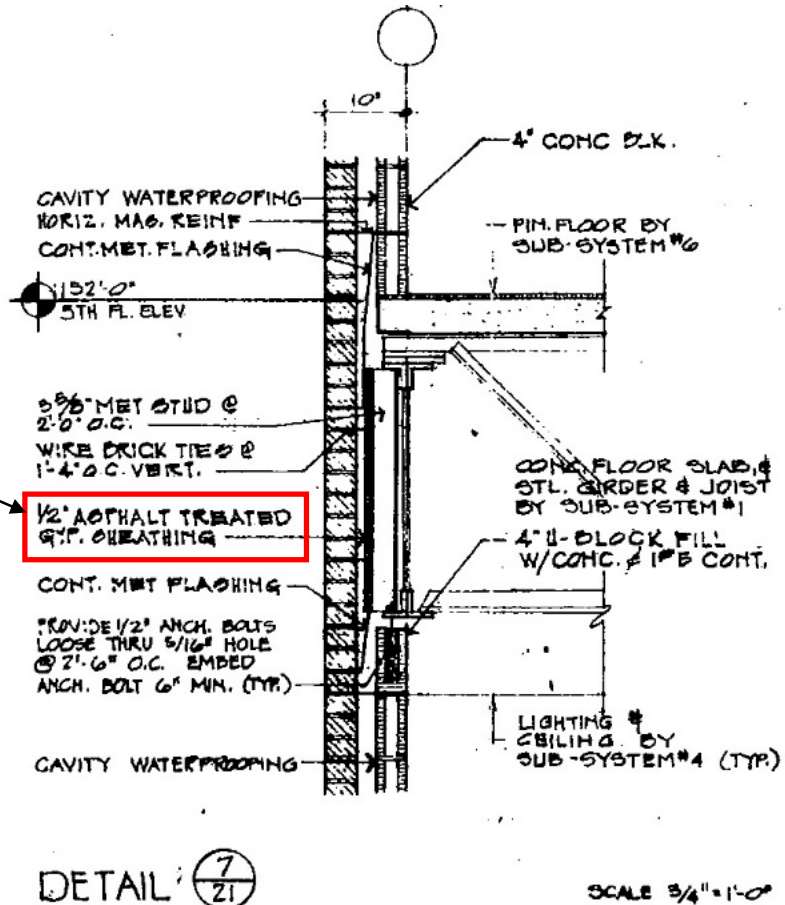
## Tower Section

no asphalt  
in existing  
construction

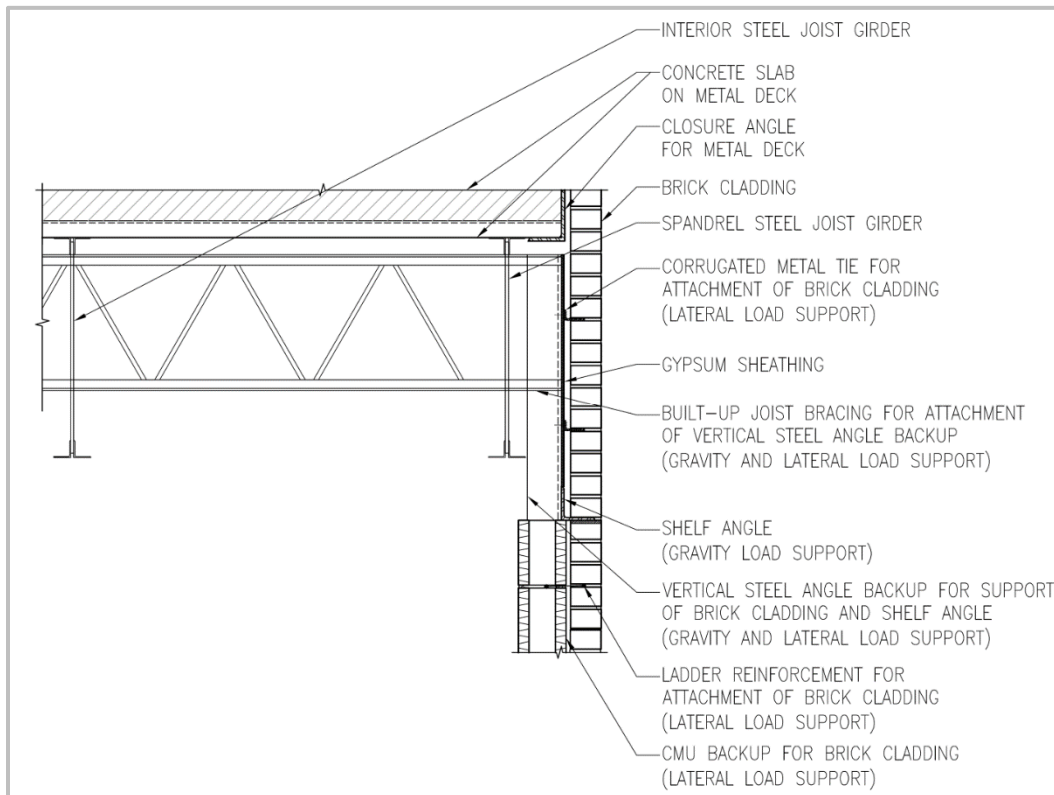
Figure 3. Diagrammatic representation of the typical façade gravity and lateral structural backup systems.

- d. **Brick Masonry Support for Gravity Loads** - The gravity load supports were noted to vary from steel shelf angles at the main core area of the building to continuous brick stacking at the attached tower structures. Continuous brick stacking refers to the condition where the veneer is supported only at the base of the wall.

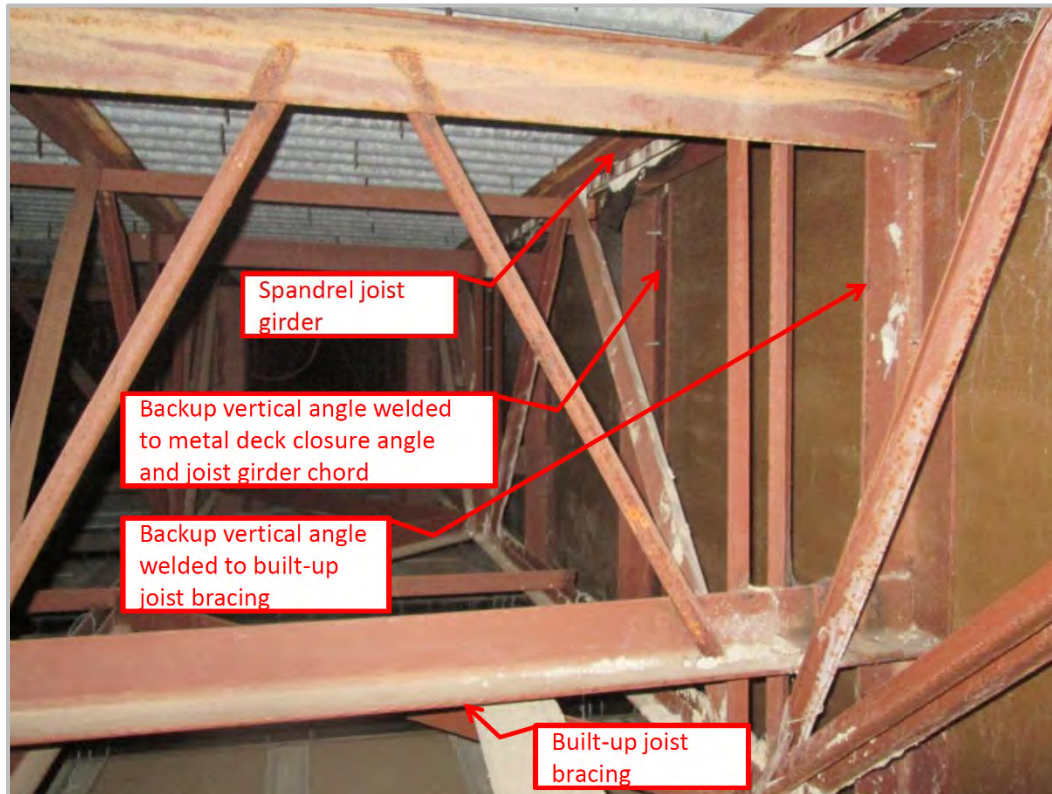
Figure 3. Photographic representation of the typical façade backup vertical steel angle framing

- 2. Angles were tack welded to the metal deck steel closure angle and the bottom chord of the spandrel joist girder (Photo S26).
