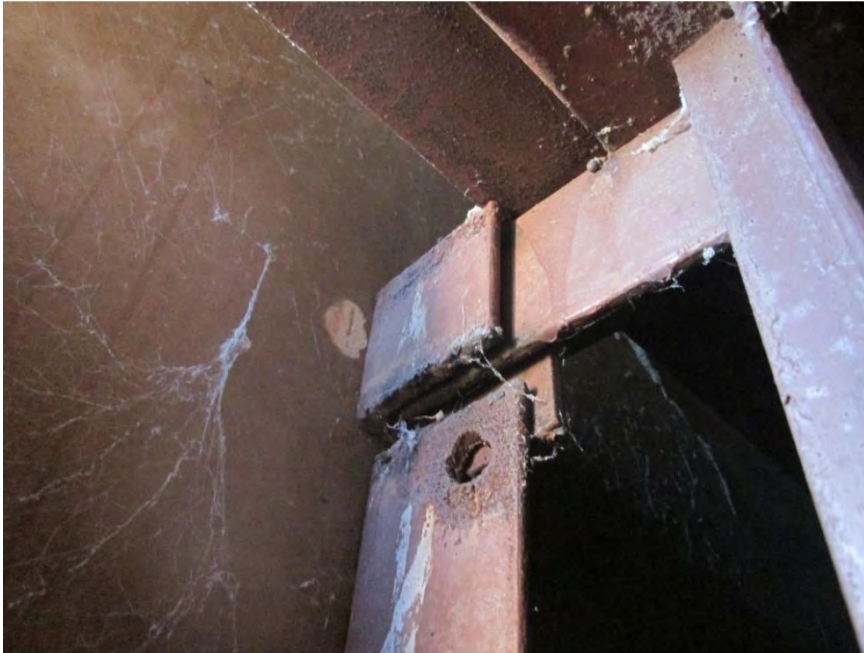
S25 - Backup vertical steel angles welded using steel tab plates to built-up joist bracing framing

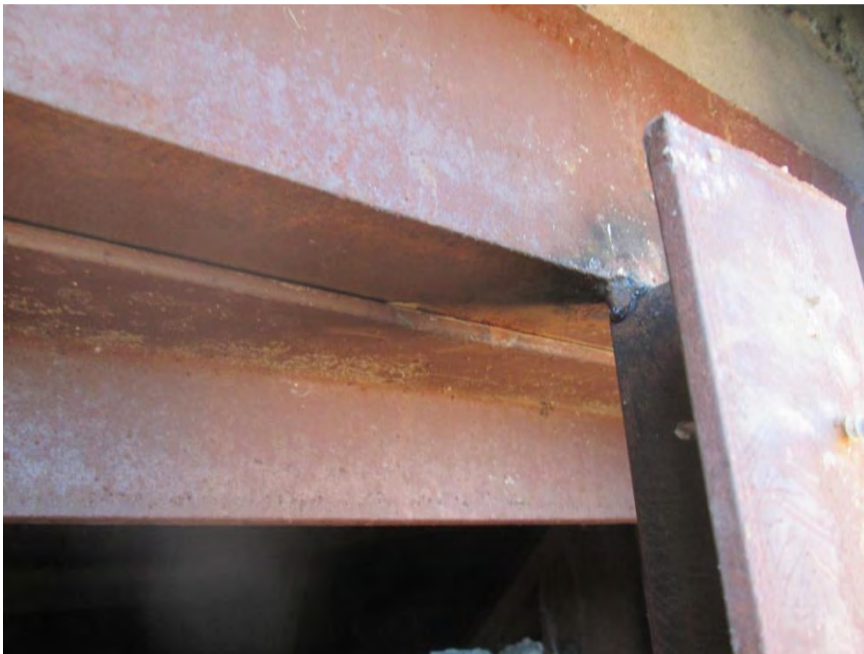
S26 - View of backup vertical steel angles tack welded to the metal deck steel closure angle

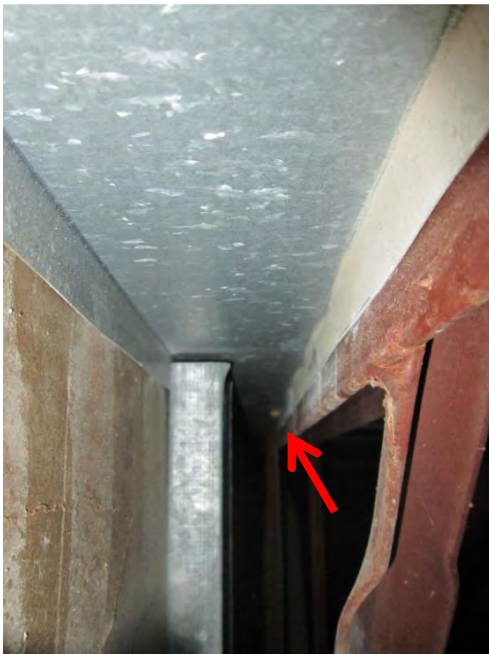
S30 - Cold-form metal stud and tracking framing (tracking attached to chords of spandrel joist)

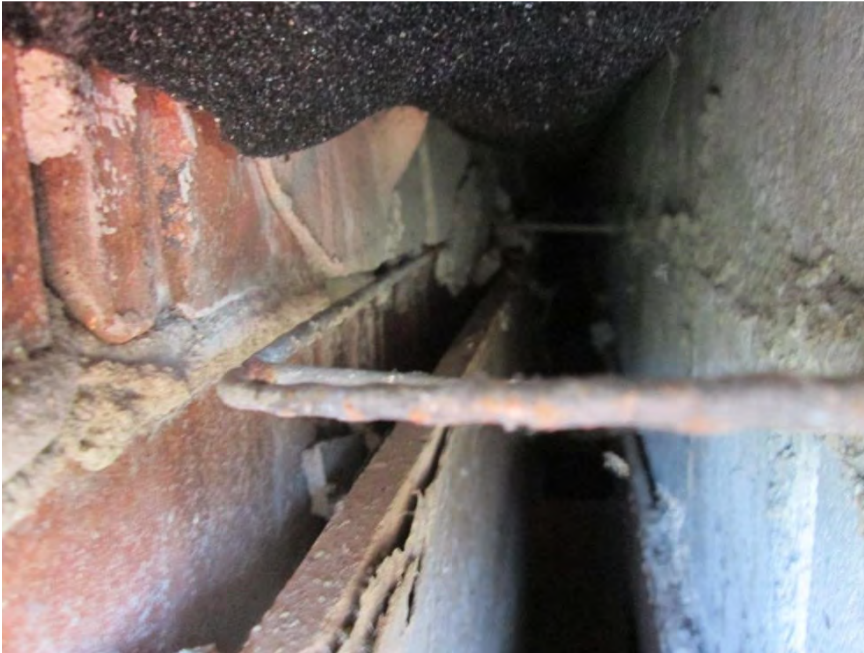
S39 - Horizontal ladder reinforcement not embedded in brick masonry bed joint

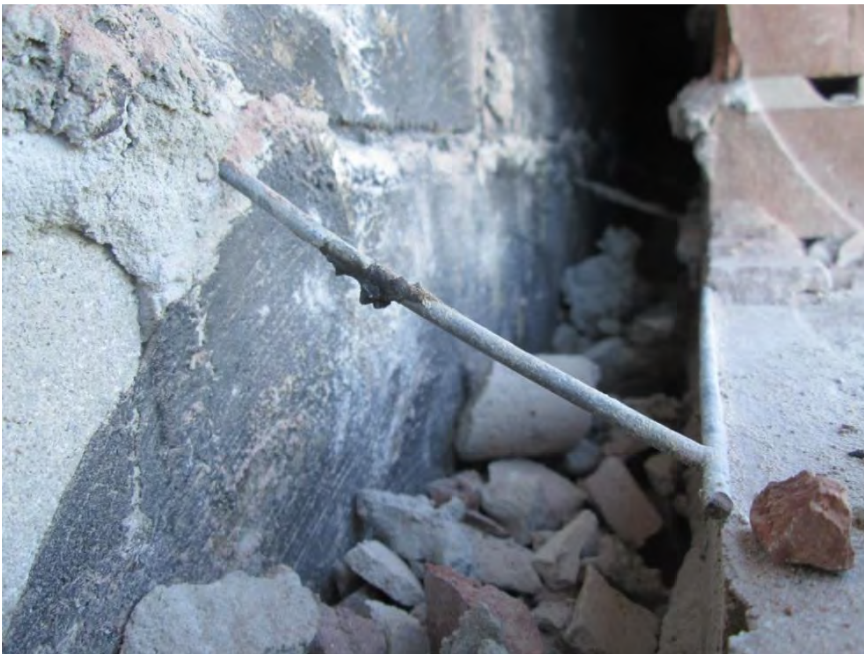
S40 - Horizontal ladder reinforcement not embedded in brick masonry bed joint (note ladder reinforcement is bent)

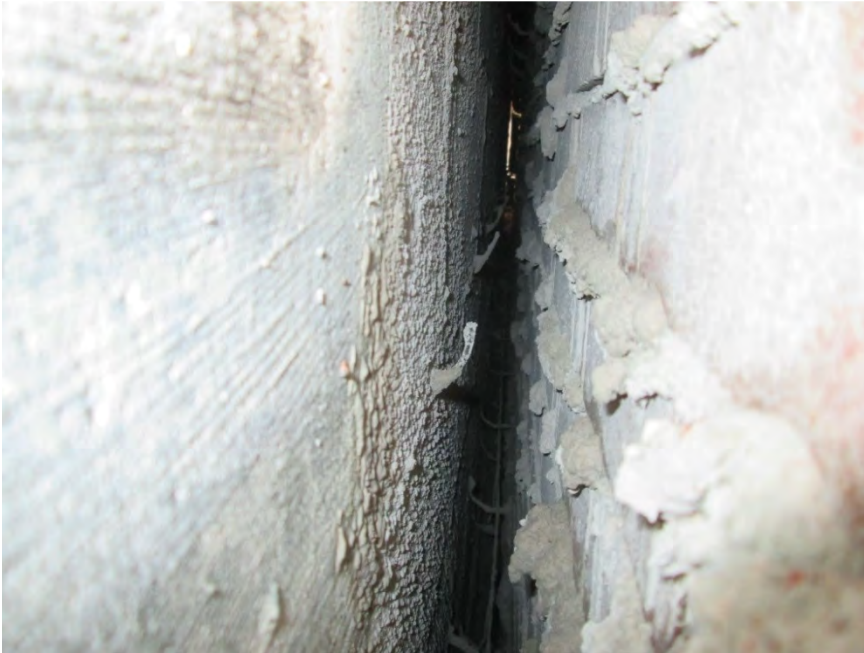
S41 - Cut section of horizontal ladder reinforcement spanning between Exploratory Openings 12 and 13

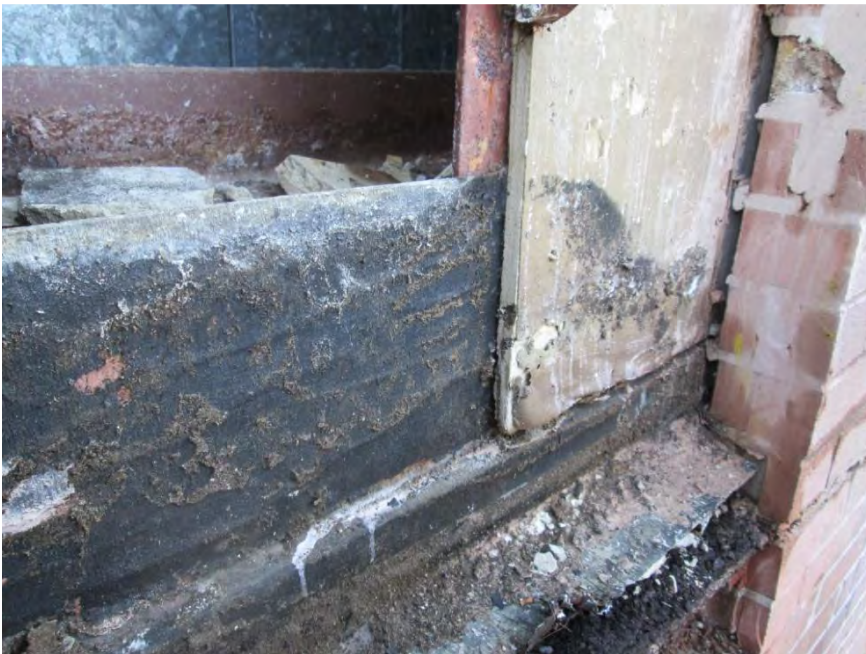
S46 - Cavity wall waterproofing consisting of gypsum sheathing and discontinuous flashing

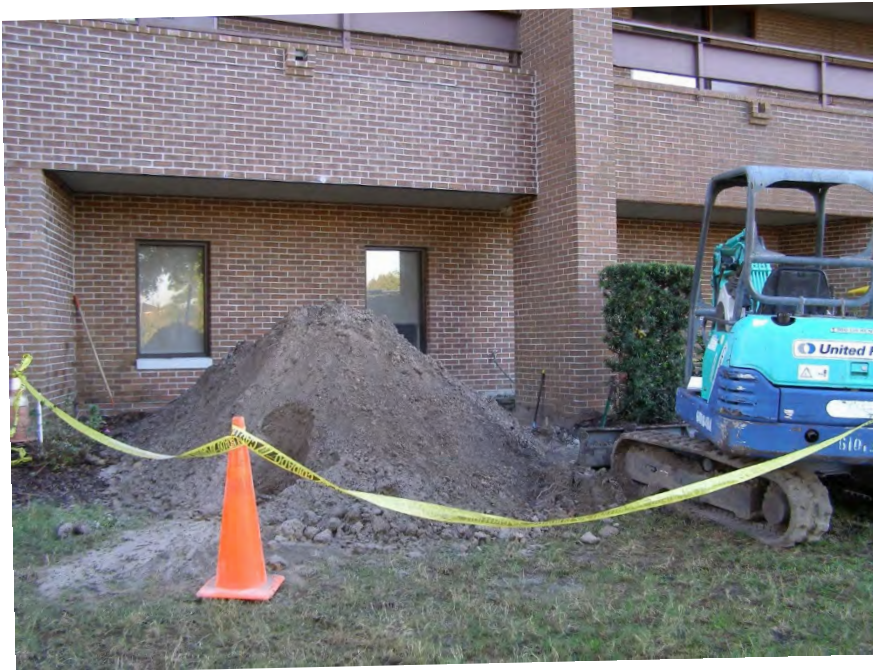
S50 - Excavation of exterior column footing on north side of building

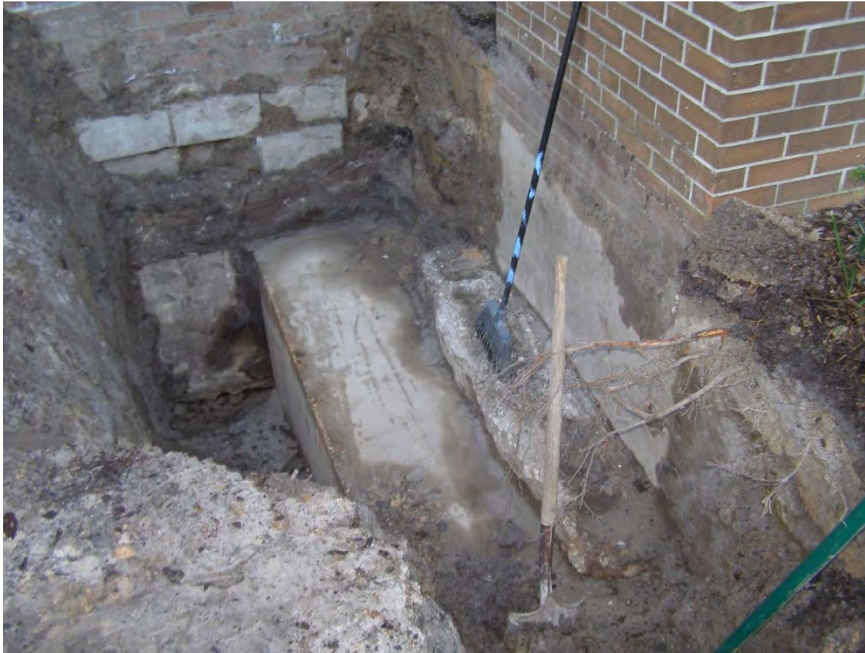
S51 - Exposed footing

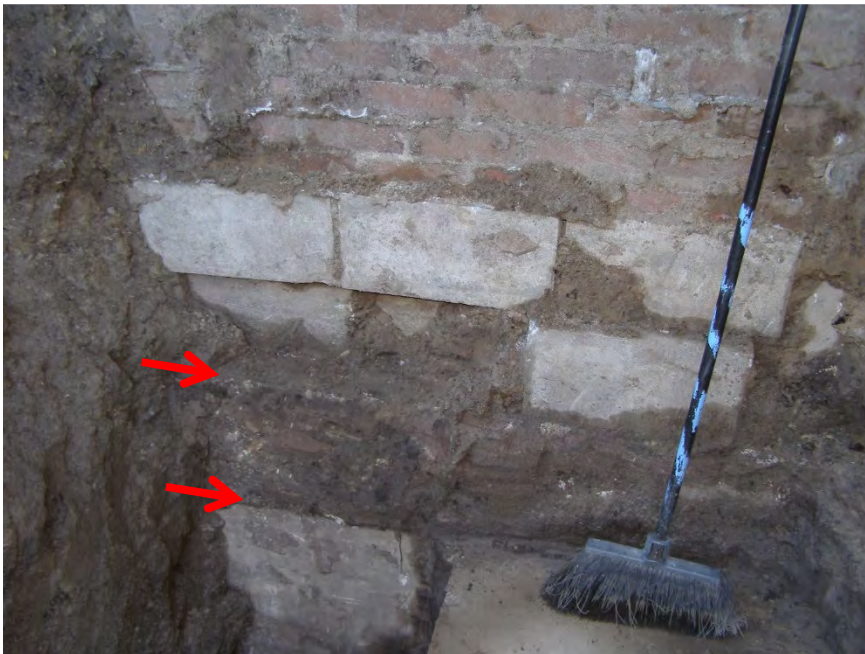
S52 - View of exterior wall at column footing excavation (lower arrow highlights top of interior column footing, upper arrow highlights continuous wall footing, concrete masonry units placed between wall footing and brick veneer).

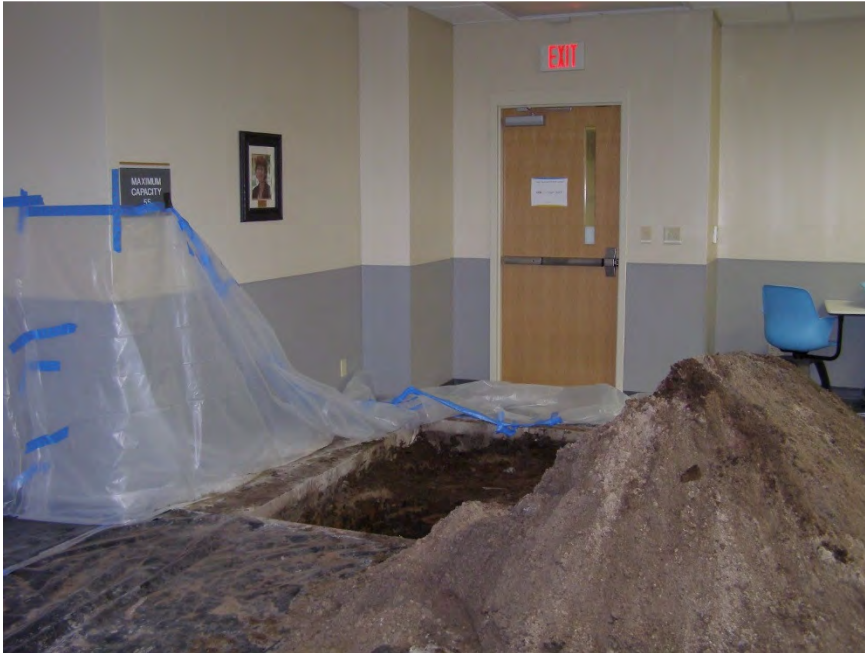
S53 - Interior column excavation

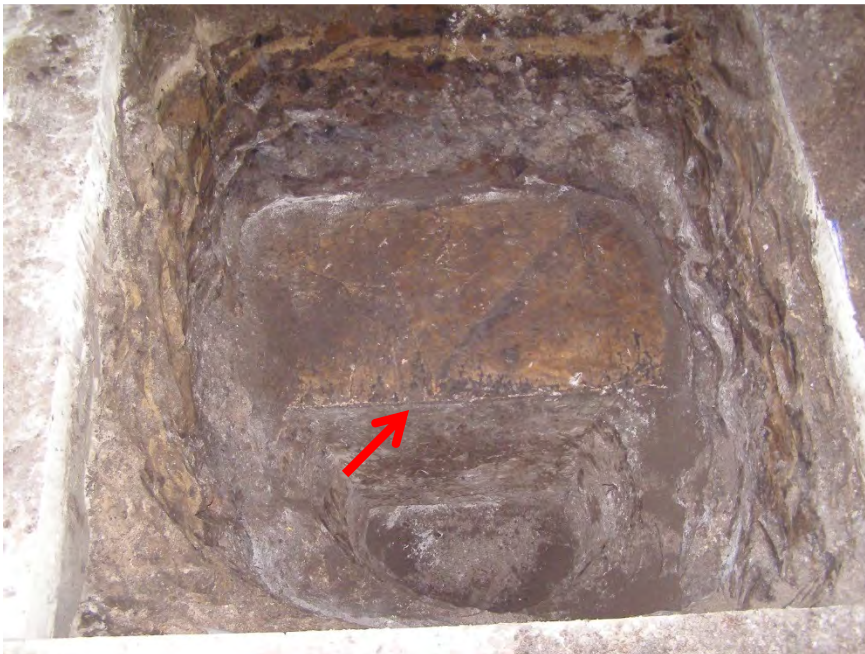
S54 - View of exposed footing at location shown in previous photo

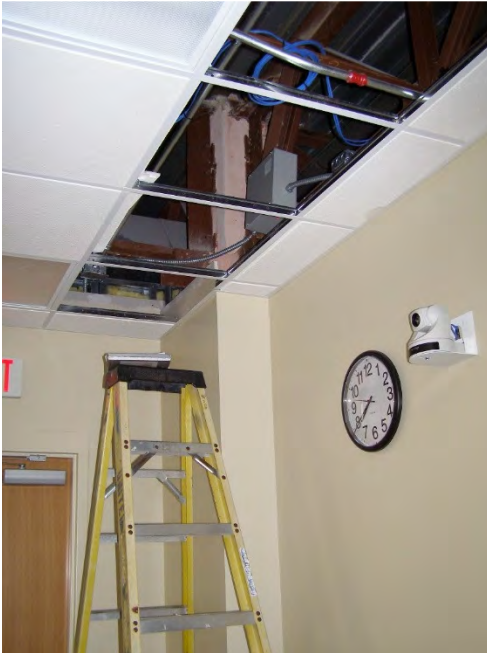
S55 - Example location of above-ceiling observations of steel framing on Level 1

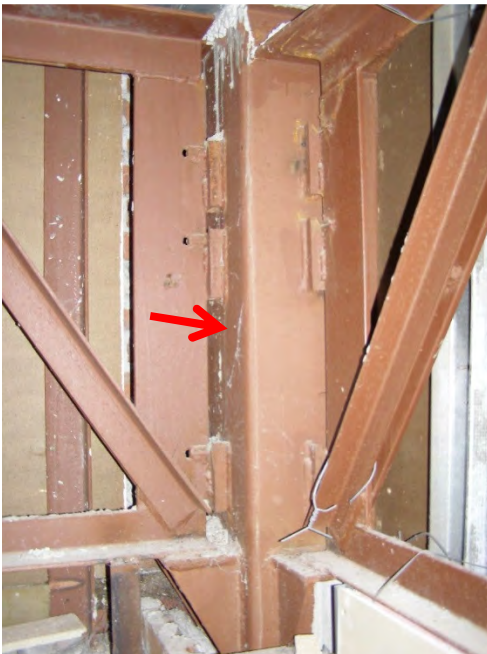
S56 - Arrow highlights typical 10"x10" tube steel column

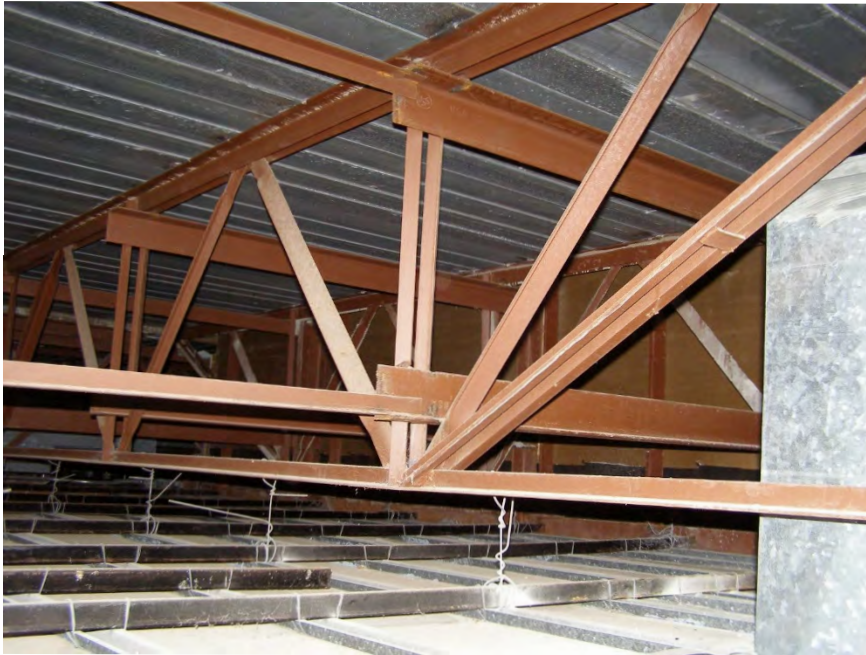
S57 - General view of Level 5 floor joist

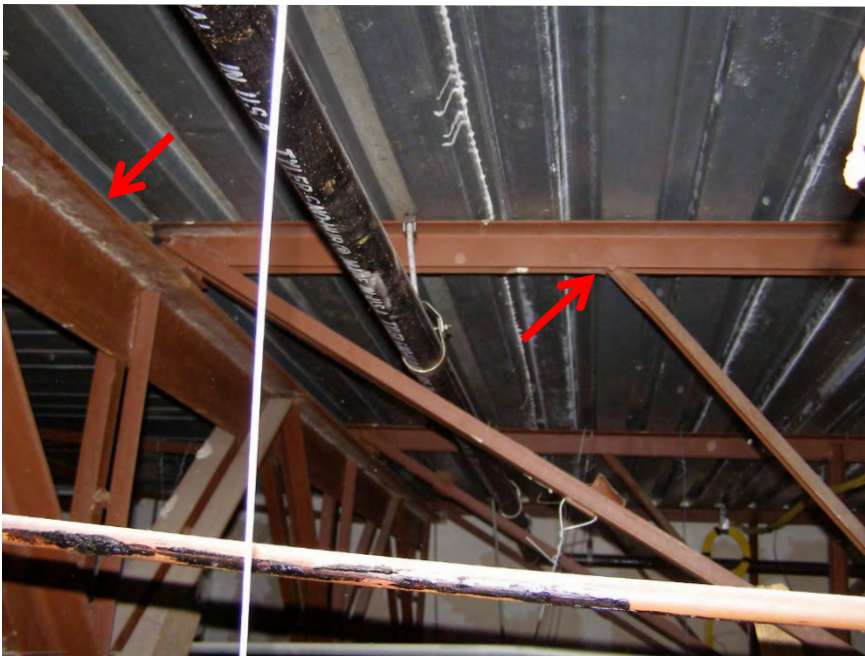
S58 - General view of floor joist (right arrow) bearing on top chord of joist girder (left arrow)

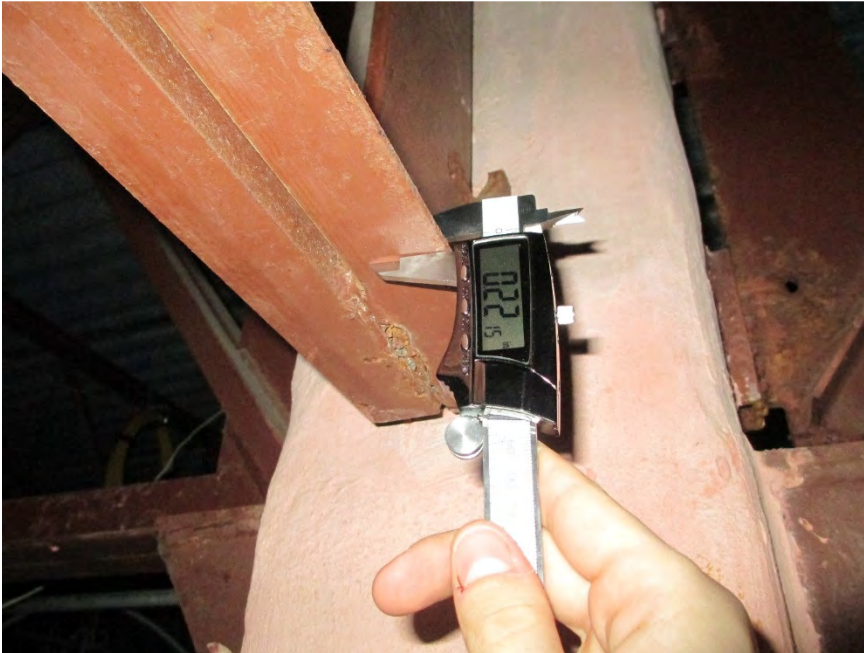
S59 - Caliper thickness measurement of joist bottom chord angle

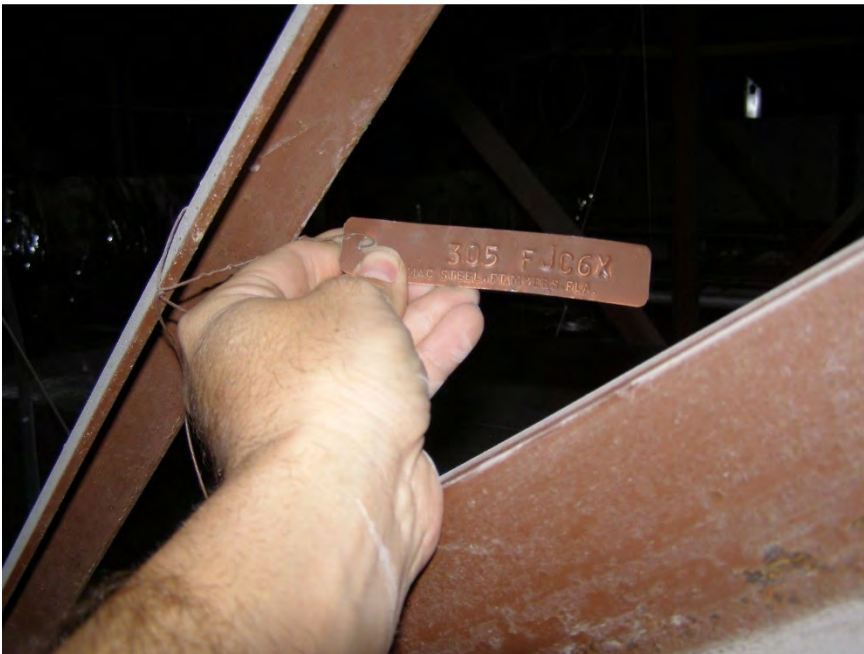
S60 - Example joist tag

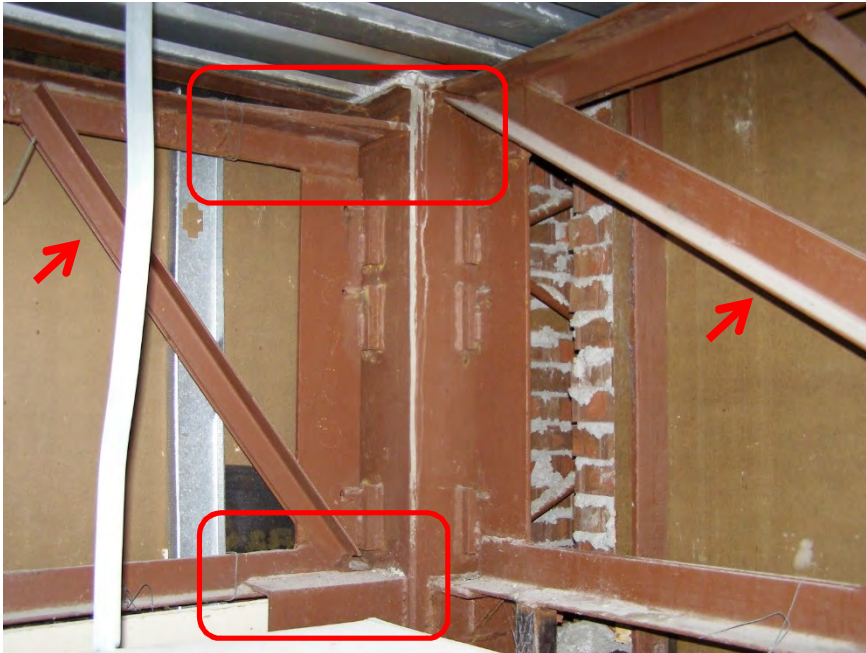
S61 - Typical joist/joist girder and column joint (joist girder highlighted by left arrow, joist highlighted by right arrow, lower box identifies typical bottom chord to column moment connection, upper box identifies typical top chord to column moment connection).

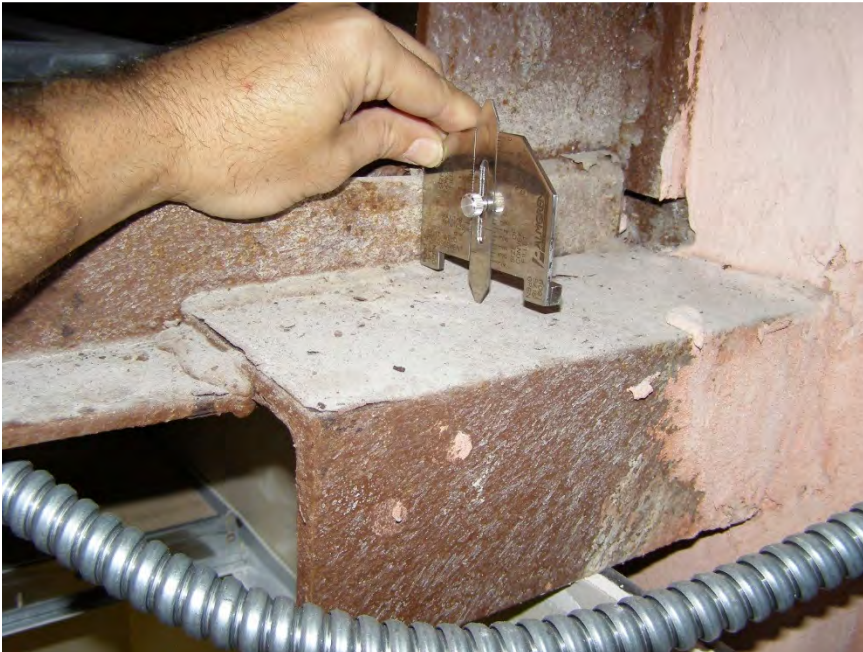
S62 - Close-up view of typical bottom chord-to-column moment connection consisting of angle welded to chord and column (photo also shows measurement of fillet weld)

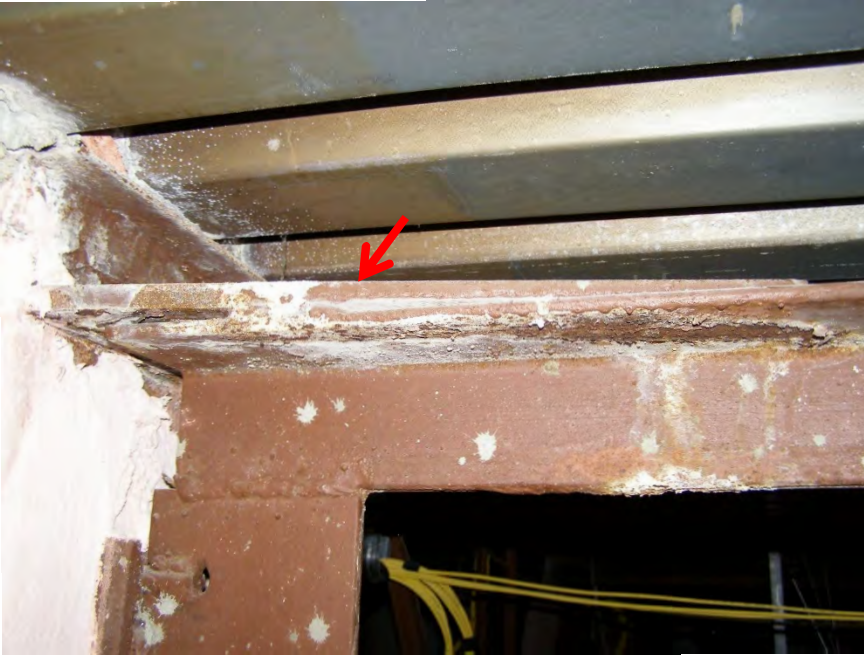
S63 - Close-up view of typical top chord-to-column moment connection consisting of angled plate (arrow) welded to chord and column

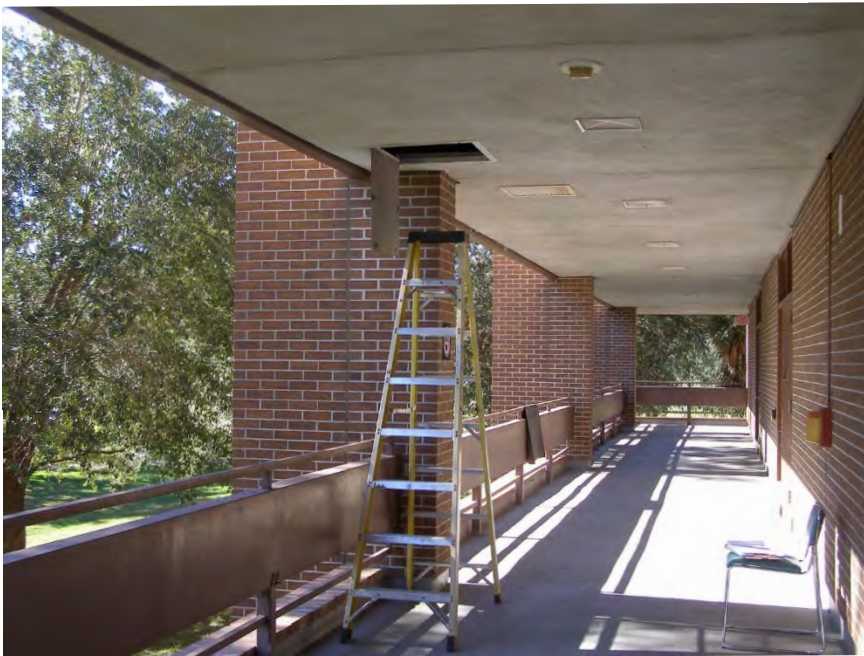
S64 - Soffit access panel used to access steel framing below exterior walkway on south side of Level 3

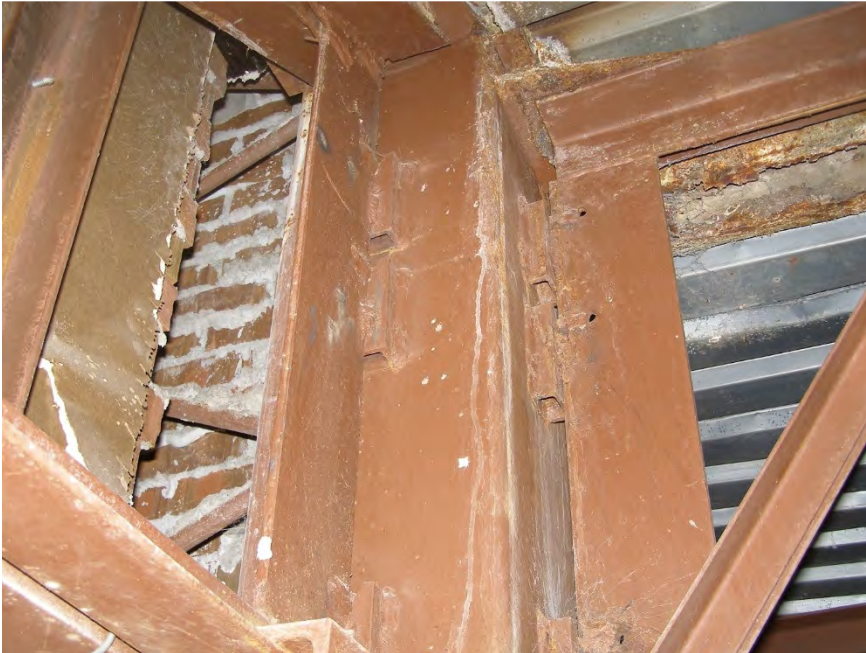
S65 - General view of area of long-term water intrusion at location shown in previous photo

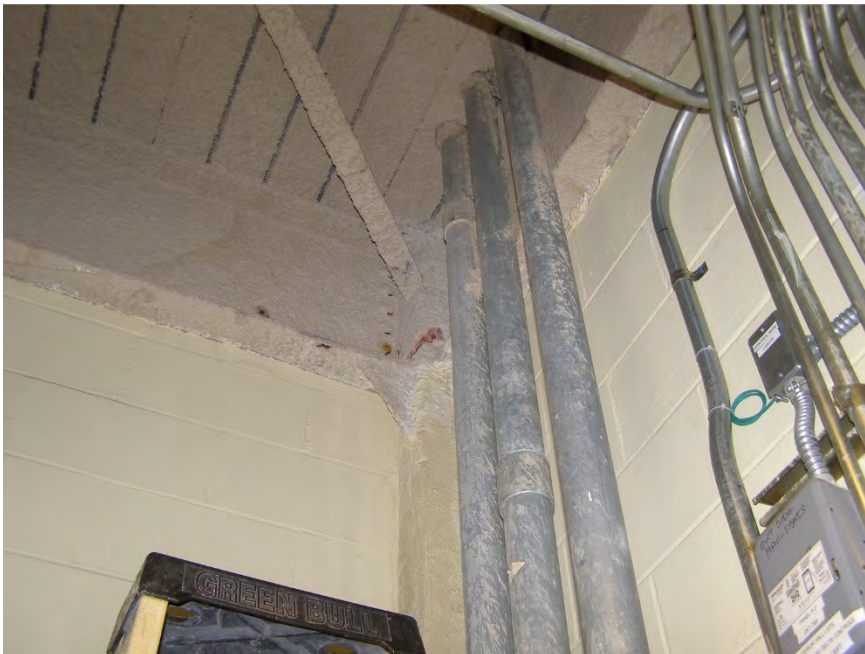
S70 - General view of framing at corner of mechanical room

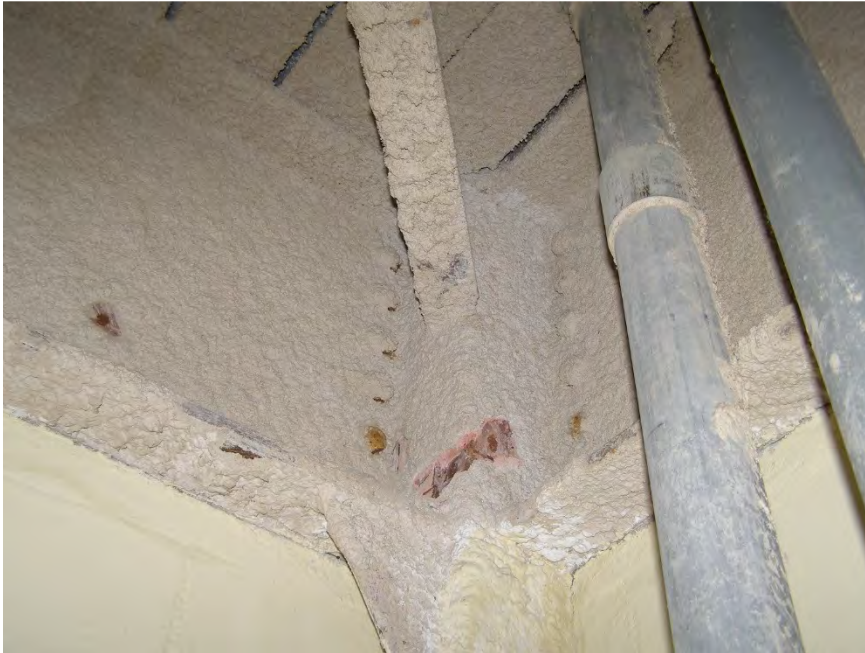
S71 - Closer view of beam-column joint shown in previous photo

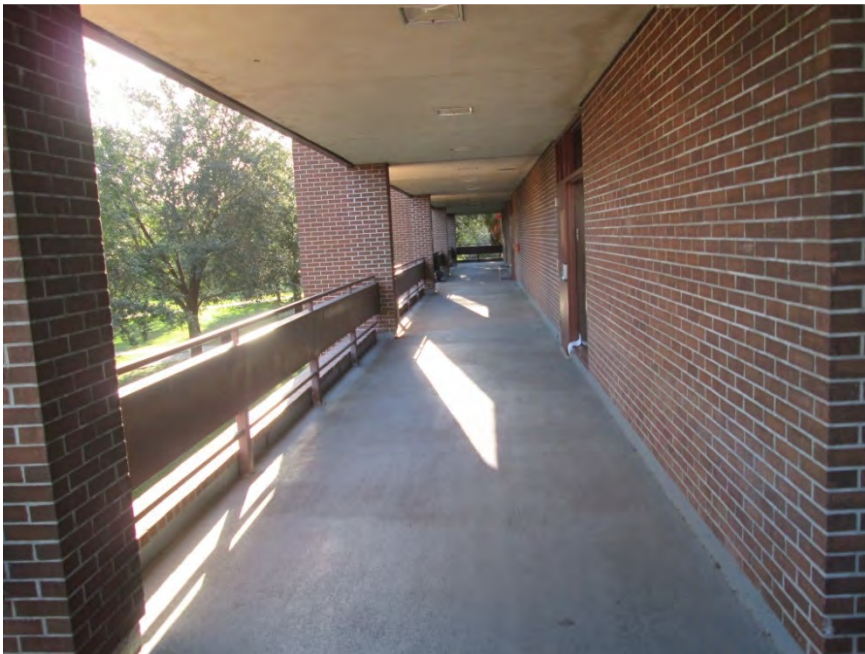
S72 - General view of inset wall at exterior corridor

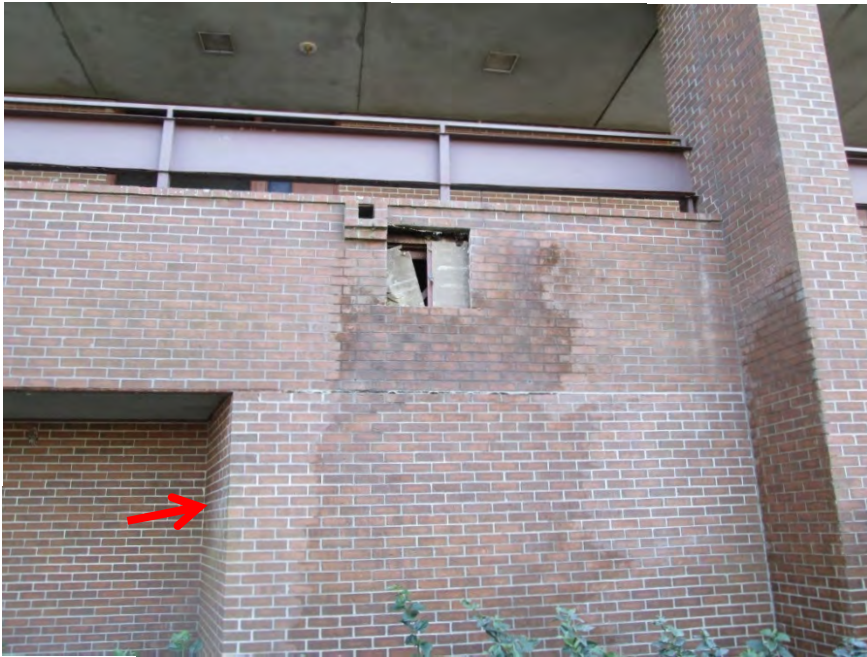
S73 - General view area of north elevation where observations of top of discontinuous CMU backup wall were made from façade exploratory opening (arrow highlights wall in following photo)

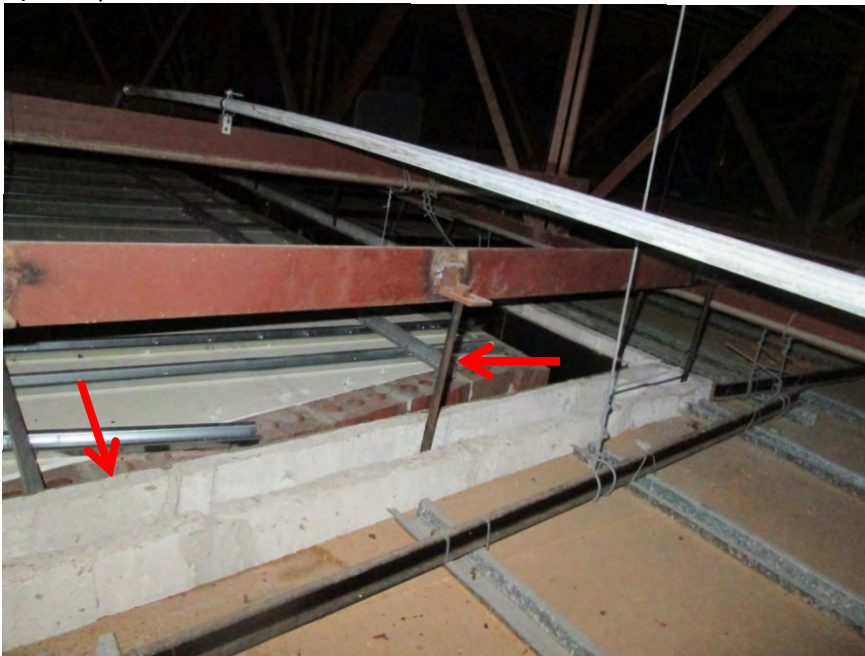
S74 - UngROUTED top course of CMU backup wall (left arrow), anchor rod hung from framing above highlighted by right arrow

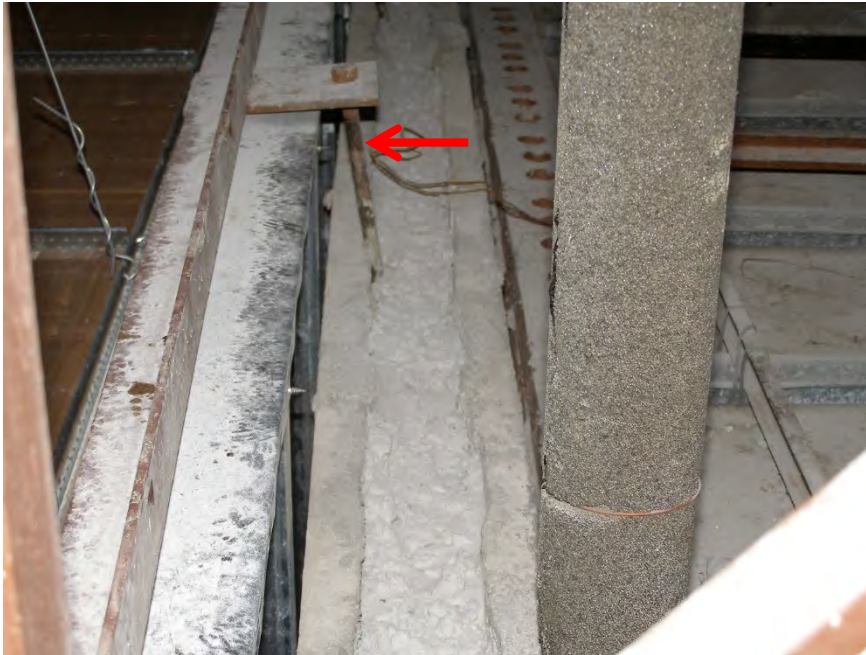
S75 - Top 6-inch CMU backup wall on south side of building below Level 2 exterior corridor (top course of masonry is grouted, anchor rod hung from joist above is embedded in wall)

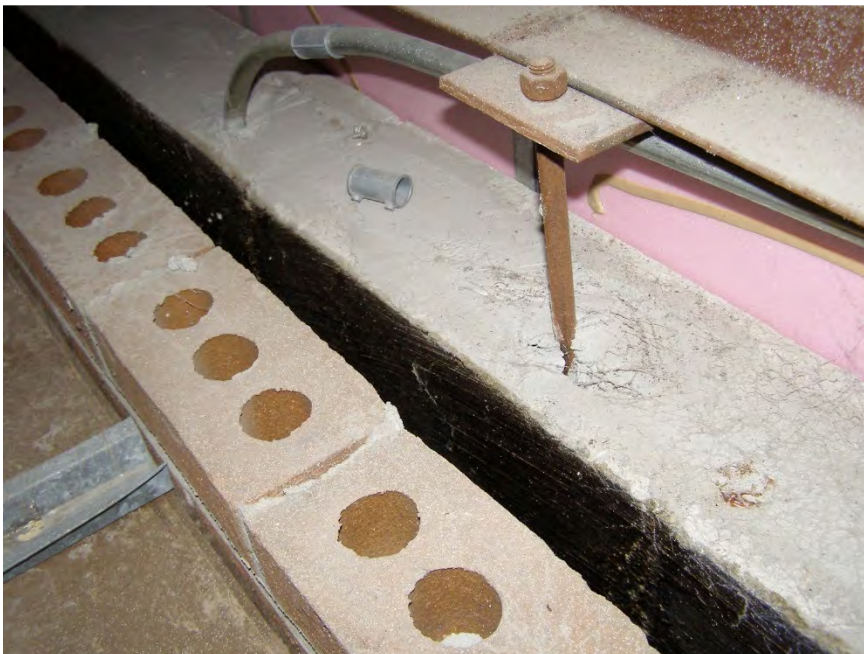
S76 - Top of inset wall at Level 3 on south side of building (top course of 6-inch CMU backup wall is grouted, photo shows anchor rod connected to bottom chord of joist and embedded in wall)

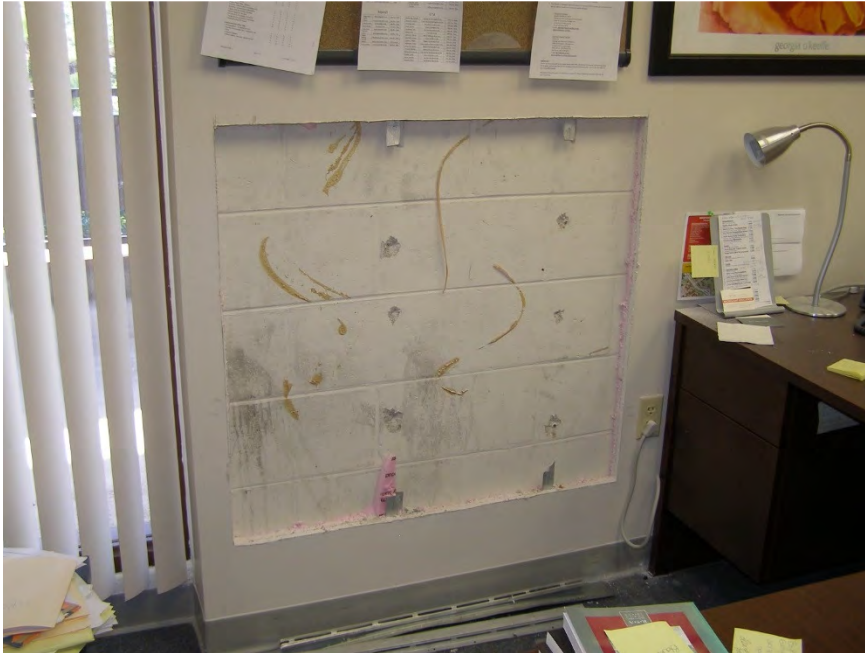
S77 - Typical opening in gypsum wallboard at interior face of setback exterior wall where GPR scanning was performed to check for the presence of vertical reinforcing steel

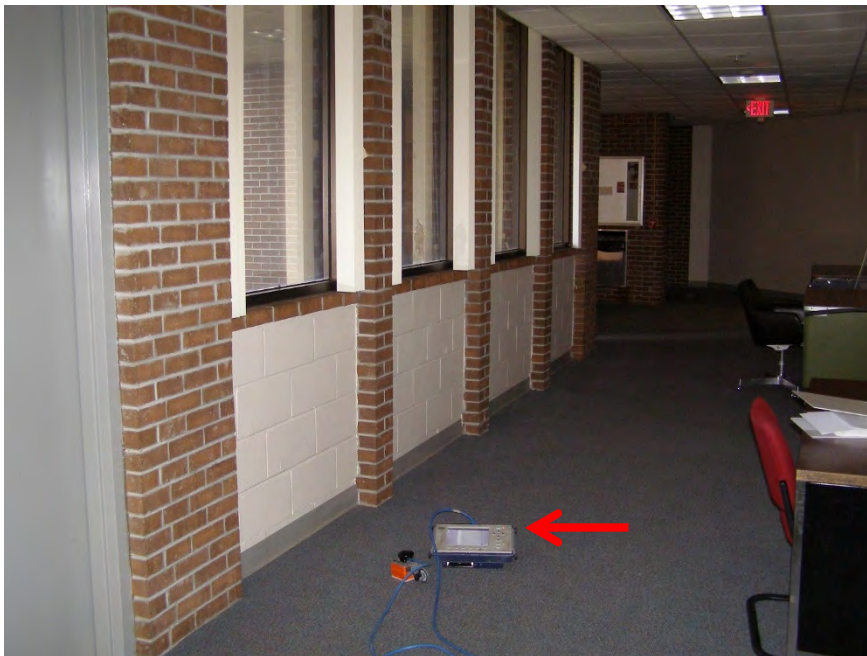
S78 - Exposed CMU backup wall at west end of Level 4 (arrow highlights GPR equipment)

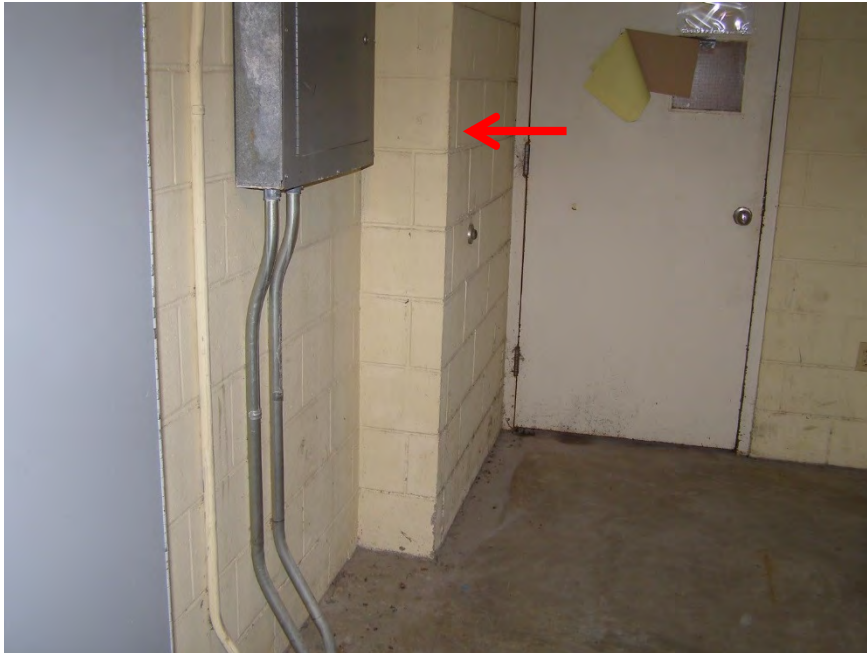
S79 - General view of exposed CMU backup wall inside mechanical room on Level 2 (arrow highlights location of following photo)

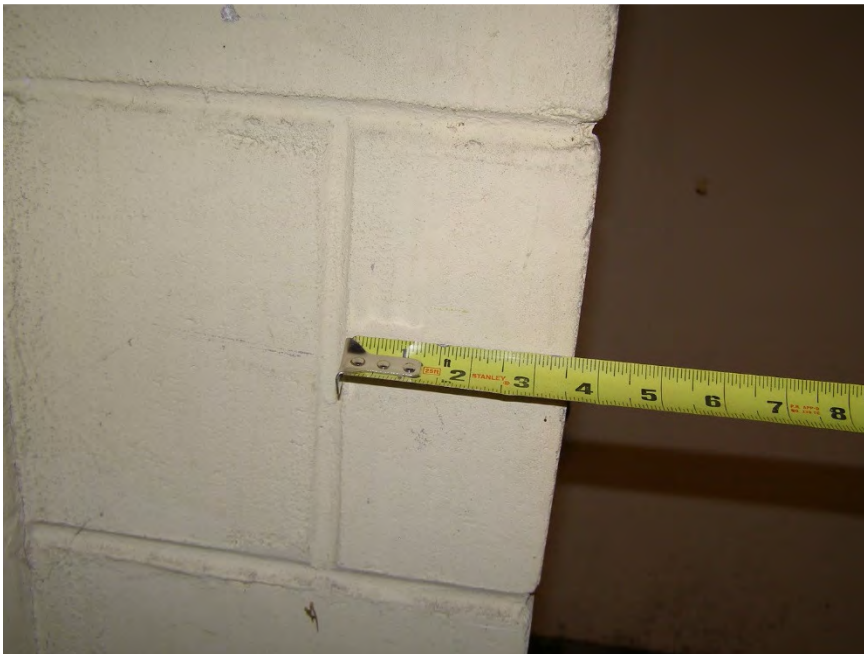
S80 - Tape measure shows width of nominal 4-inch CMU backup wall inside mechanical room

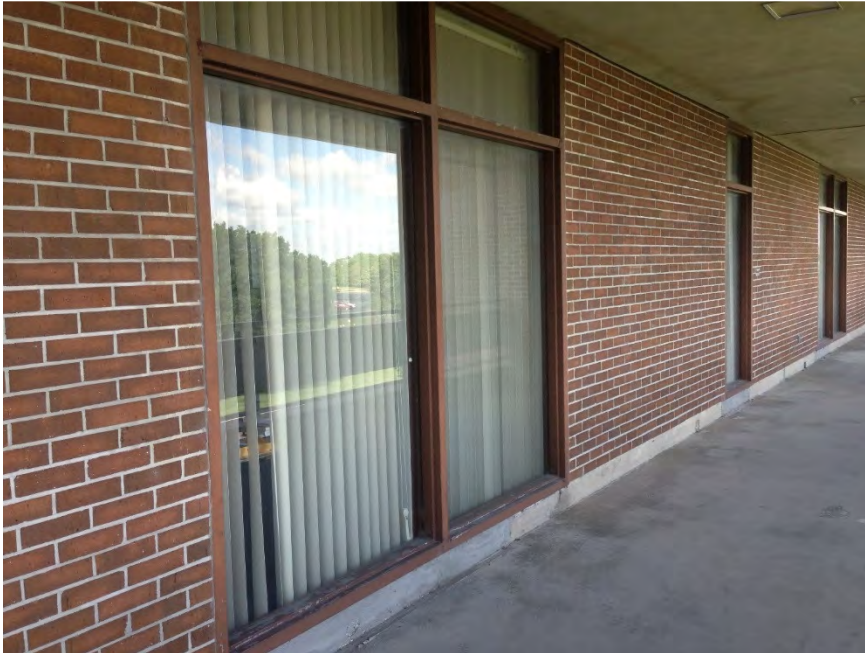
S81 - Typical windows in inset wall at exterior corridor

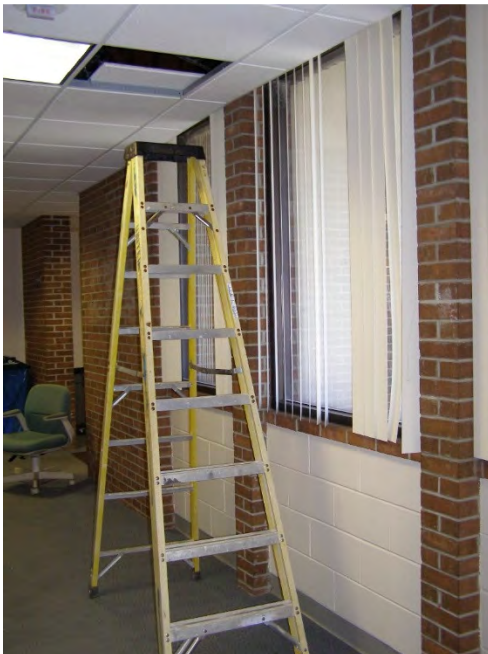
S82 - General view of area above ceiling at east end of Level 4 where window head support was reviewed

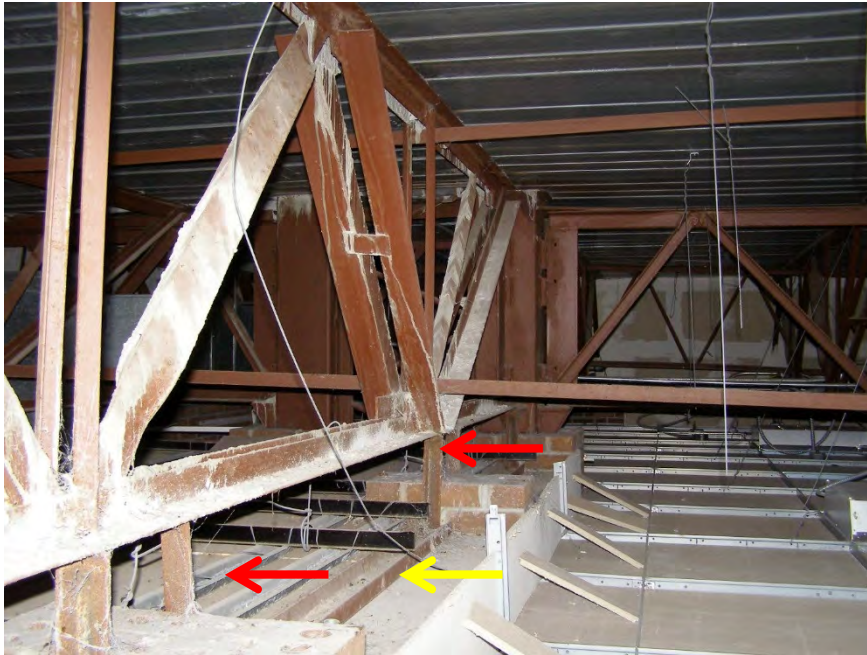
S83 - General view looking along top of wall shown in previous photo (red arrows highlight vertical angles hung from bottom chord of joist and welded to steel channel (yellow arrow) at top of window below)

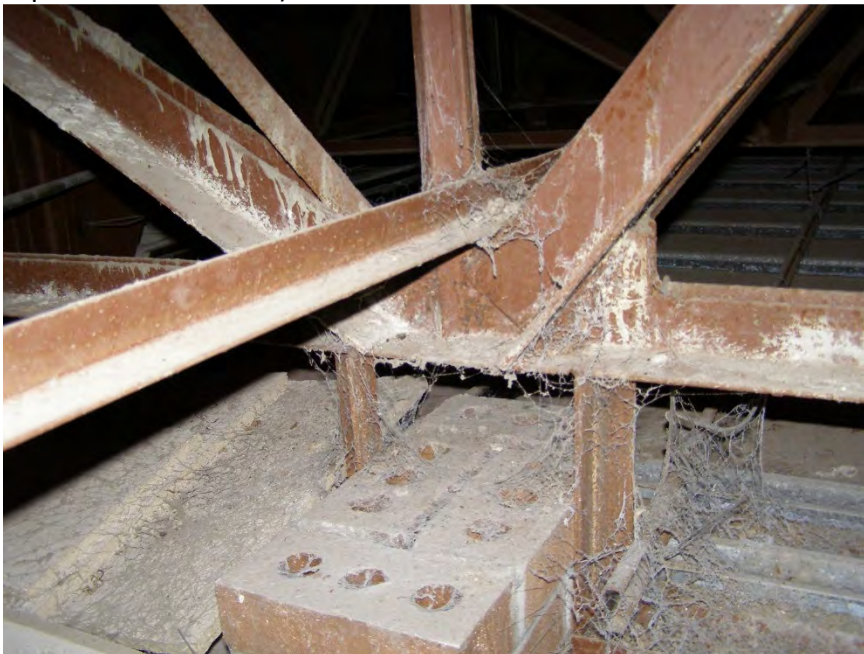
S84 - Top of discontinuous ungrouted, unreinforced brick pilaster at location shown in previous photo

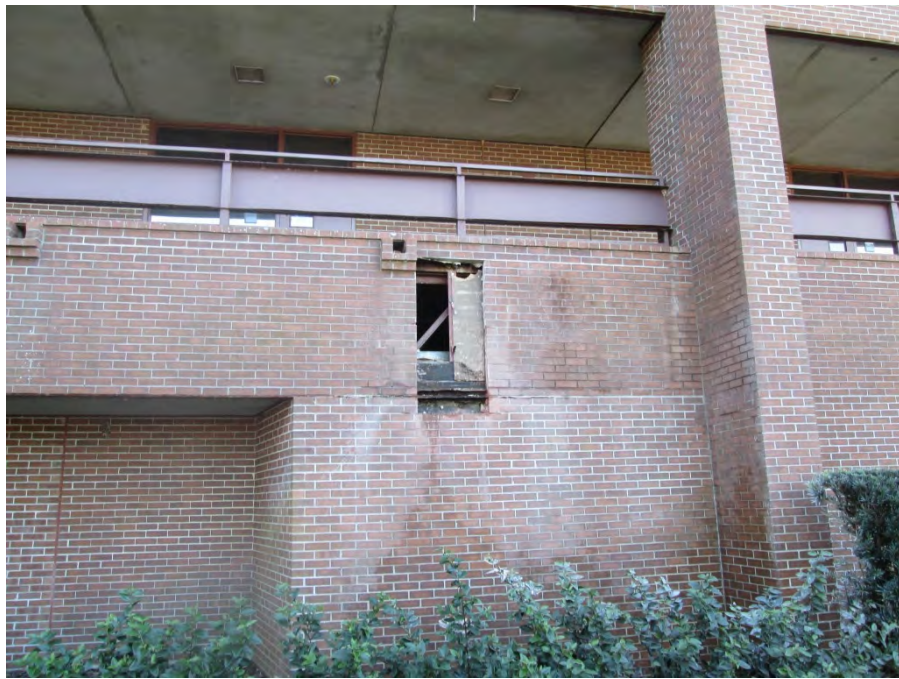
Overview of Exploratory Opening 01

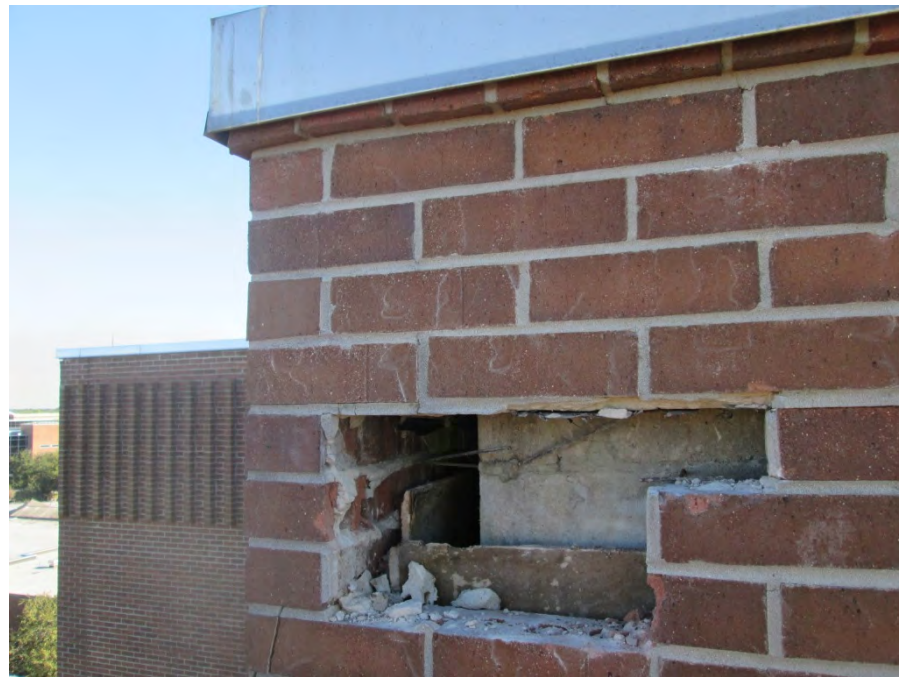
Overview of Exploratory Opening 02
