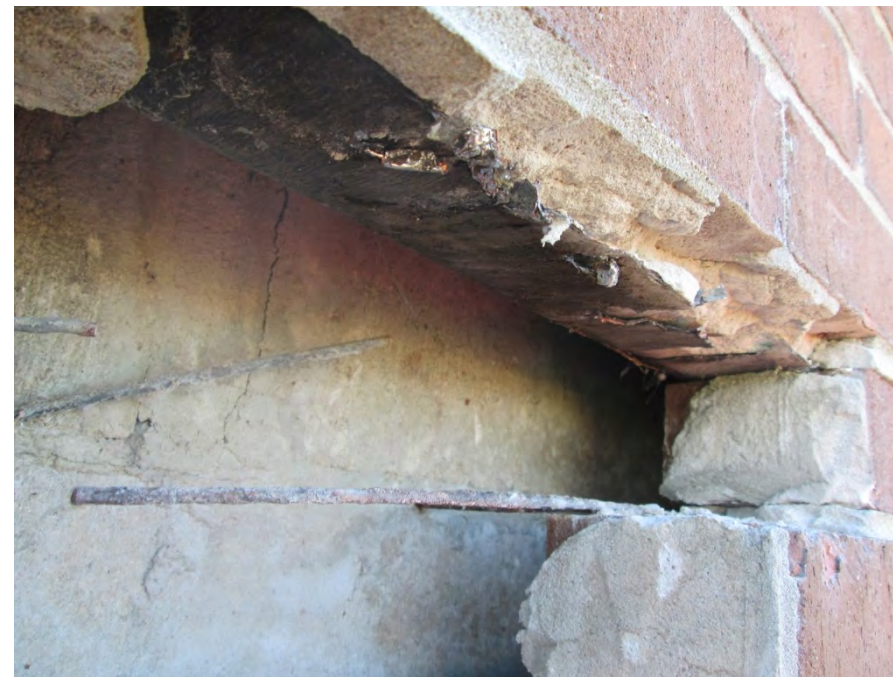
Through-wall fabric flashings act as bond-breaker for mortar joint

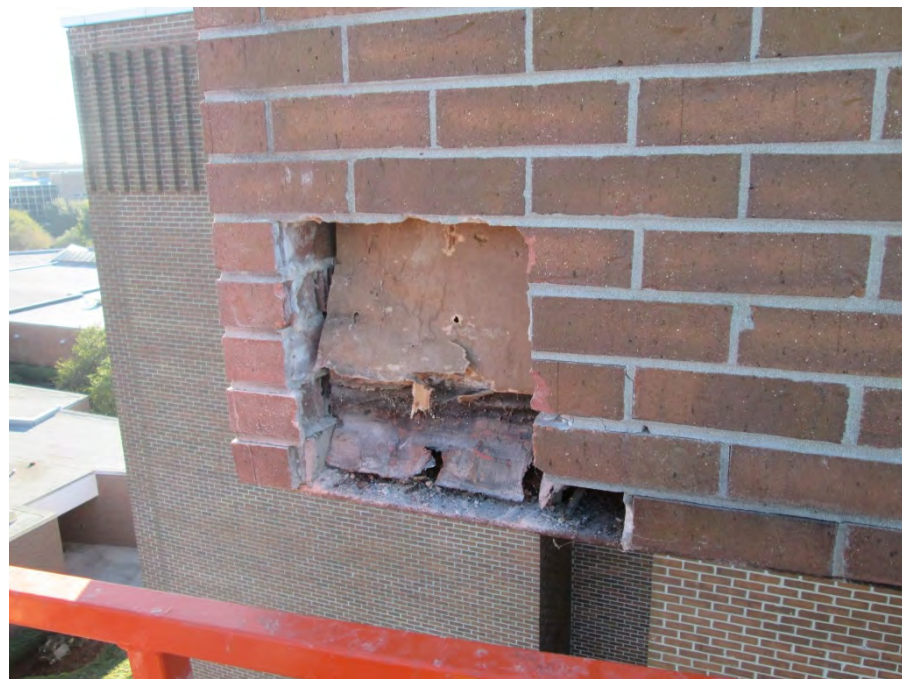
Overview of Exploratory Opening 03

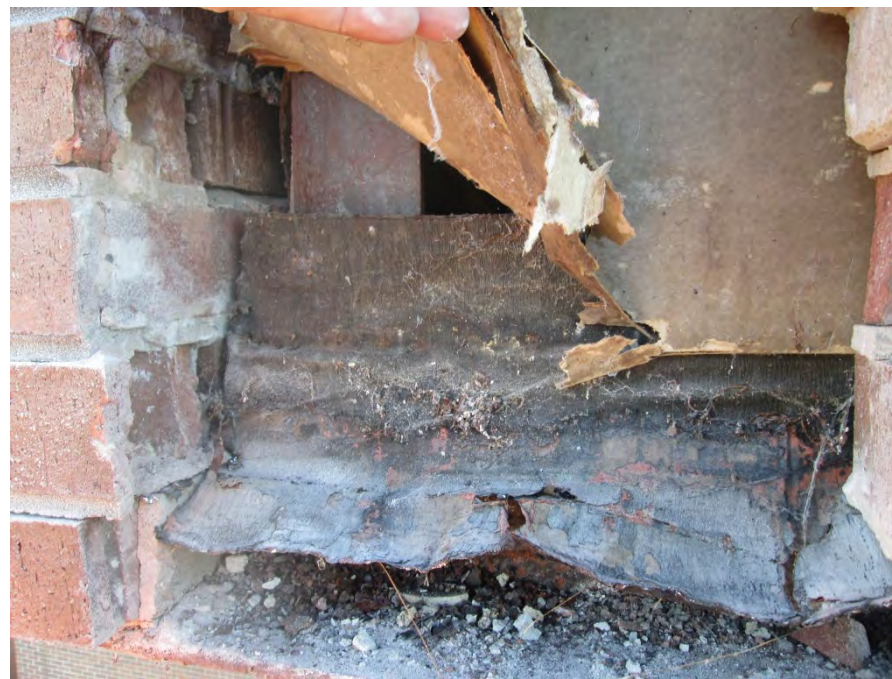
Discontinuous flashing of cavity wall waterproofing

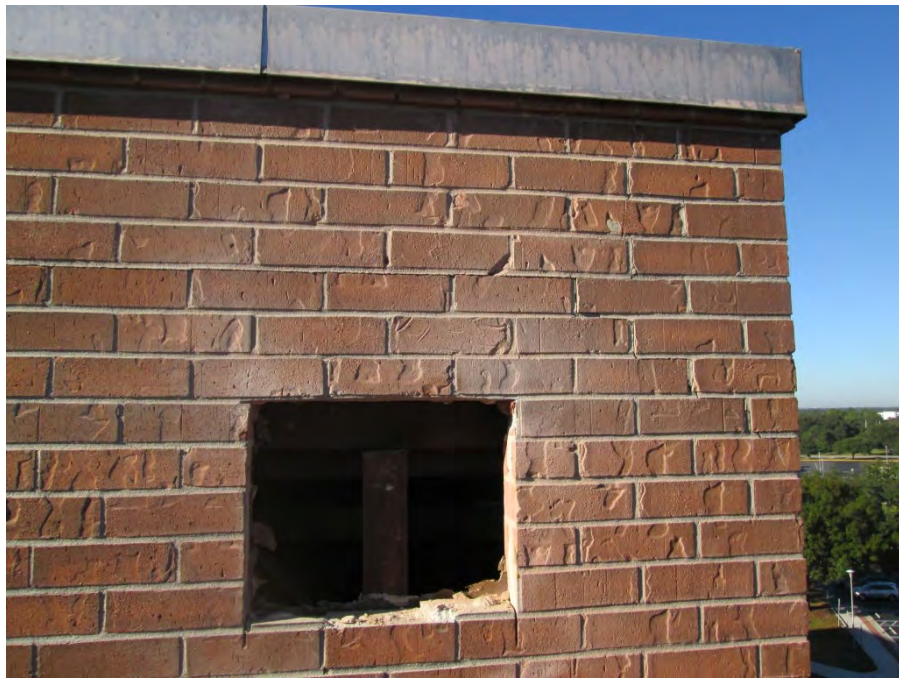
Overview of Exploratory Opening 04

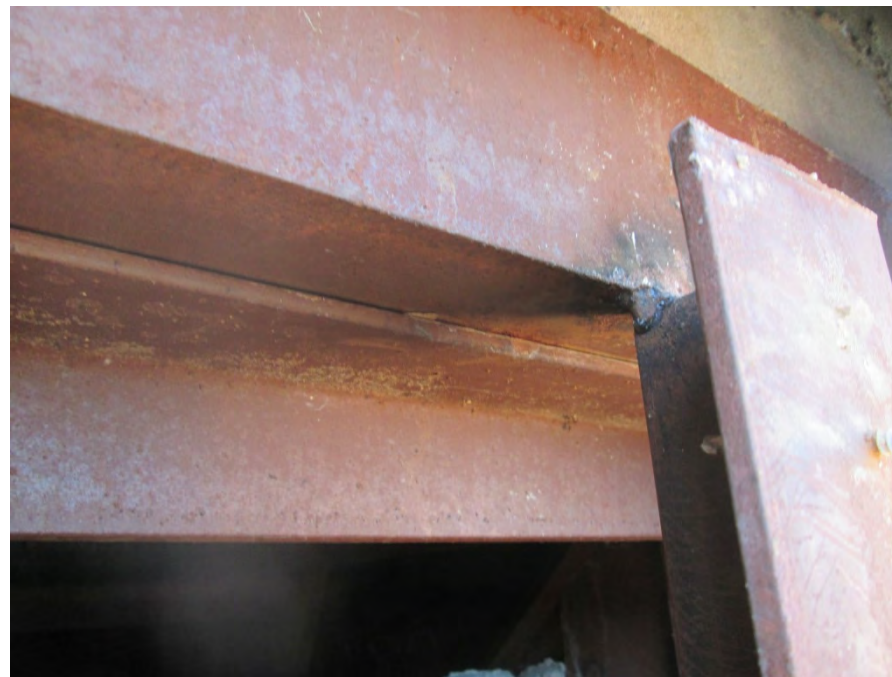
Tack welding of vertical angle support to metal deck closure angle

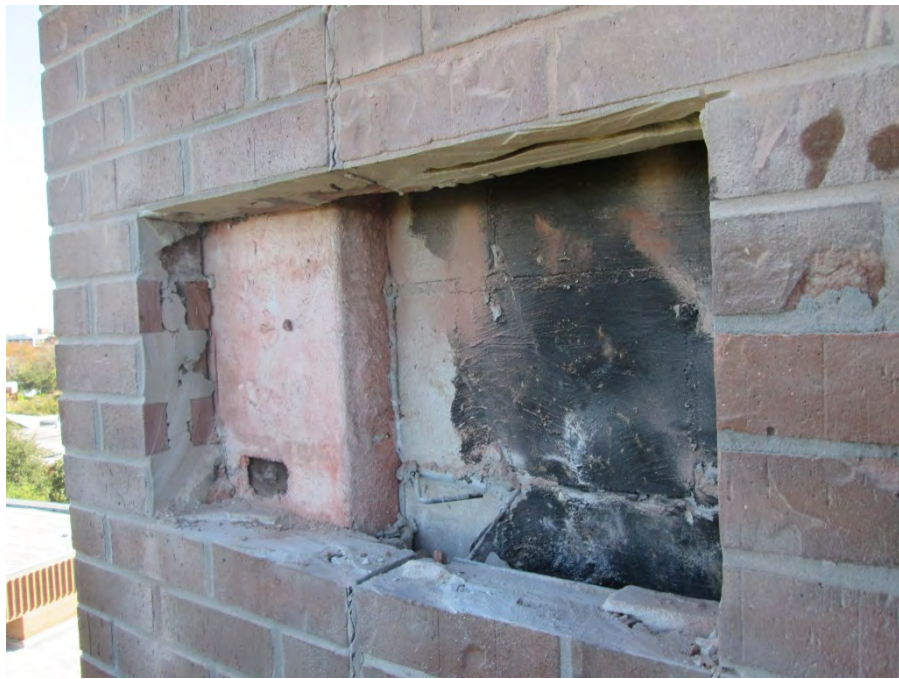
Overview of Exploratory Opening 05

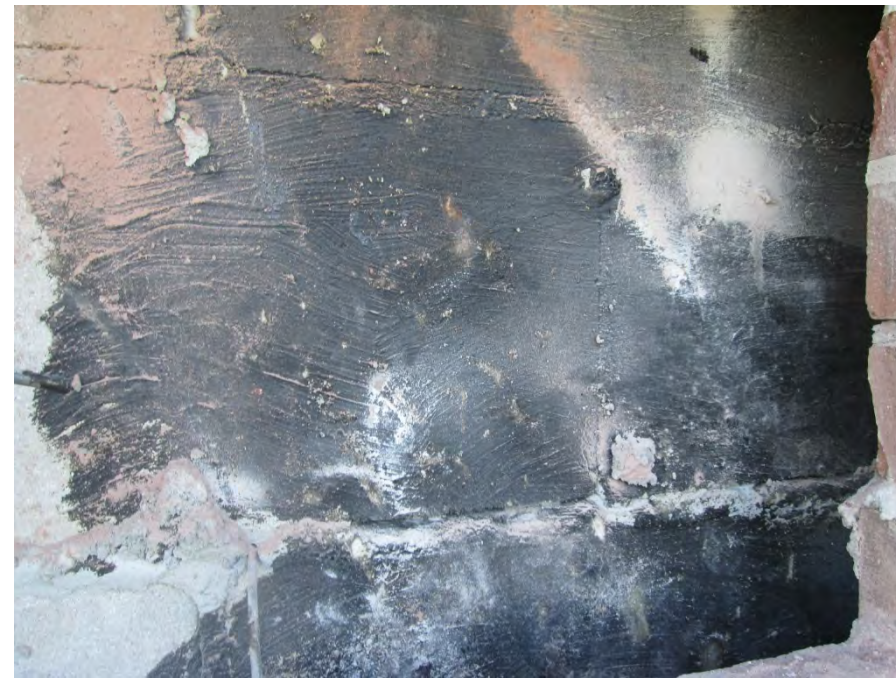
Fluid applied asphaltic waterproofing  
on CMU backup wall

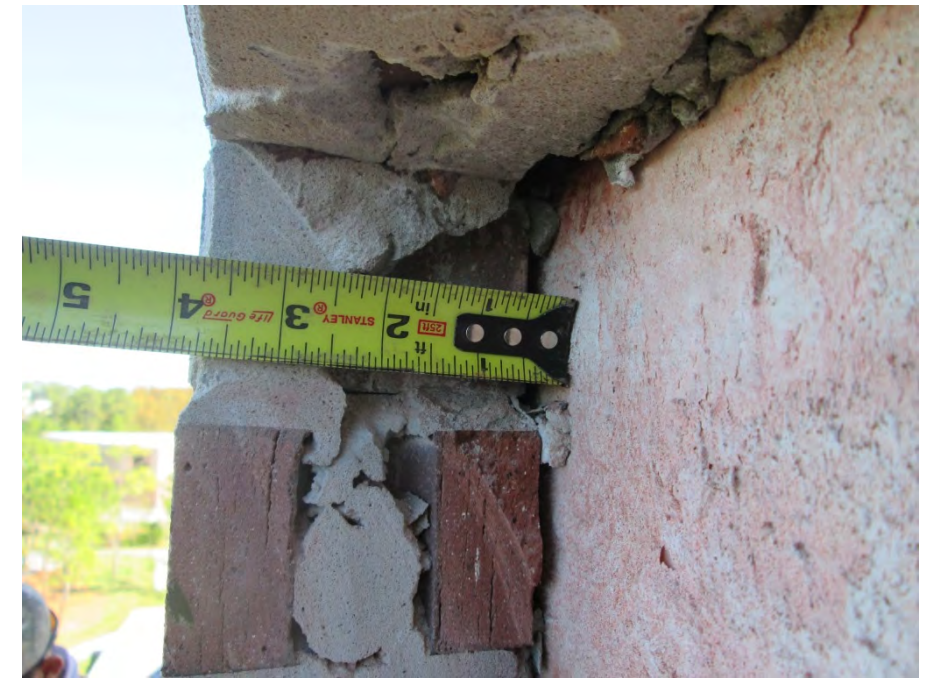
Cavity depth a steel tube column  
measured as 1/2-inch

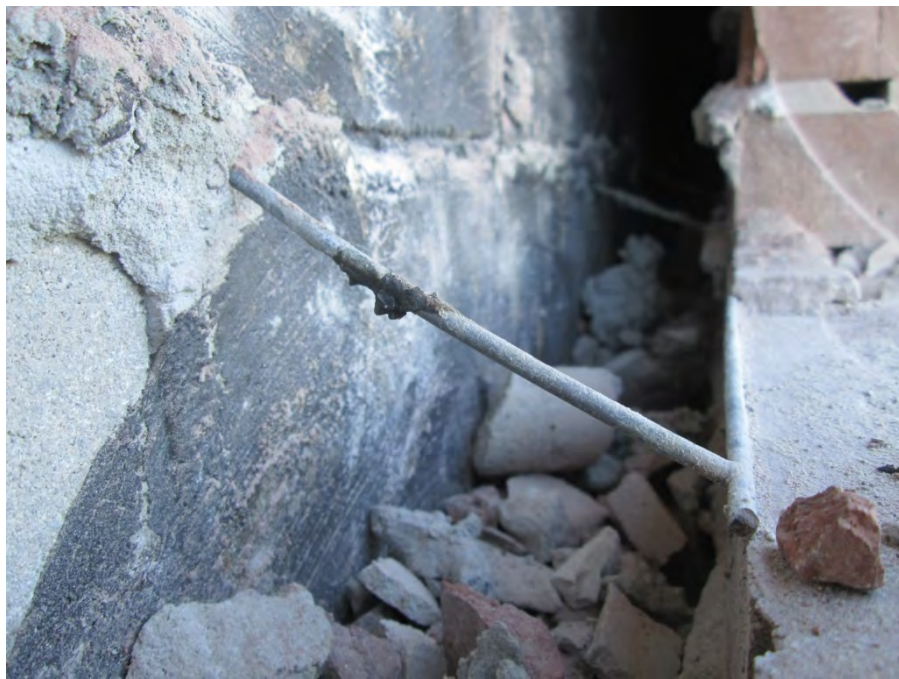
Ladder reinforcement tie not adequately  
embedded in brick masonry bed joint

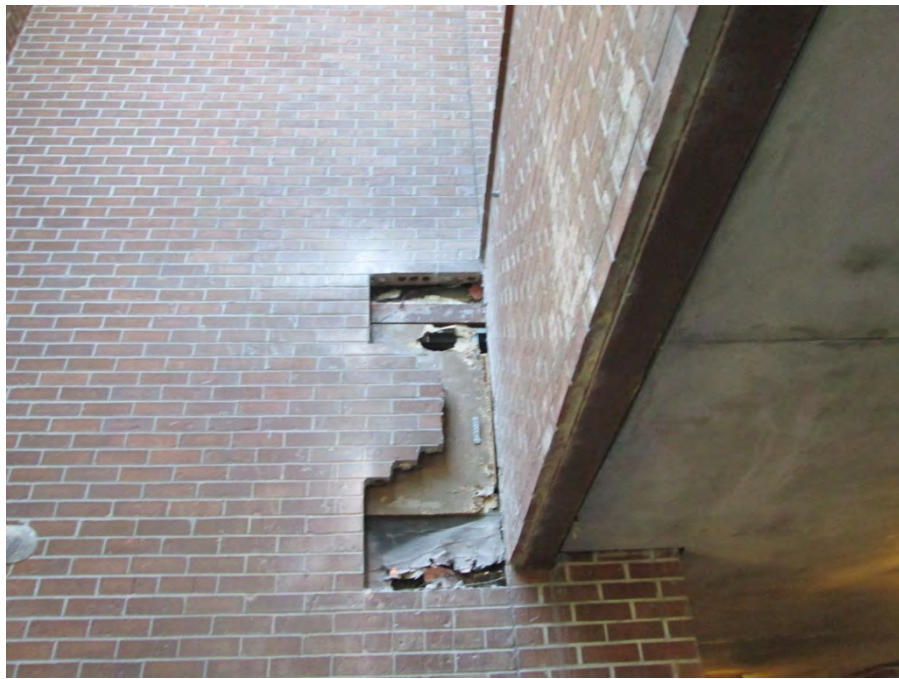
Overview of Exploratory Opening 06

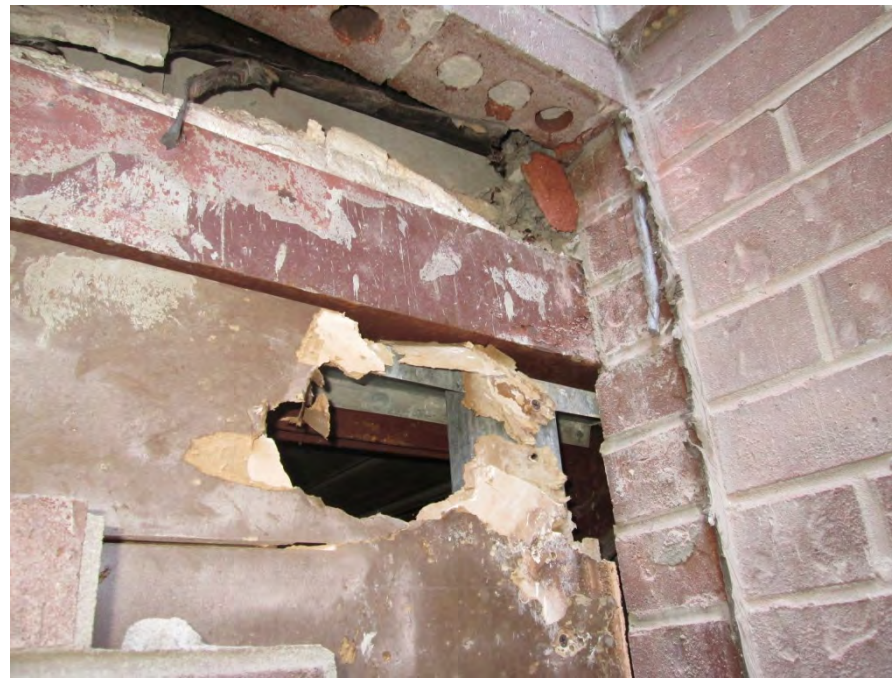
Metal stud with gypsum sheathing backup

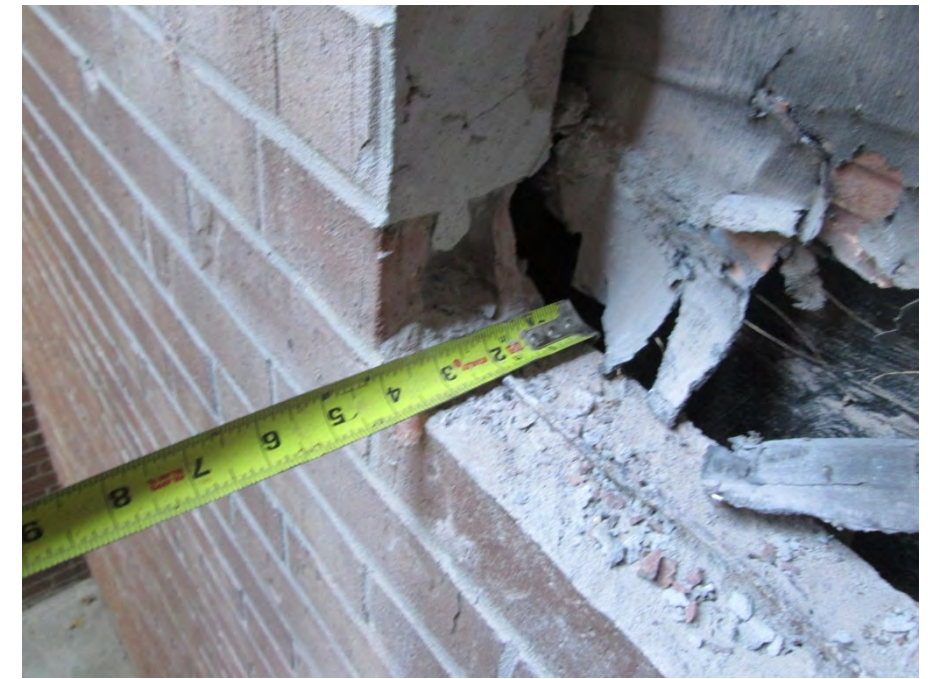
Ladder reinforcement embedded in brick masonry bed joint

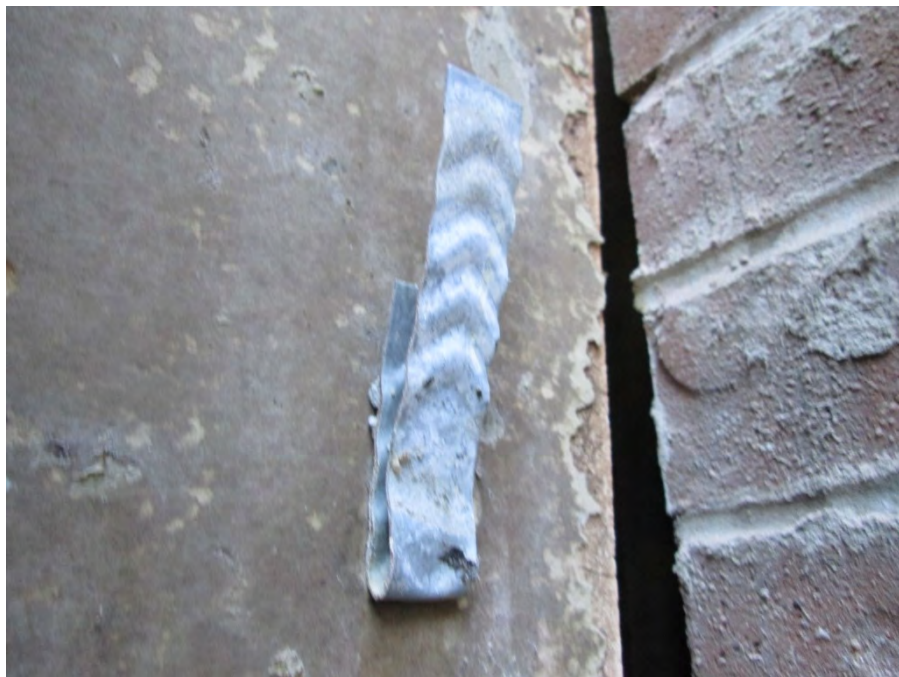
Corrugated metal tie not installed in brick masonry bed joint during original construction

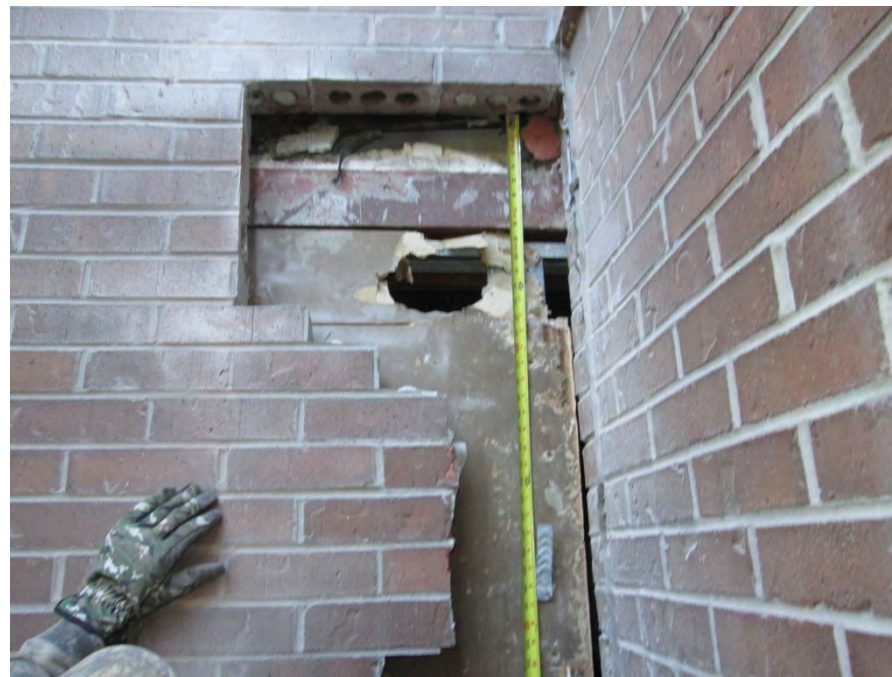
Vertical tie spacing measured at approximately 29-inches on center

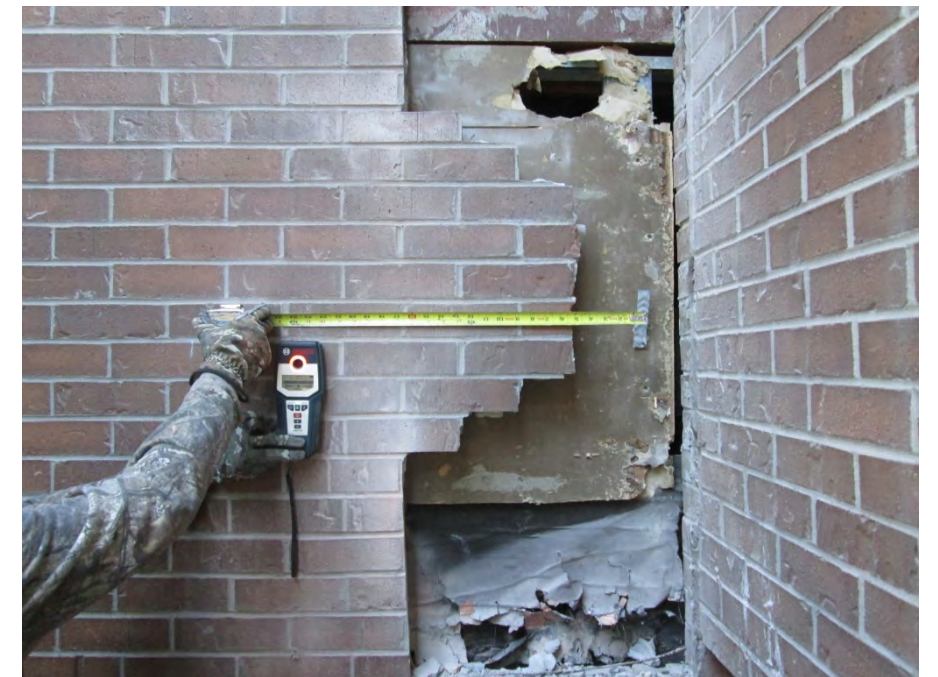
Horizontal tie spacing measured at approximately 24-inches on center

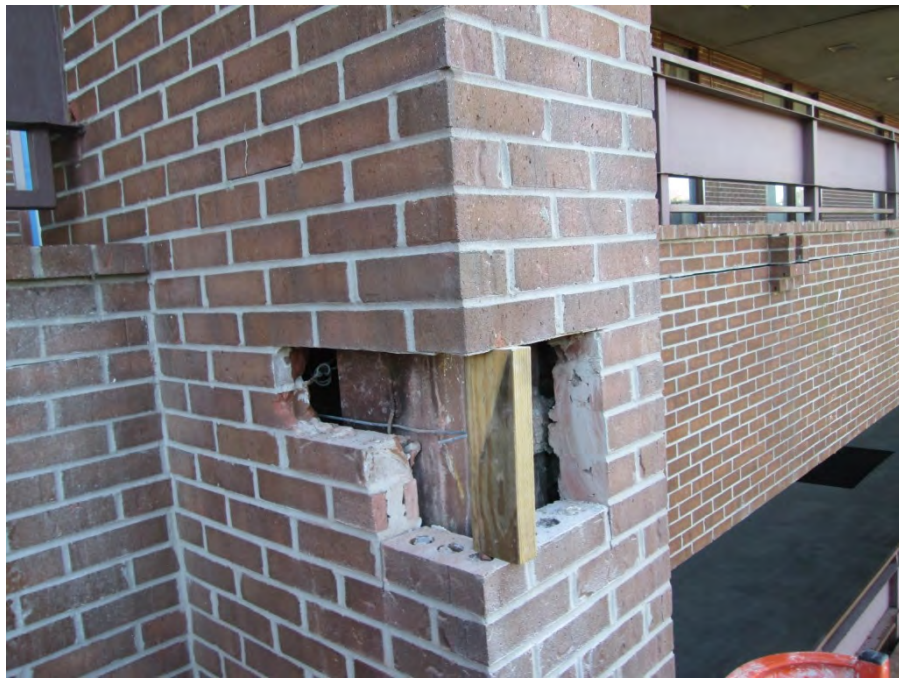
Overview of Exploratory Opening 07

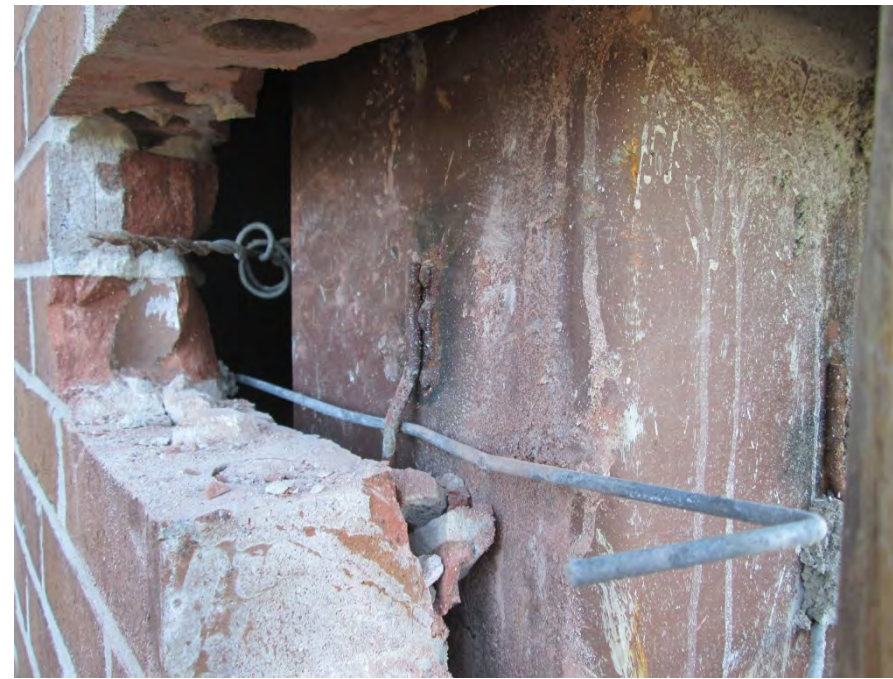
Wire tie attached to welded wire loops on steel tube column

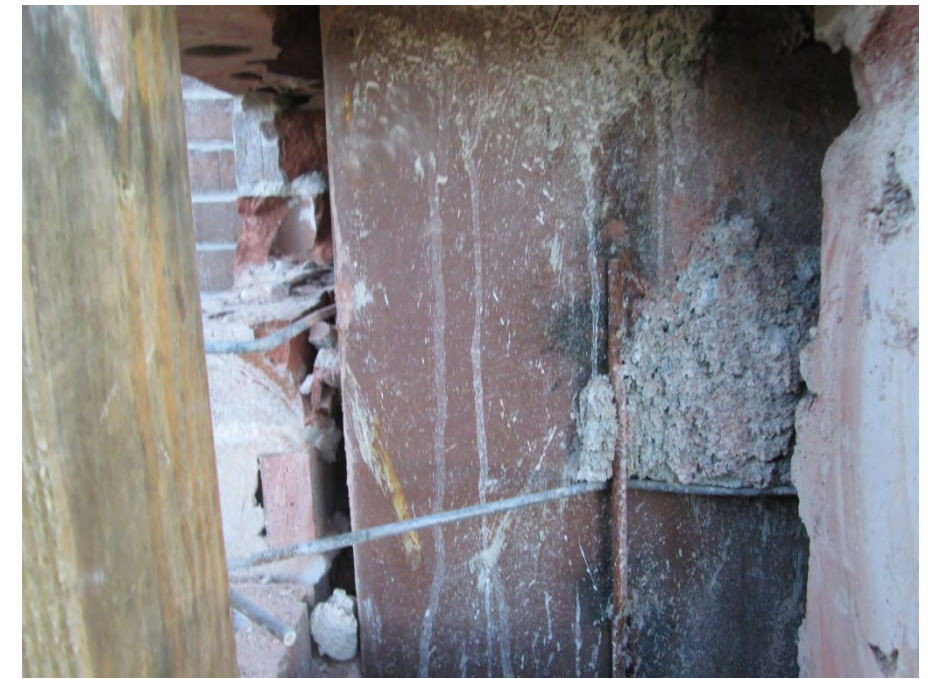
Wire tie attached to welded wire loops on steel tube column

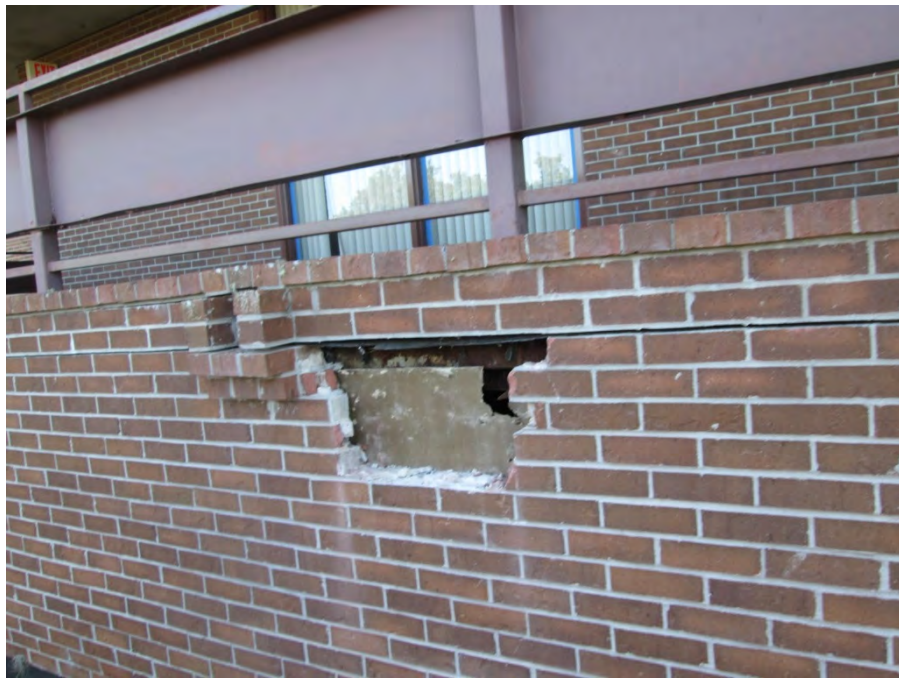
Overview of Exploratory Opening 08

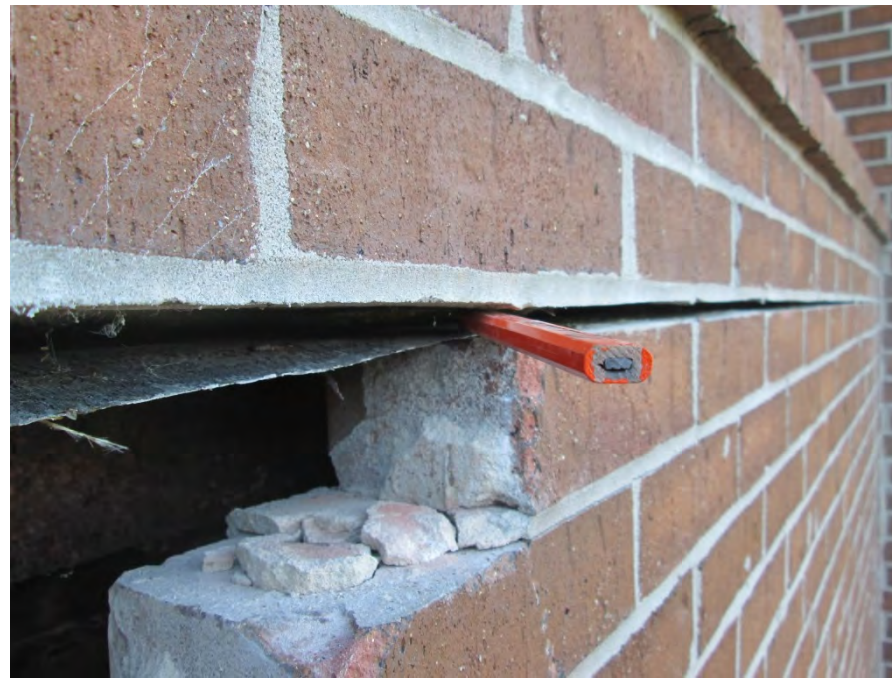
Deflected brick and separated mortar (through wall fabric flashing acts as bond breaker in masonry bed joint)

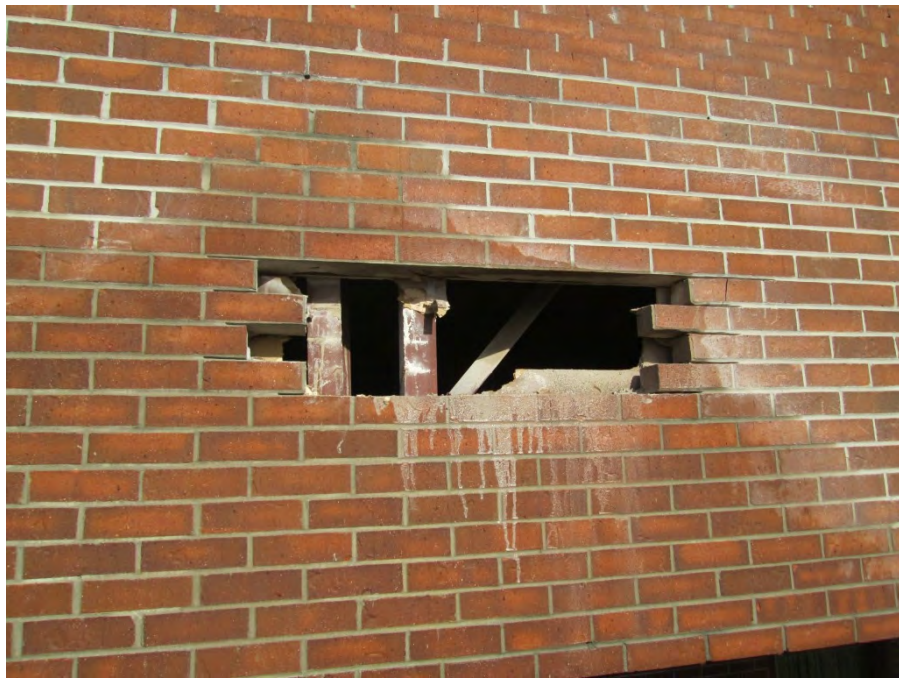
Overview of Exploratory Opening 09

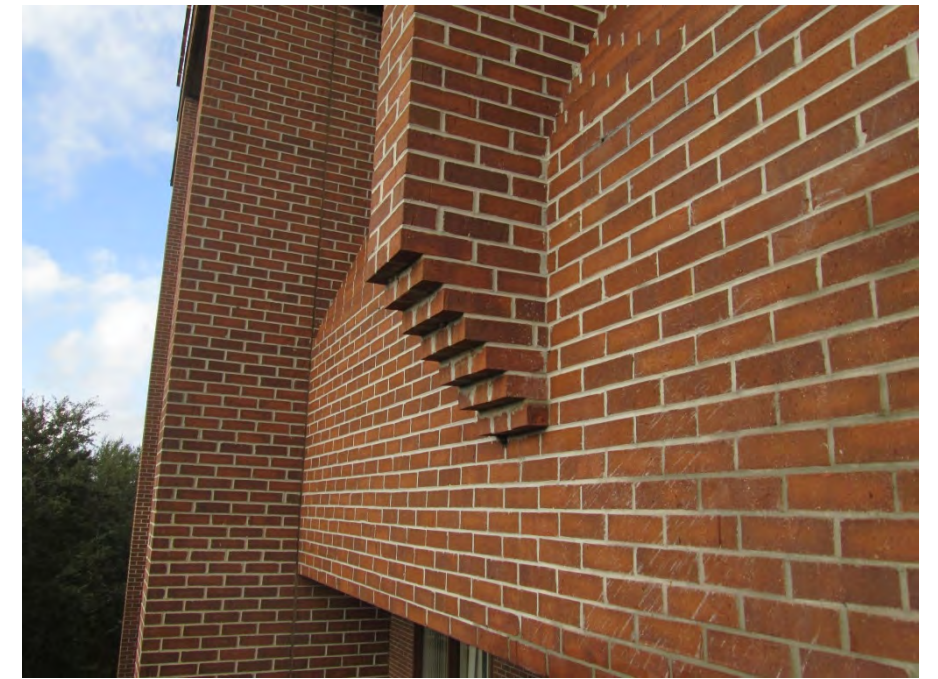
Corbelled brick façade at Level 4

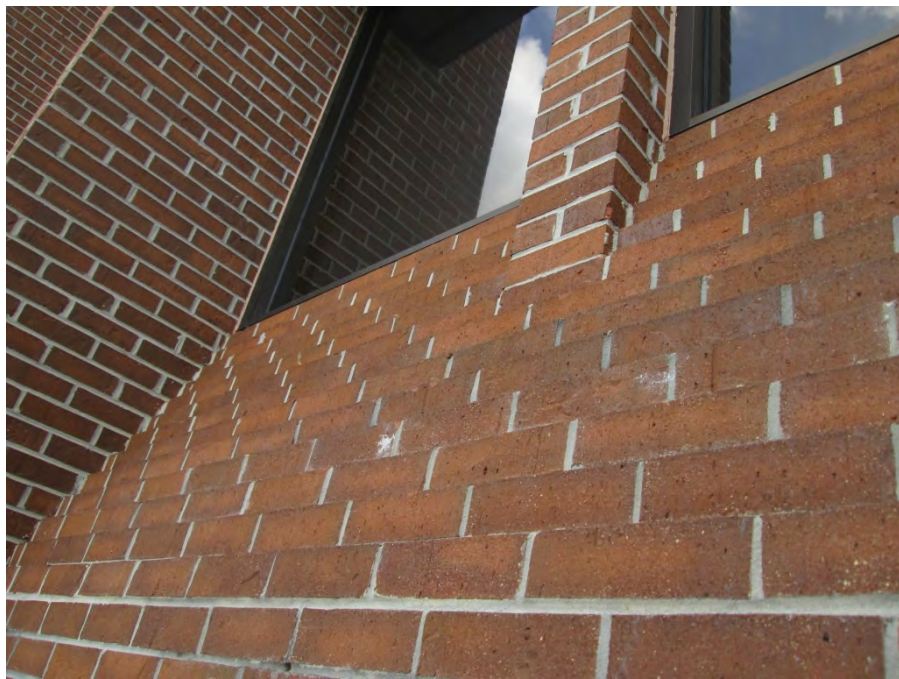
Corbelled brick façade at Level 4

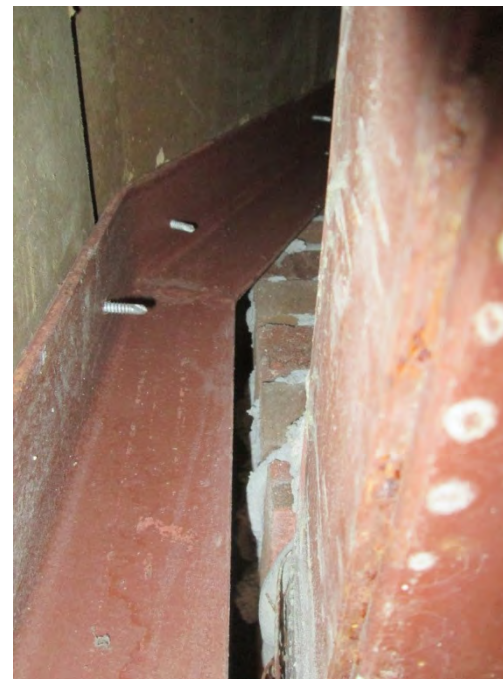
Bent steel angle backup for corbelled brick façade (view looking up towards start of corbelled wall section)

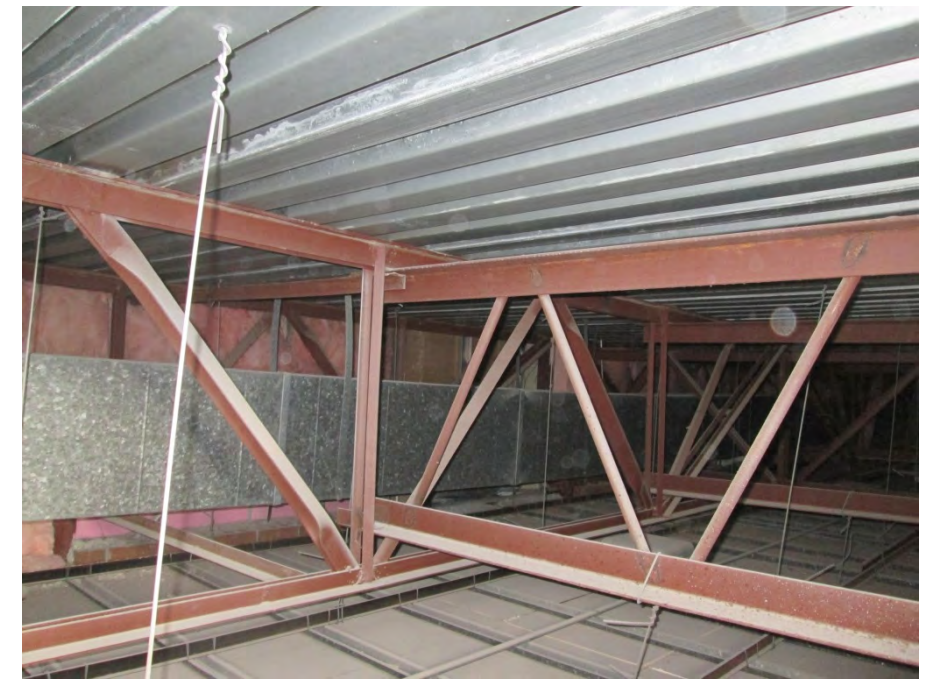
Interior structural framing noted to be in generally fair condition

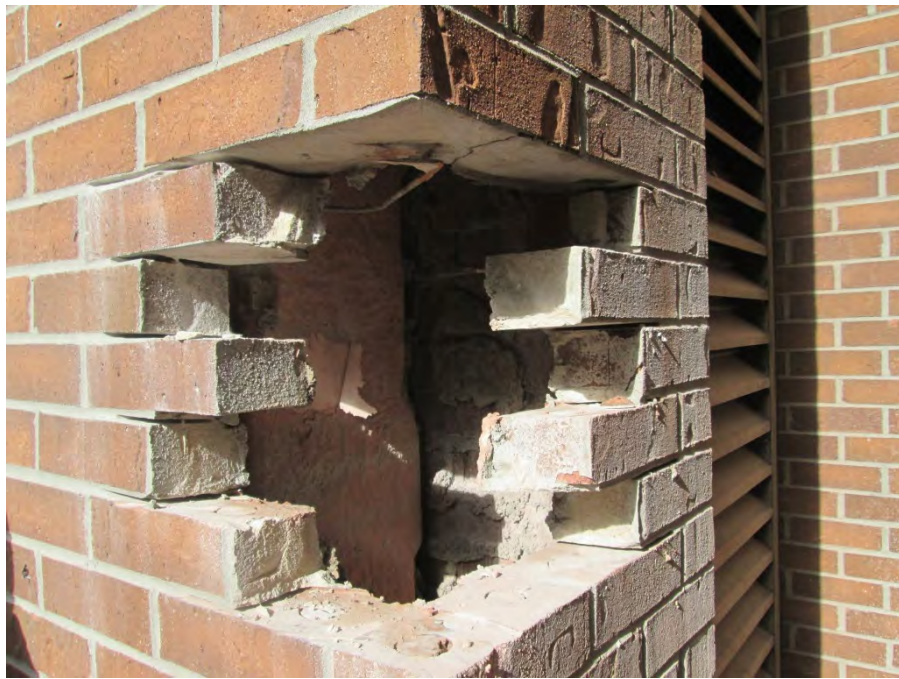
Overview of Exploratory Opening 10

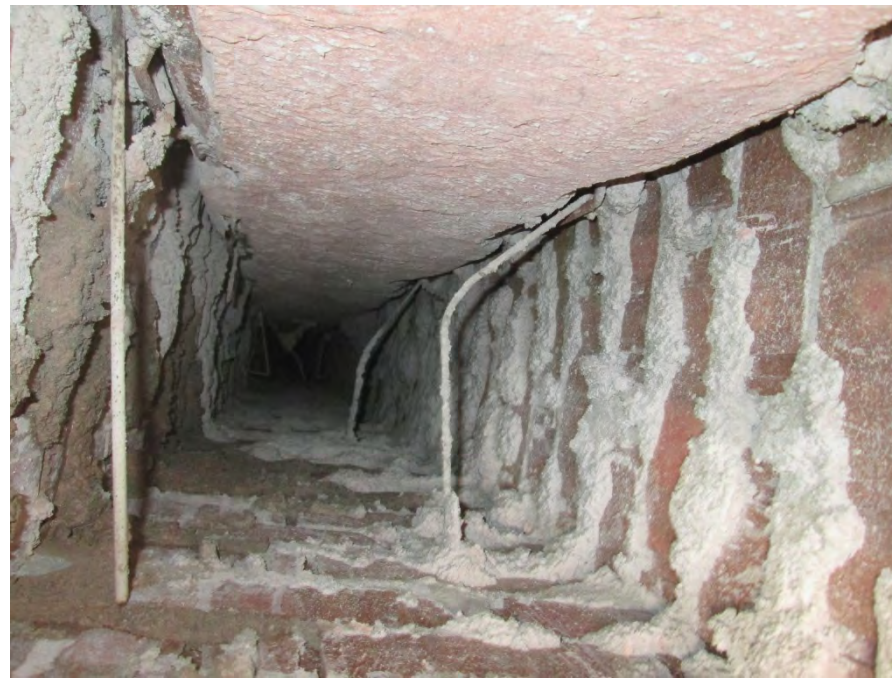
Wire ties for lateral attachment of brick cladding

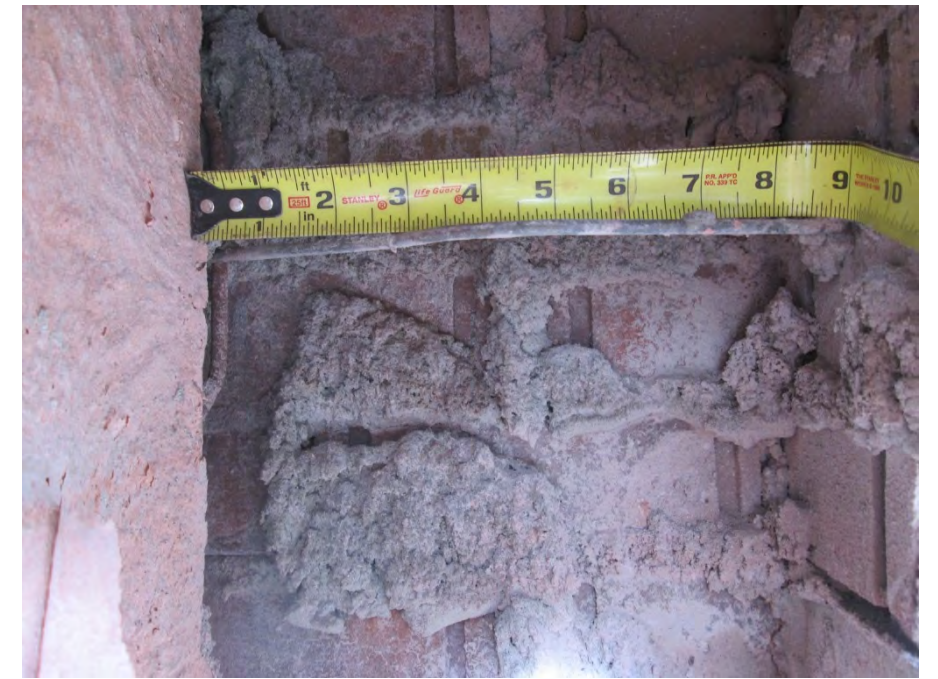
Wall cavity depth measured as 9-inches on west elevation of opening

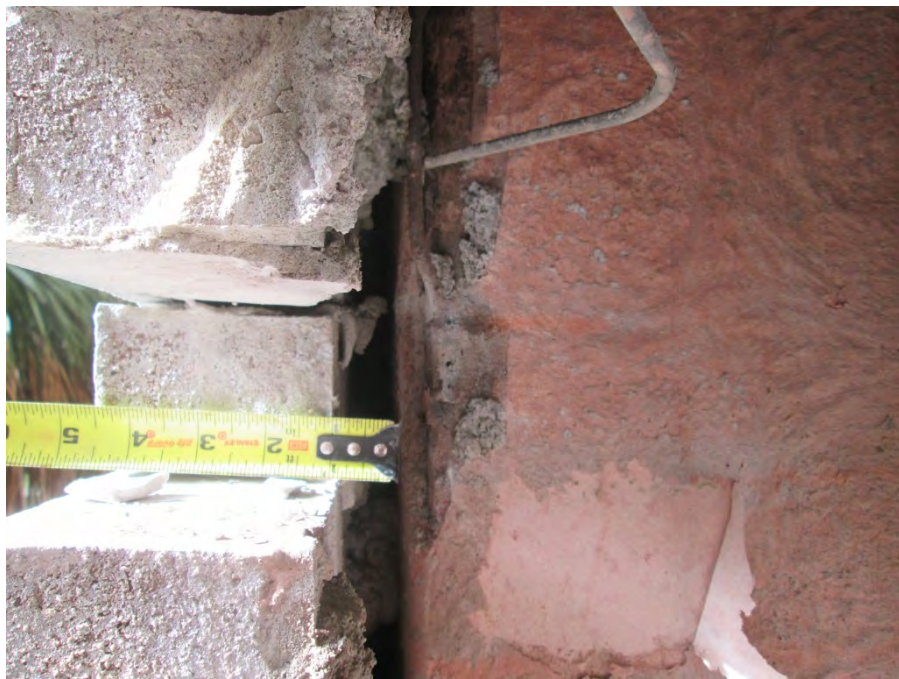
Wall cavity depth measured as 1-inch on south elevation of opening

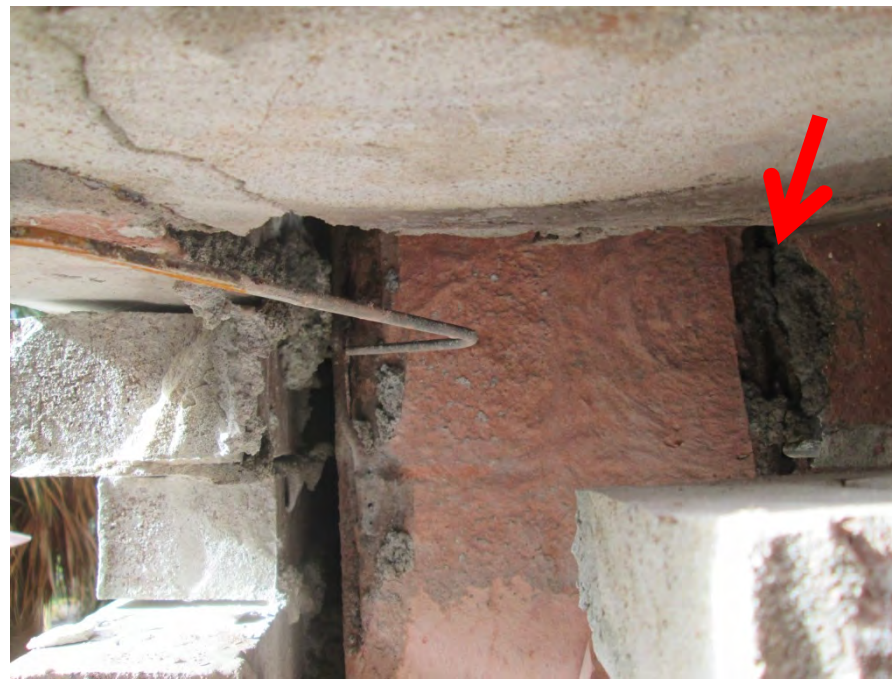
Mortar droppings at north elevation of opening inhibit cavity wall drainage

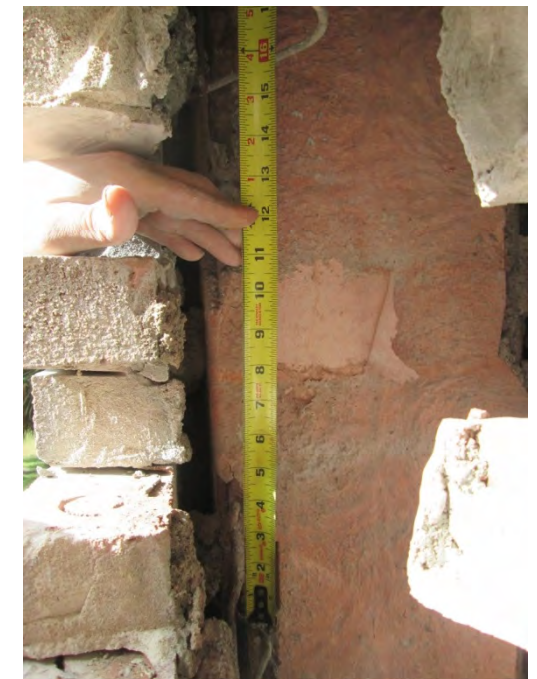
Vertical wire tie spacing measured as approximately 16-inches on center

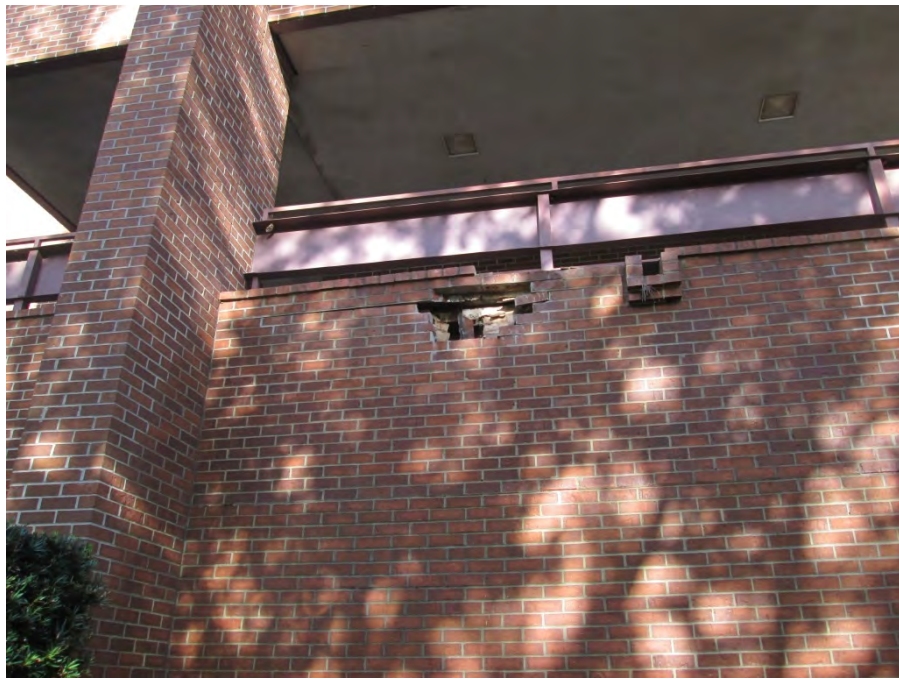
Overview of Exploratory Opening 11

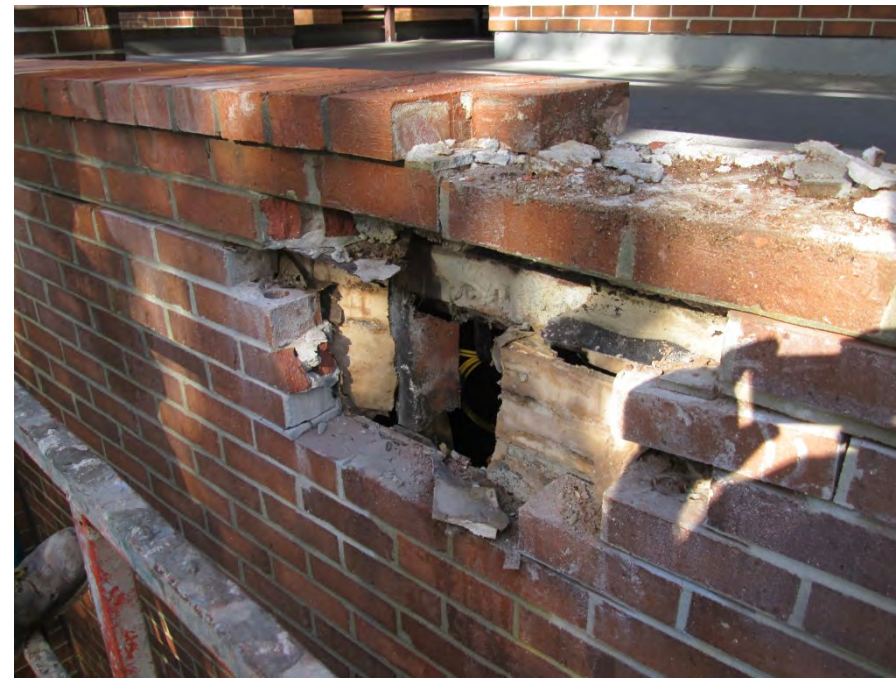
Deflected brick and separated mortar (through wall fabric flashing acts as bond breaker in masonry bed joint)

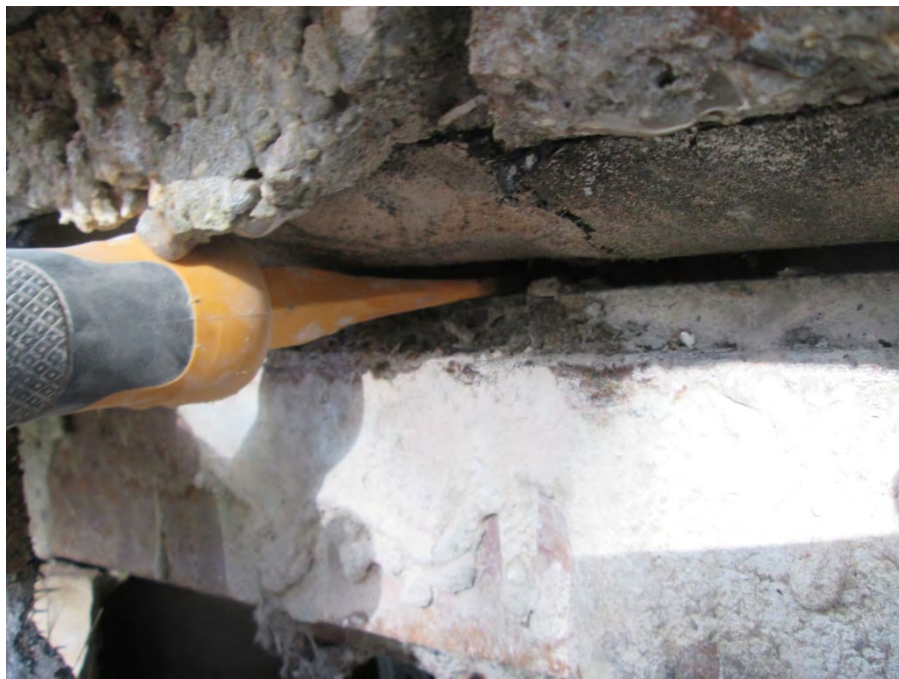
Gap between mortar bed joint for brick coping and concrete curb support

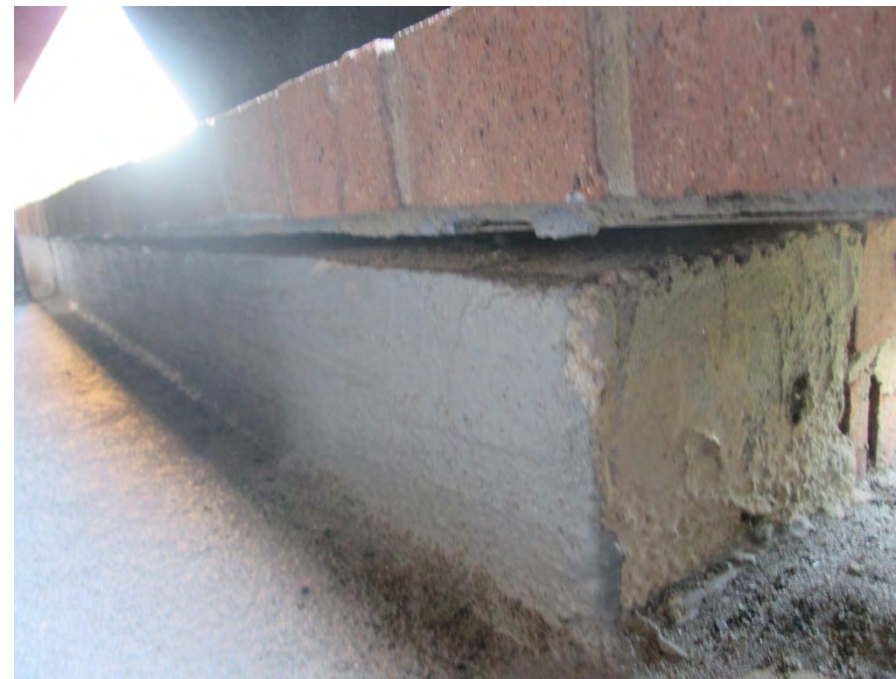
Gap between brick coping and concrete curb support (view from corridor)

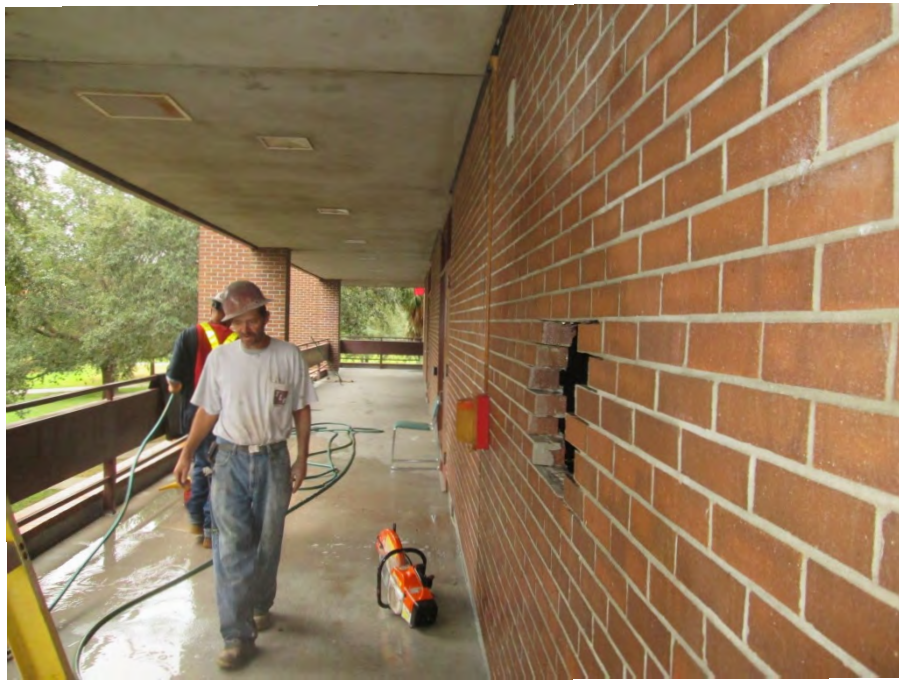
Overview of Exploratory Opening 12

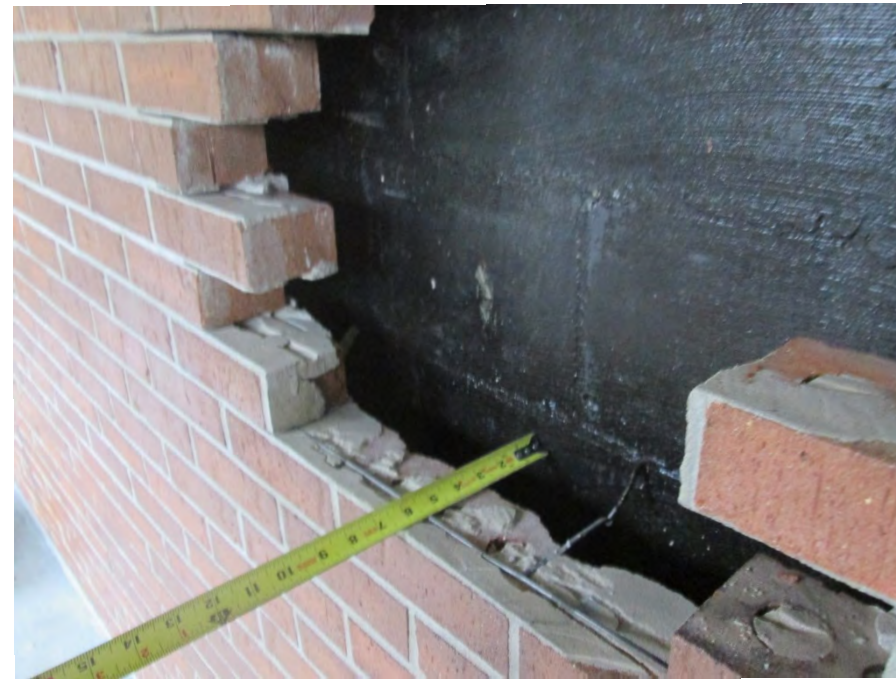
Ladder reinforcement embedded in brick masonry bed joint
