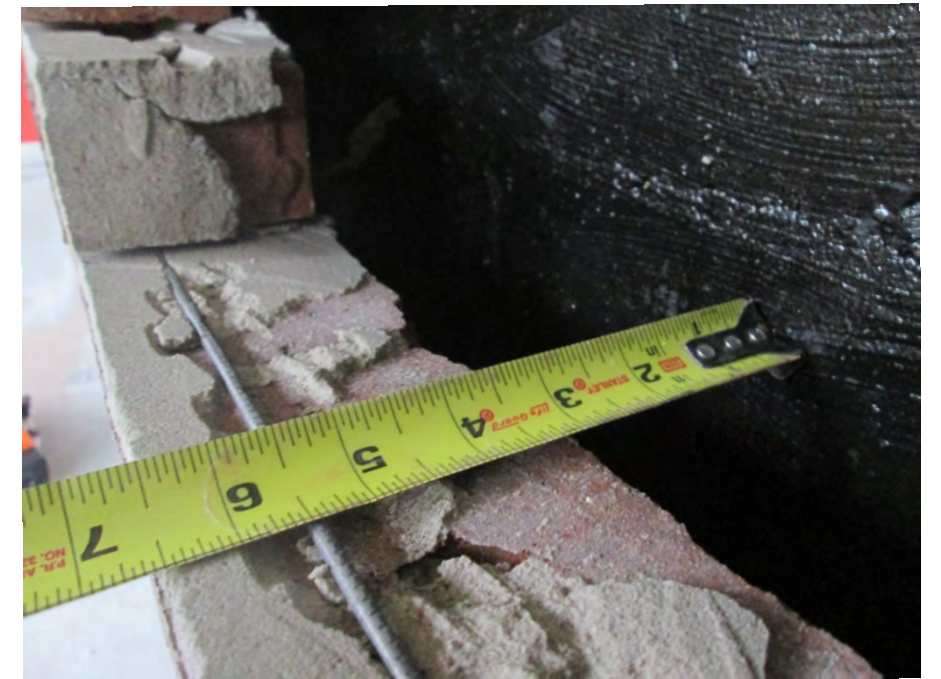
Ladder reinforcement embedded in brick masonry bed joint

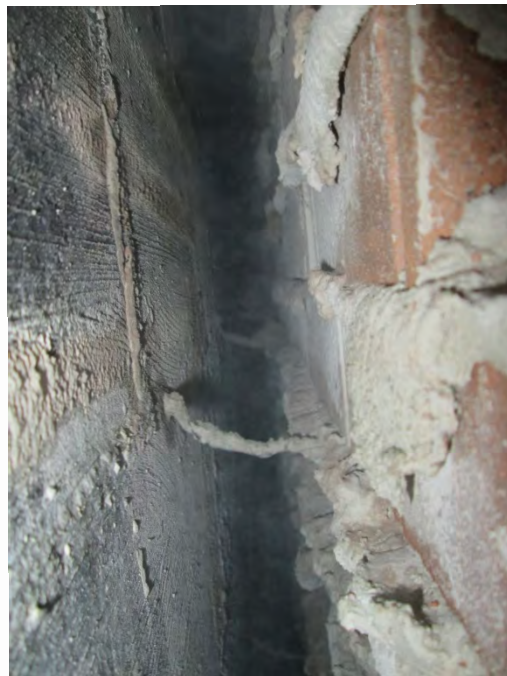
Ladder reinforcement attached to CMU wall backup

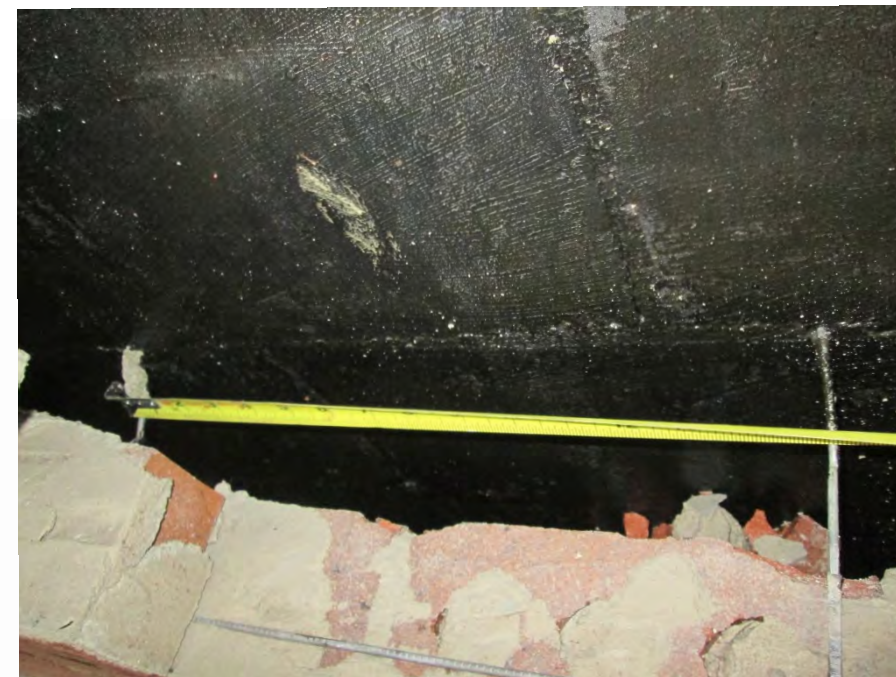
Vertical tie spacing measured at approximately 15-inches on center

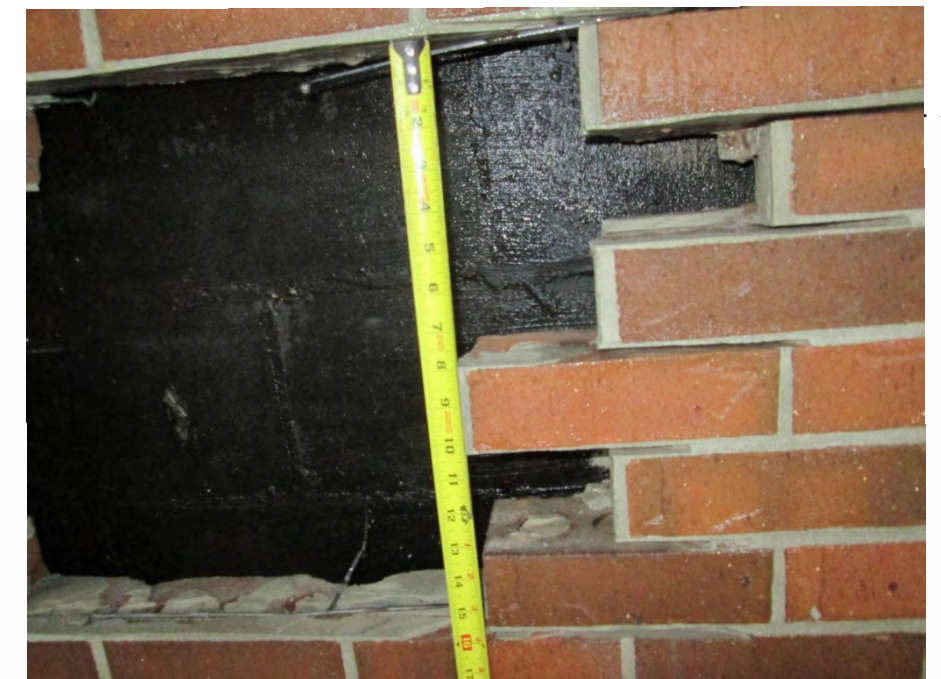
Vertical tie spacing measured at approximately 15-inches on center

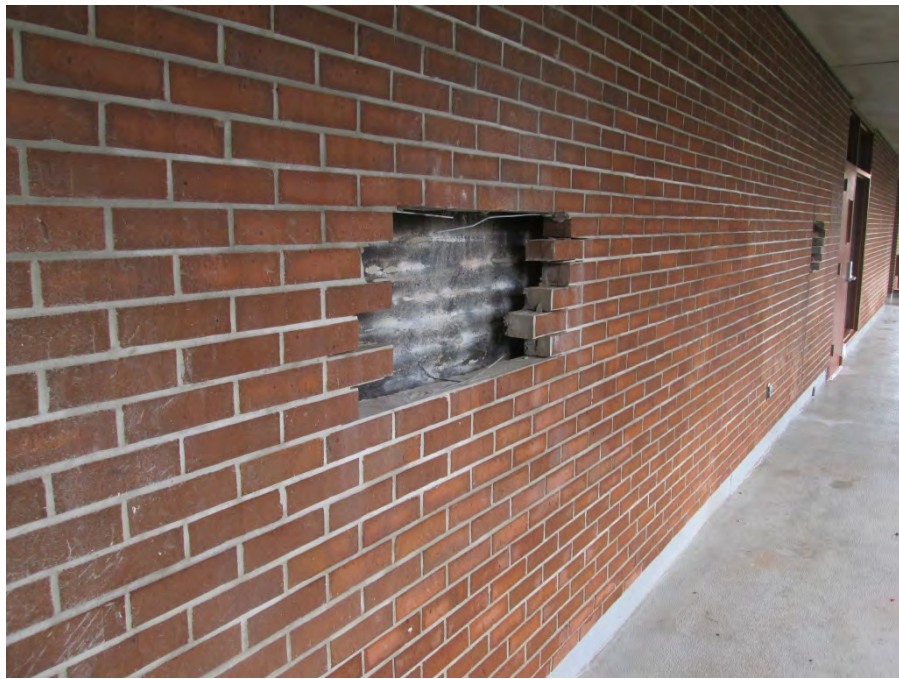
Overview of Exploratory Opening 13

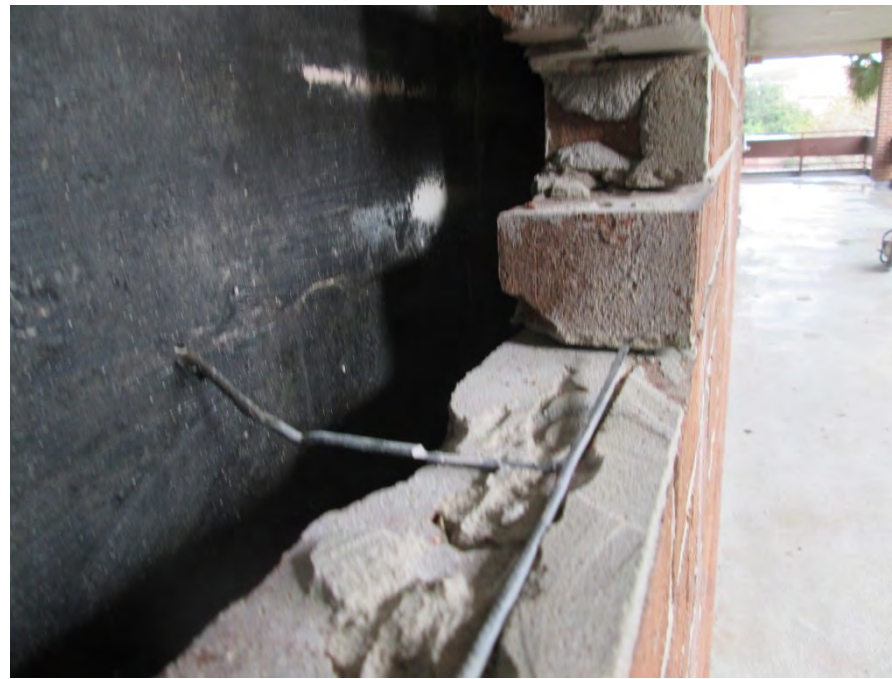
Ladder reinforcement embedded in brick masonry bed joint

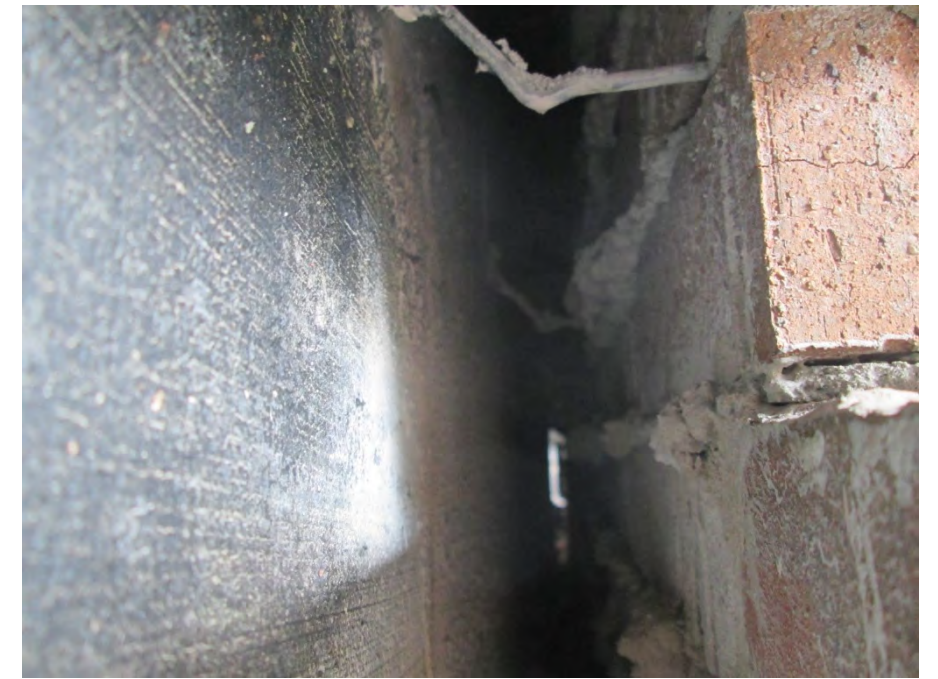
View of ladder reinforcement from CMU backup wall to brick masonry bed joint

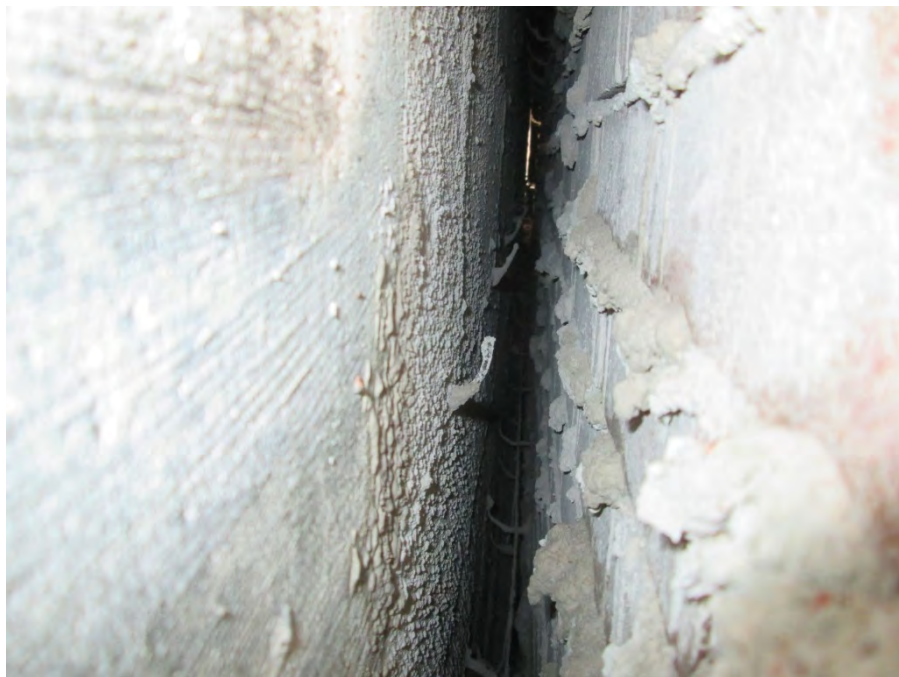
Cut ties of ladder reinforcement projecting from CMU wall backup

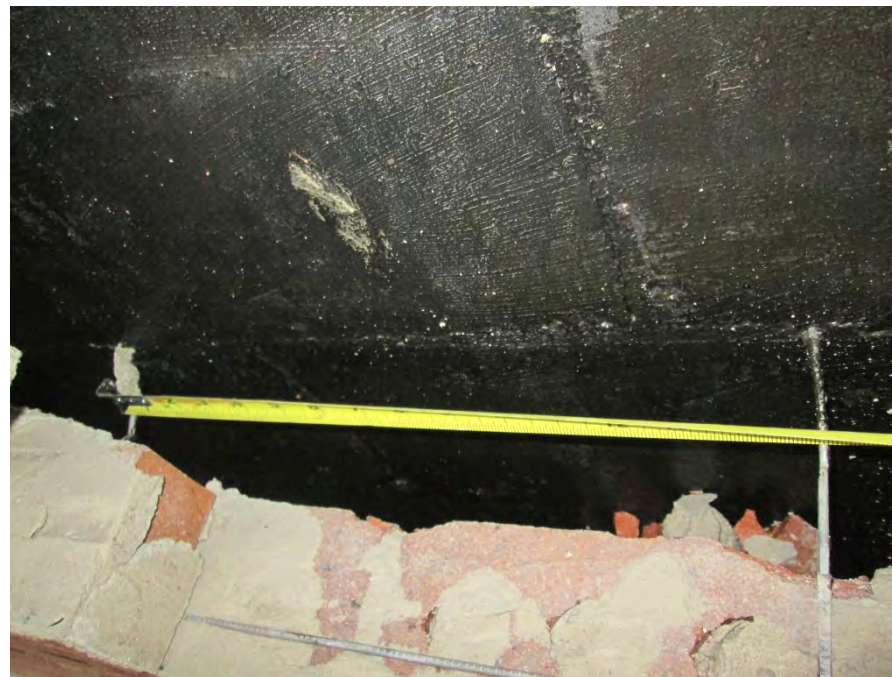
Vertical tie spacing measured at approximately 15-inches on center

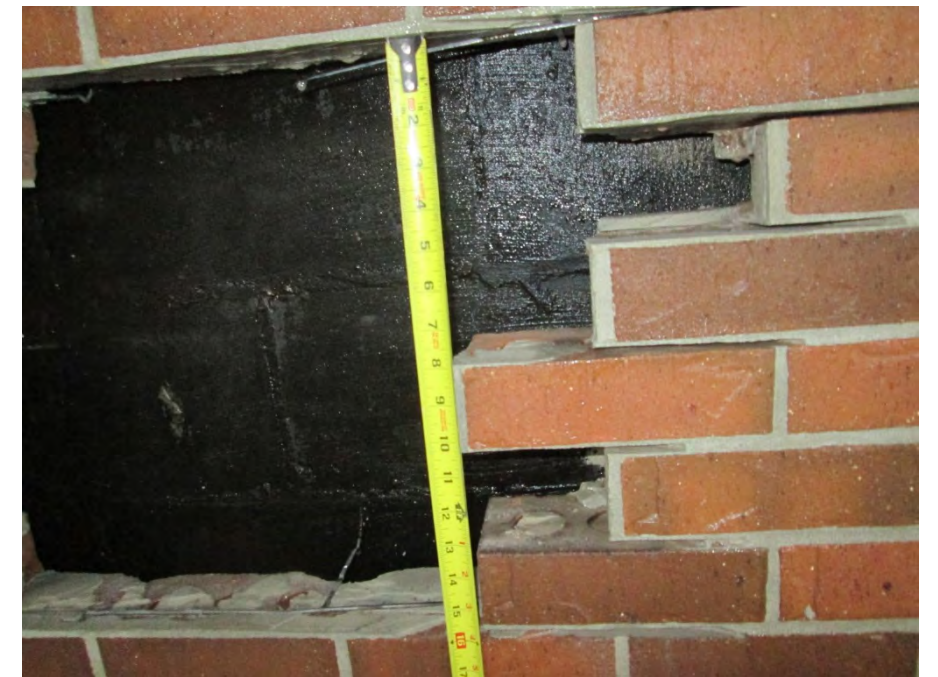
Vertical tie spacing measured at approximately 15-inches on center
